# Building Inspection Report

Inspection Date: 9 Aug 2023

**Property Address: 16 Aaran Close  
Endeavour Hills 3802**

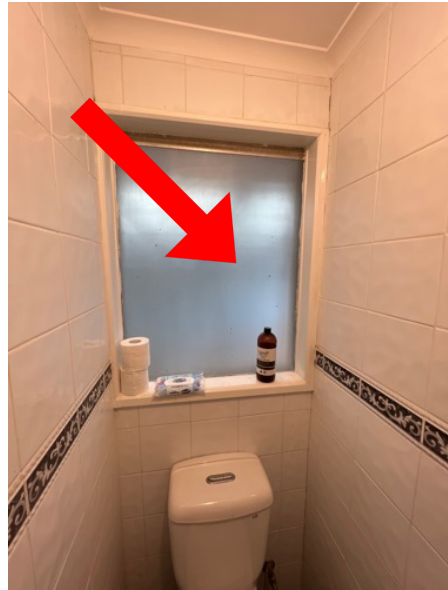
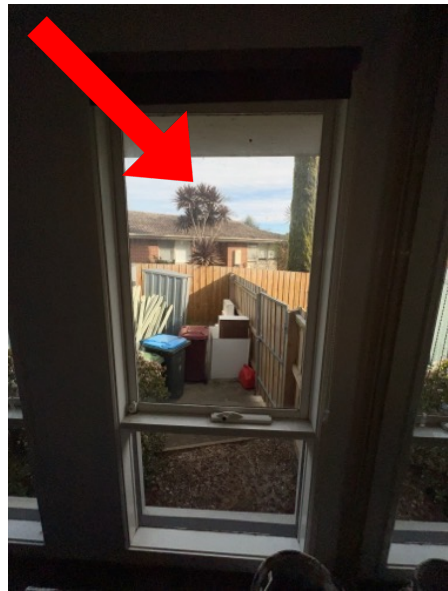
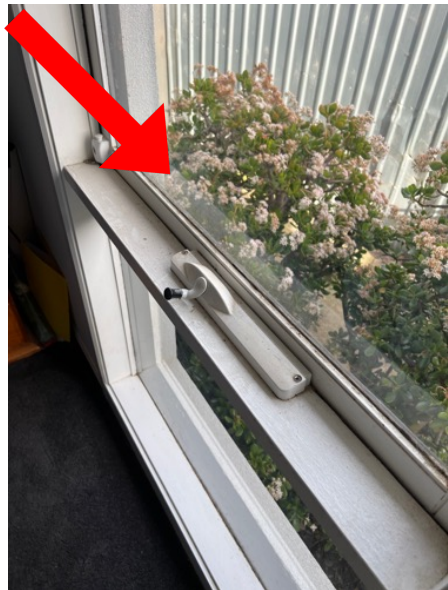
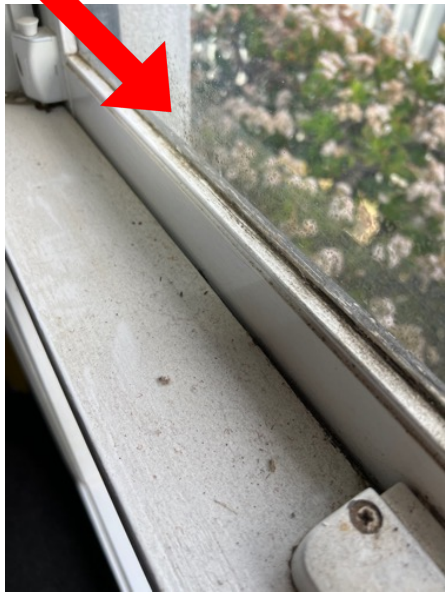
### Safety Hazard 1.01

**Location:** All areas

**Finding:** Mould - Present

Mould growth was evident in areas of the property which can be due to previous water leaks. Where evidence of mould growth was noted, there may be environmental, biological or health issues associated with the report. A specialist inspection by a suitably qualified environmental health inspector is warranted, where mould is extensive or where any queries regarding air quality spores or other related issues apply.

Any mould found during the inspection should be cleaned immediately by a cleaning contractor or the homeowner as applicable.

Please note that severely affected building elements will require replacement by a registered builder or qualified carpenter.

Once the mould has been removed, air quality samples should be collected to confirm the mould has been removed from the property.

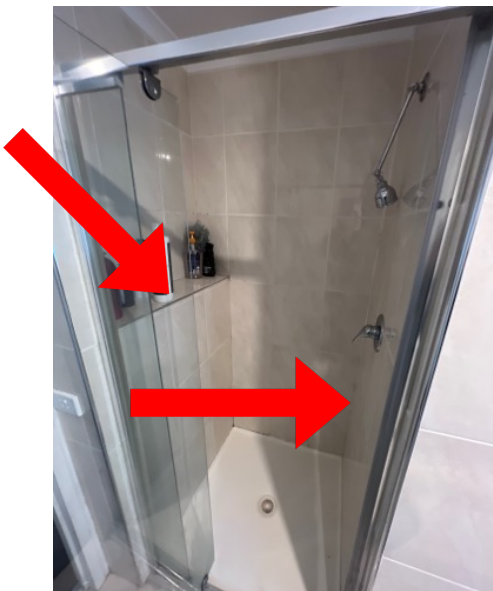
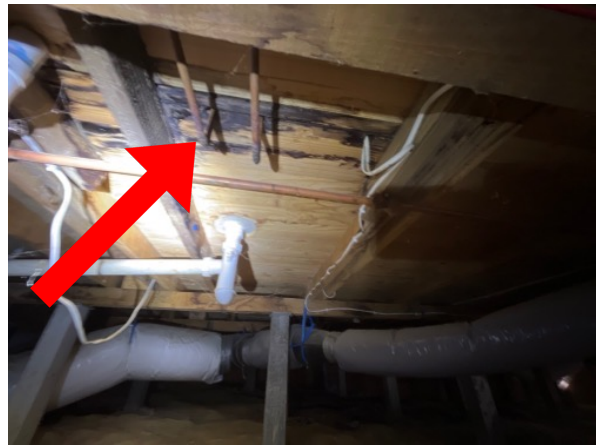
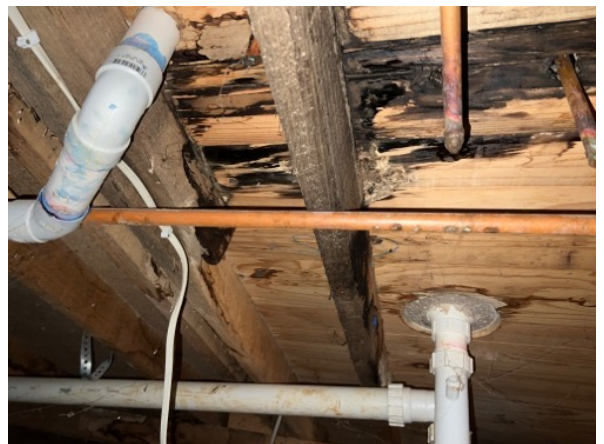
### Major Defect 2.01

**Location:** Bathroom

**Finding:** Shower Area - Leaking

Leaking appears to be evident to the shower area at the time of inspection. It is suspected that the leaking has occurred as a result of a failing membrane, leaking pipes or general ageing of the building elements.

Leaking from the shower base, where left unattended, is likely to lead to water damage to adjoining flooring and walls. Such damage can lead to water damage and necessitate extensive remedial works being required. Active water leaks may also create an environment that is susceptible to the formation and development of mould and termite activity. It's advised to consult with a registered builder to repair or replace shower area. Such works should be performed as soon as possible to ensure that no further damage occurs.

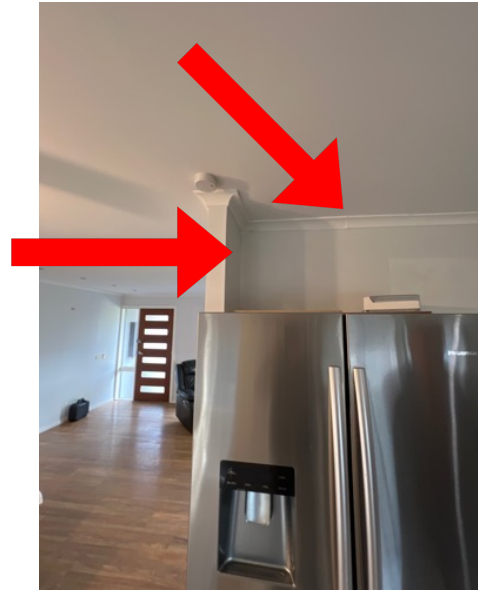
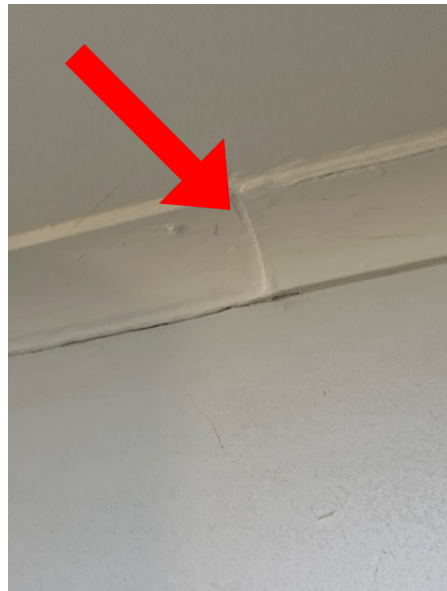
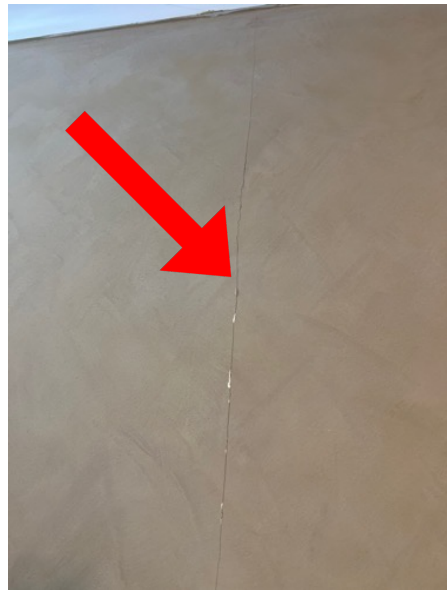
## Minor Defect 3.02

**Location:** All areas

**Finding:** Cracks - Plaster Work

Cracking was evident to the walls and ceilings throughout the property. Cracking of this nature is likely due to movement of the structure and poor workmanship during construction and renovations. It's advised to consult with a registered builder for rectification works.

Monitoring of all cracking should be conducted frequently. Always contact a building inspector should cracks widen, lengthen, or become more numerous.

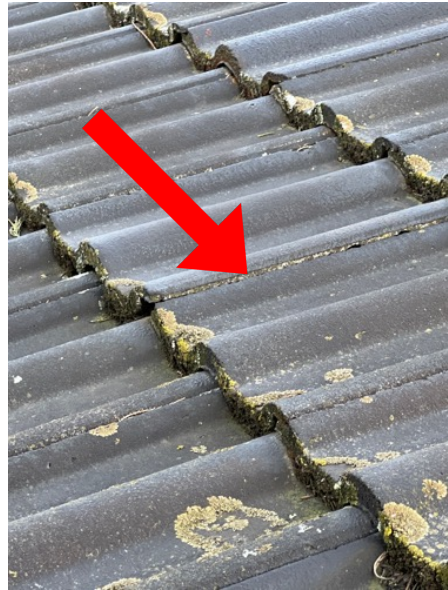
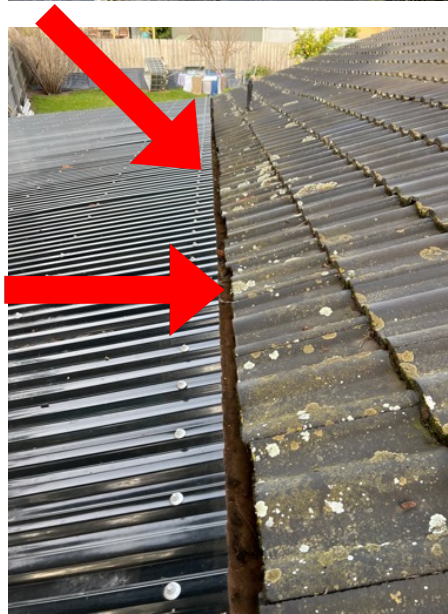
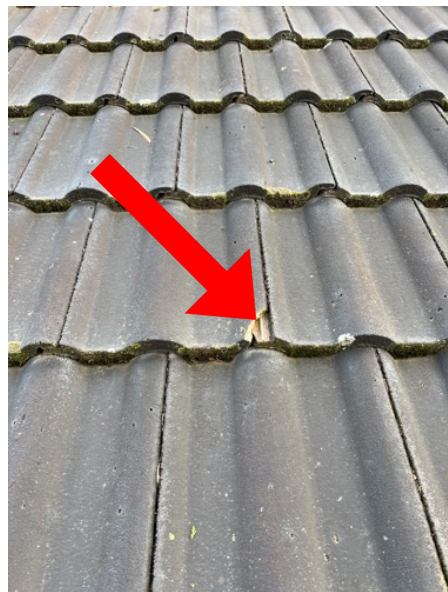
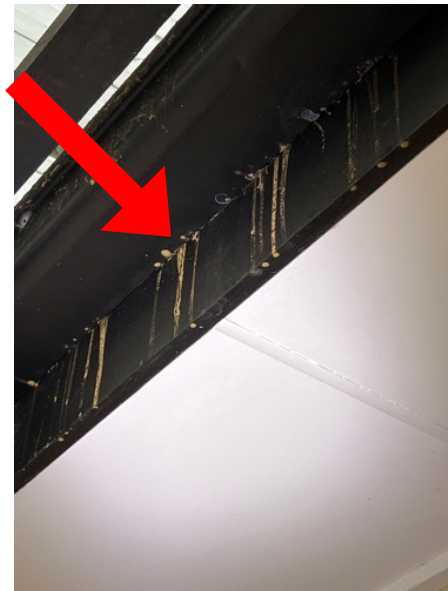
### Minor Defect 3.03

Roof exterior

Overhang of roofing - Tiles roofing

Tiled roofing is defective in these areas as the tiles overhang the inside face of a gutter by less than 35 mm which has caused capillary action and allowed water to cause water staining on the roofing timbers. It's advise to consult with a registered builder and licensed plumber for rectification works. These works should be conducted as soon as possible.

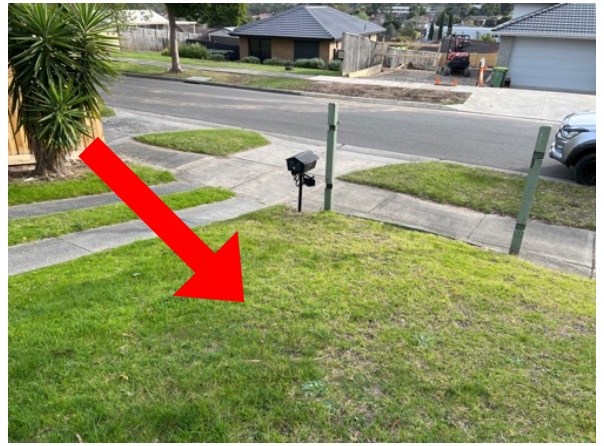
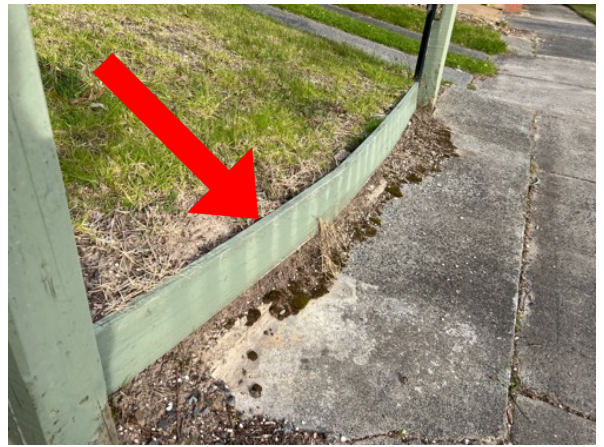
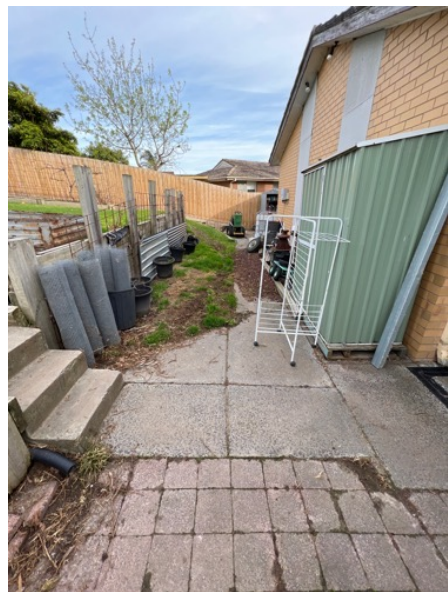
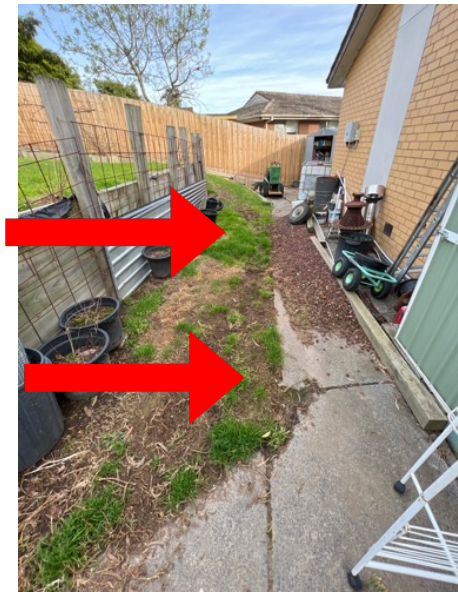
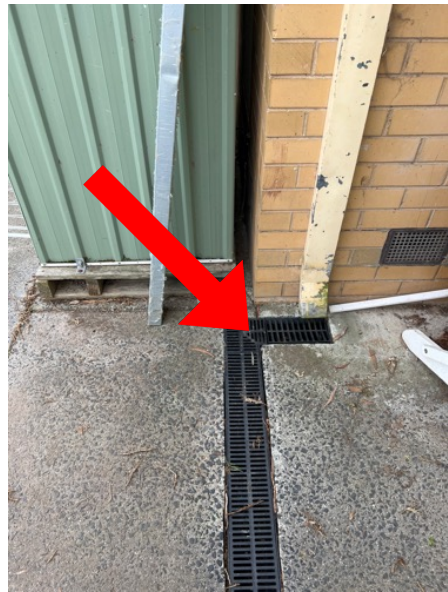
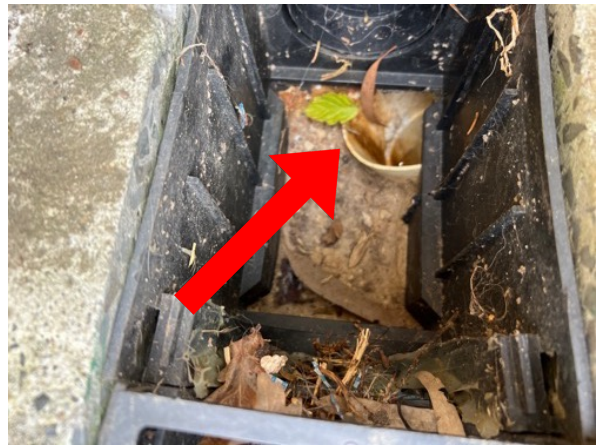
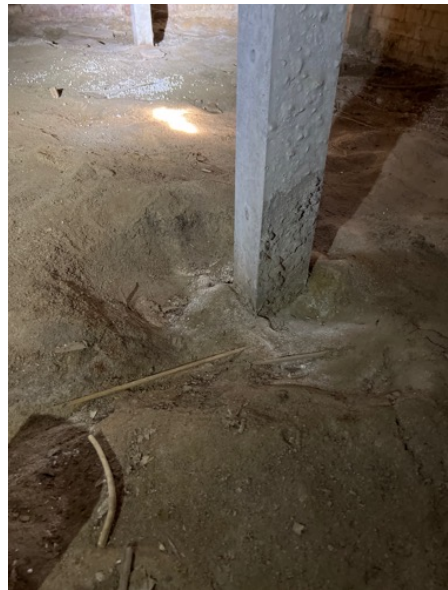
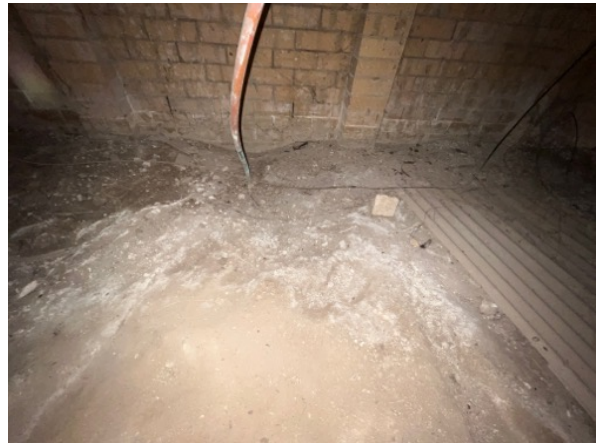
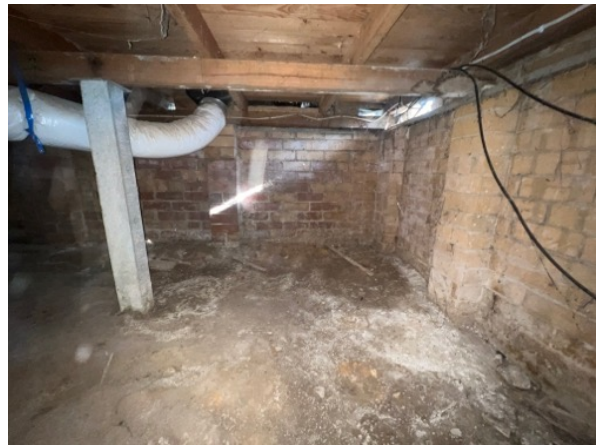
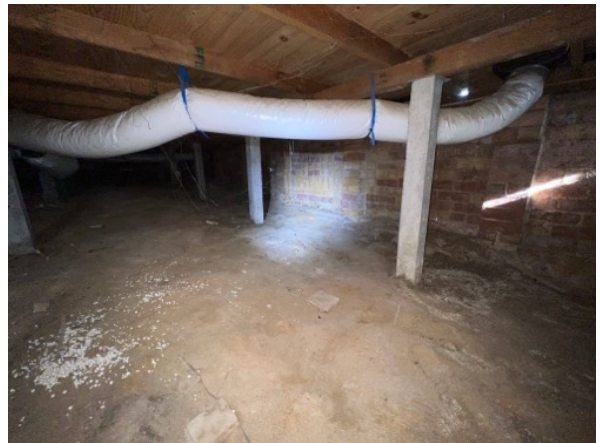
### Minor Defect 3.04

**Location:** All External Areas

**Finding:** Site drainage - Possible Damage

The site drainage around the property appeared poor and allows water to run into the subfloor during rain fall. Poor site drainage can create subsequent water damage to building elements. It is important that water does not lie against the base of walls; surrounding paths and ground levels should be sloped to drain water away from walls. Downpipes should not discharge stormwater onto lower walls or plinths. Stormwater should be carried away by drains. Due to the location of the property, evidence of water flowing, pooling in the subfloor damage to parts of the subsoil drainage should be expected and should be further inspected by a licensed plumber. Inspection of the drainage is excluded from this report.

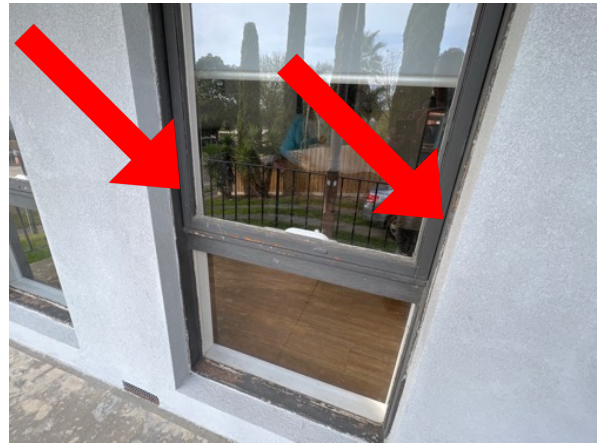
### Minor Defect 3.06

**Location:** All areas

**Finding:** Windows - Binding/Jamming

Binding and/or jamming of these windows was evident during standard operation. This defect inhibits the functionality of the affected windows as well as creating potential for secondary defects to associated building elements, such as damage to the window jambs.

A window that binds to the frame may have several causes, ranging from minor defects, such as poor installation of the window or movements to building structures.

A qualified carpenter or general handyperson should be appointed to perform rectification works.

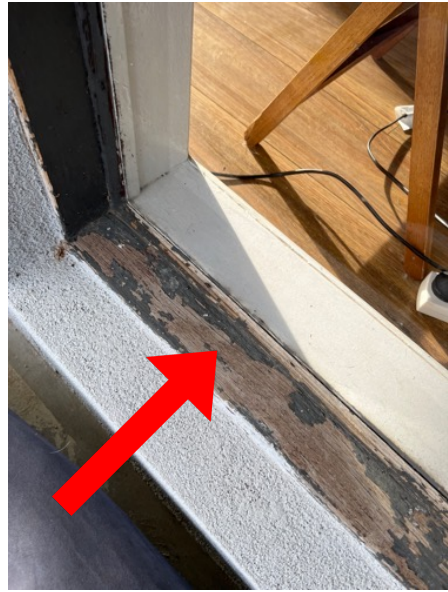
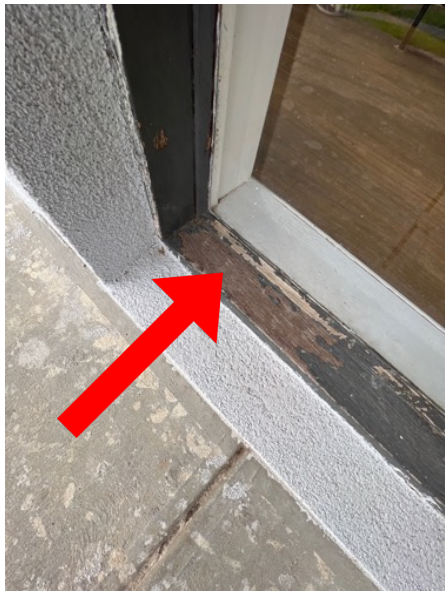
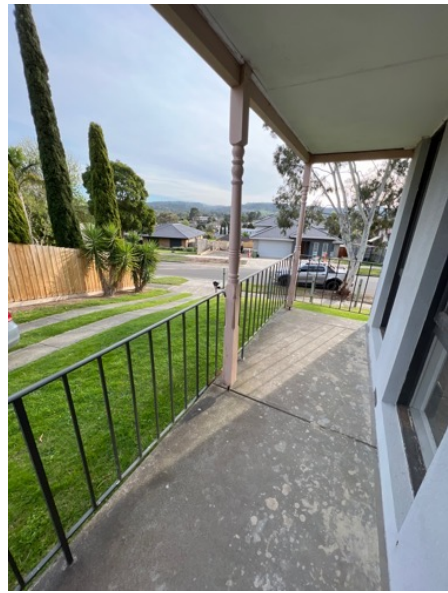
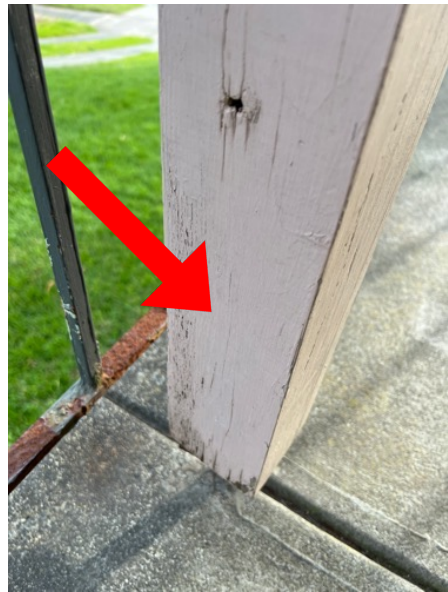
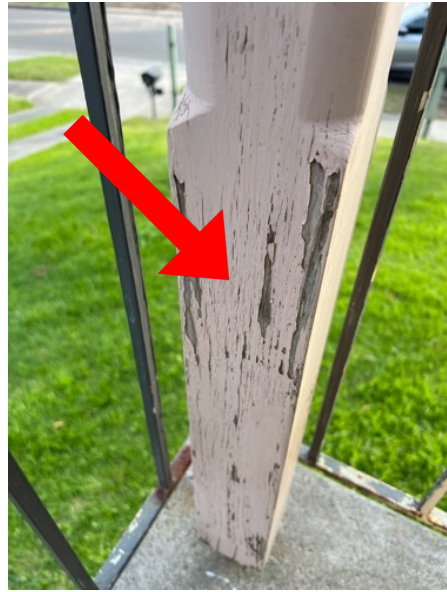
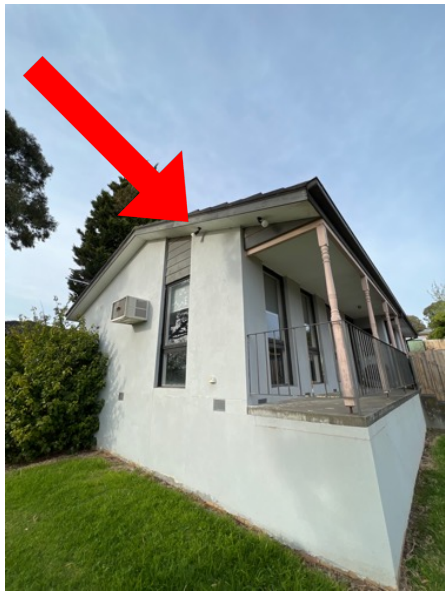
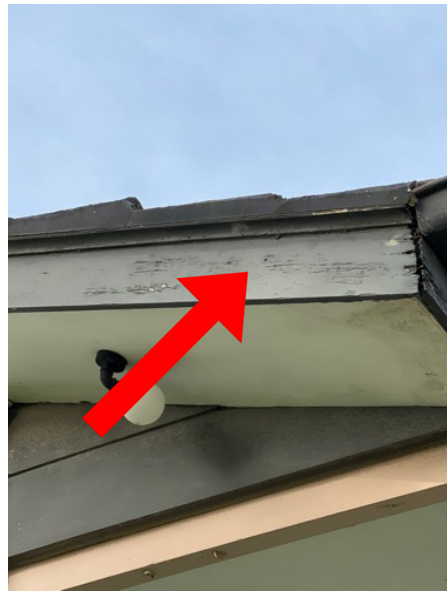
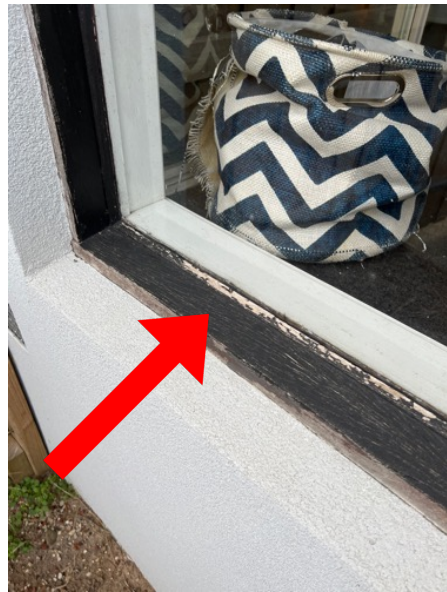
### Minor Defect 3.07

All External Areas

Timber - exposed to weather

All external timbers that are frequently exposed to harsh weather conditions require adequate protection in order to maintain their condition. Where timbers have not been painted or treated adequately, general deterioration is likely to occur at an accelerated rate. If left unattended, replacement of these timbers is likely to be necessary in the short-term future. Adequate treatment of these timbers is required as soon as possible by a painting contractor.

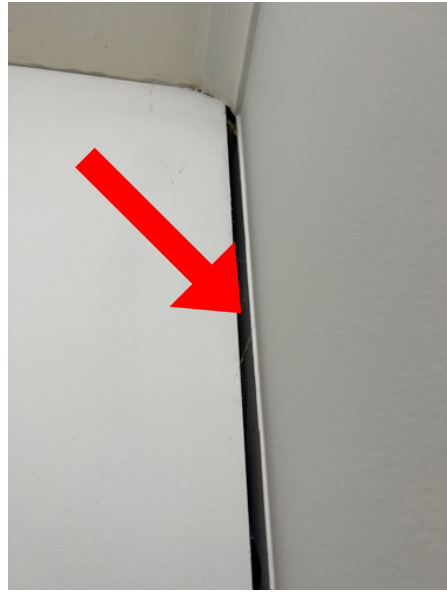
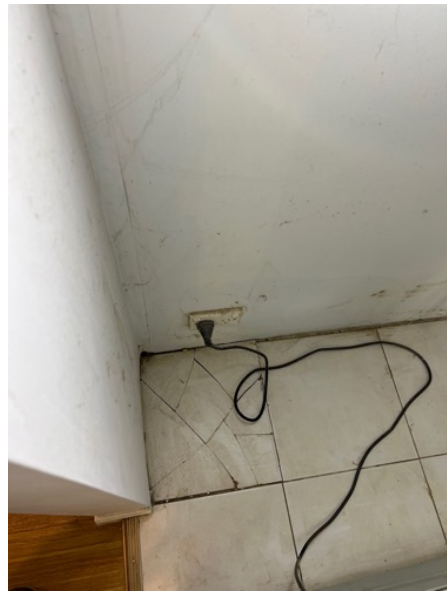
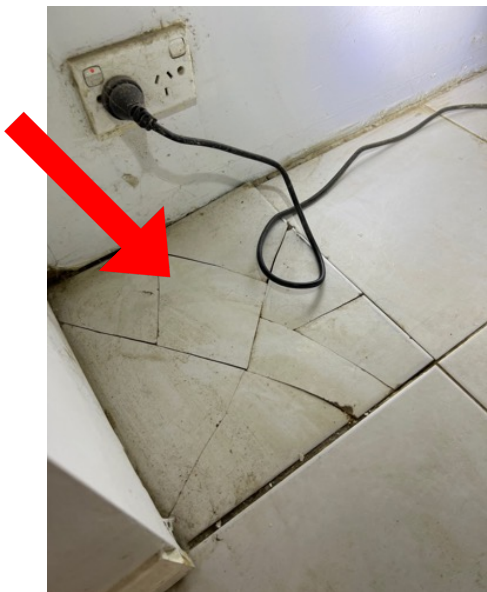
### Minor Defect 3.08

**Location:** All areas

**Finding:** Flooring - Uneven

The internal flooring throughout the property is out of level and uneven which has caused cracked tiles, wardrobe leaning from the wall, doors and windows to jamb . Uneven flooring is likely to indicate defects such as poor site drainage and the subsidence of the subfloor stumps and movement of the foundations of the property. It is advised that a more invasive inspection of the subfloor structures and stumps be conducted by a registered builder, specialist in re stumping and the repackaging of the stumps be conducted where required.

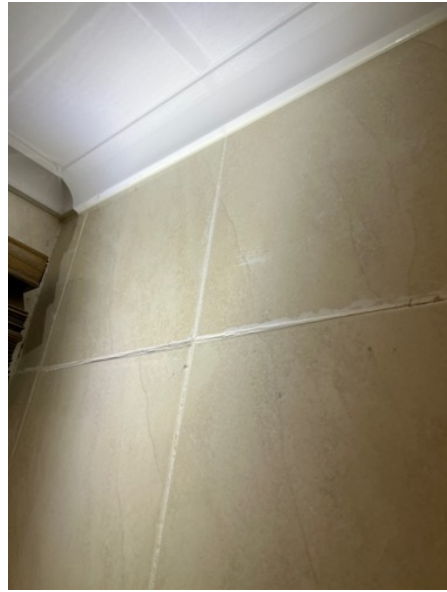
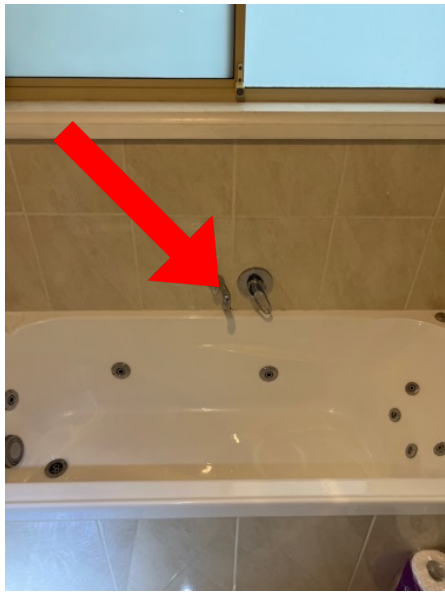
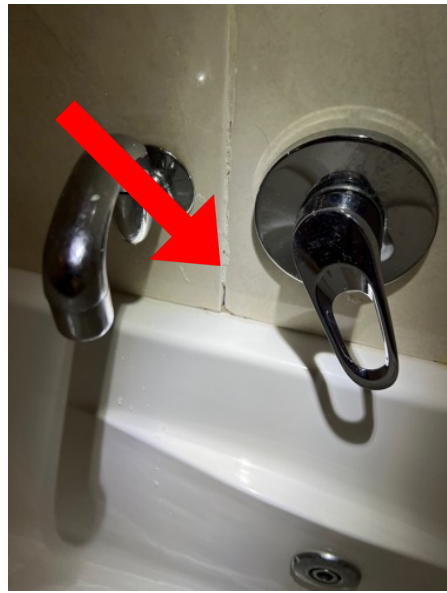
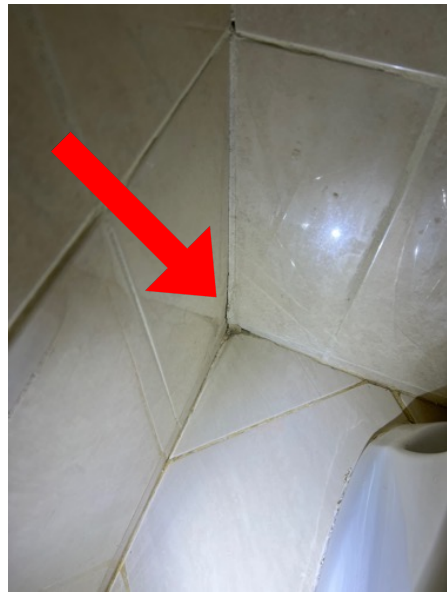
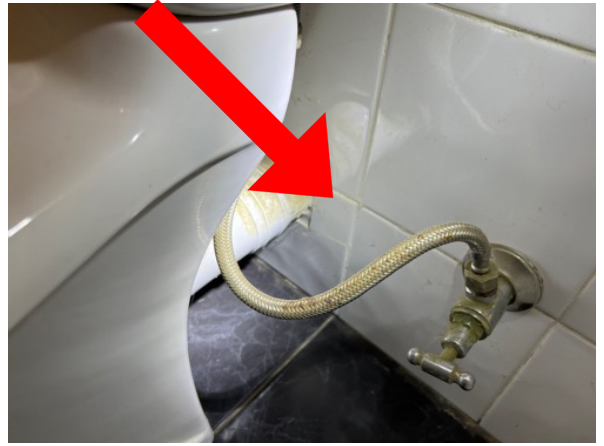
## Minor Defect 3.09

**Location:** Bathroom

**Finding:** Bathroom Area Tile - Cracked

Cracking was evident to the bathroom area tiles at the time of inspection which appears to be due to poor workmanship and water damage. This area is frequently exposed to water and any cracking and loose tiles is likely to allow water penetration. If left unmanaged, water penetration may cause water damage to other elements, and necessitate significant rectification works. Appointment of a registered builder and tiling contractor is required to repair the cracked tiles, so as to ensure no water penetration occurs. These works should be conducted as soon as possible.

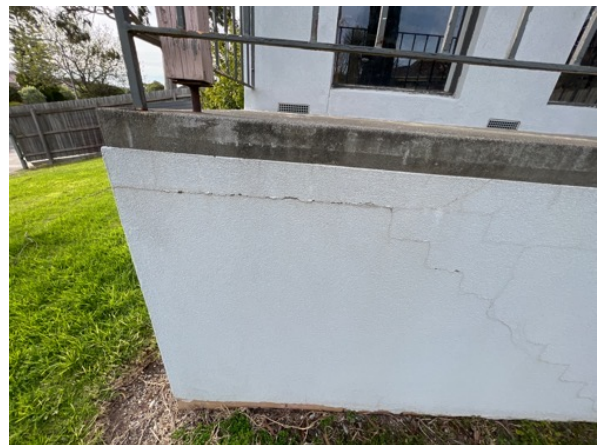
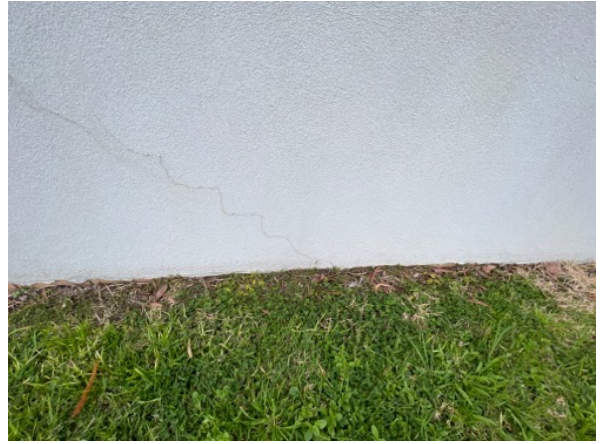
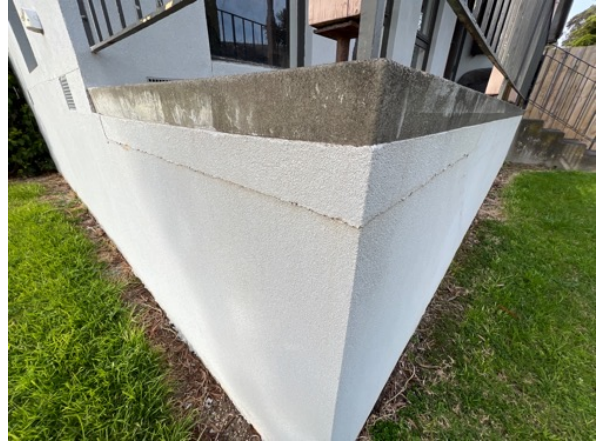
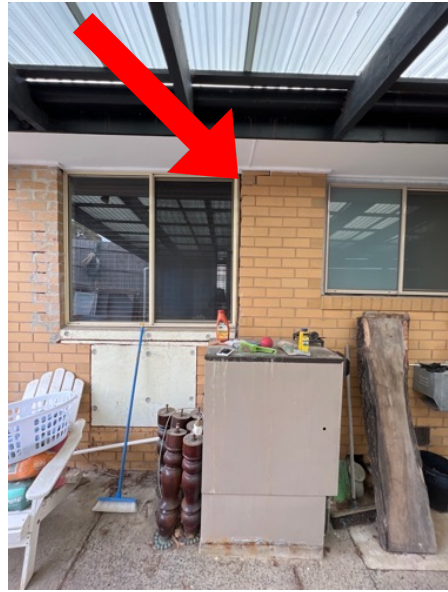
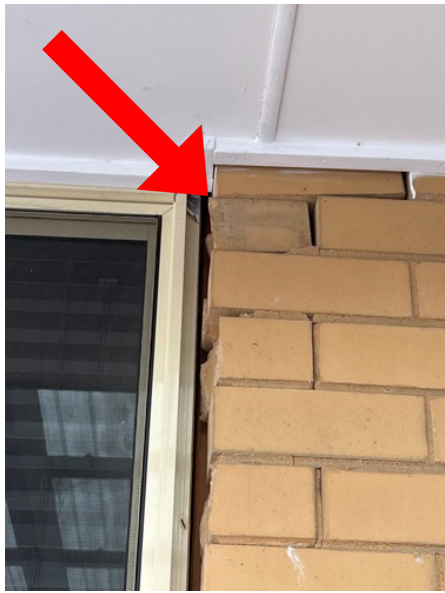
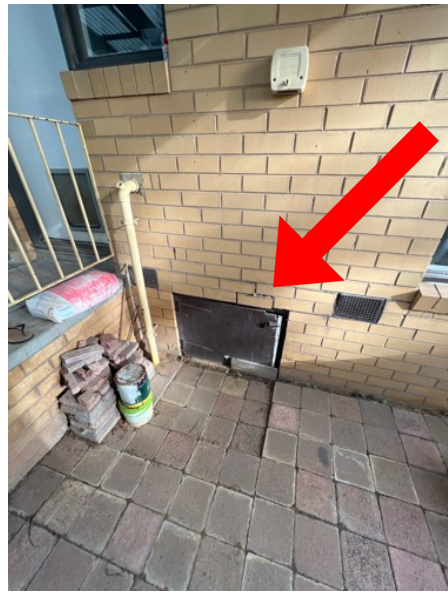
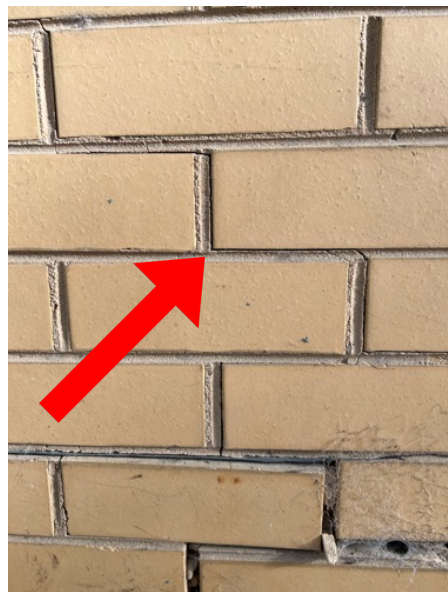
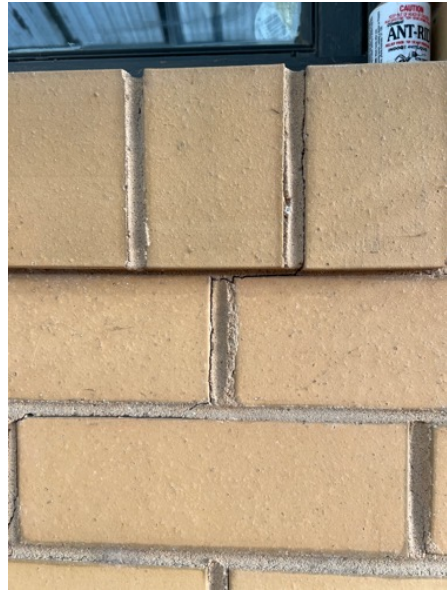
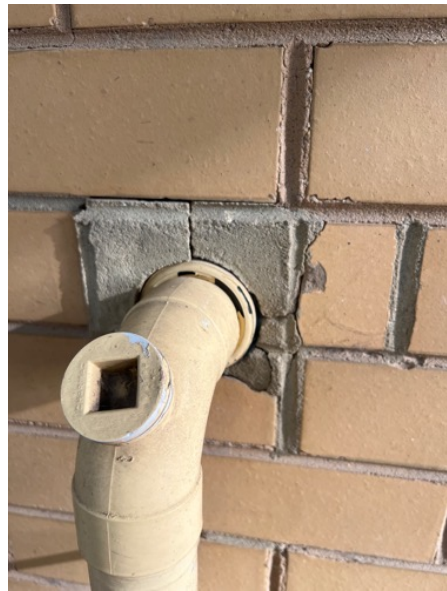
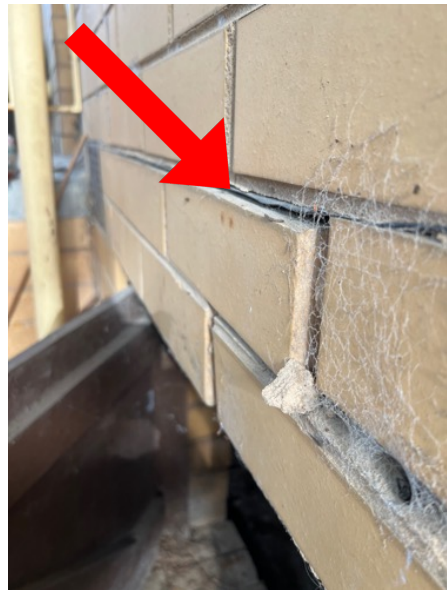
### Minor Defect 3.10

**Location:** Exterior Walls  
**Finding:** Brickwork cracking

There are several cracks evident to the sections of brick walls. These cracks usually coincide with openings (windows and doors) however they can present in other areas also. Cracks of this type are likely to have been caused by poor site drainage and flooding which causes deterioration of the bricks, mortar and footings allowing movement of building elements, but may also have a structural cause that is more significant. Noticeable cracks in walls may develop if left unattended with the potential of necessitating remedial works or replacement of sections of brickwork. Consultation with a structural engineer is required to further access the property and where structural instability is found to be the underlying cause of the cracking major rectification works should be expected. Always monitor these cracks and contact a building inspector should cracks widen lengthen or become more numerous.

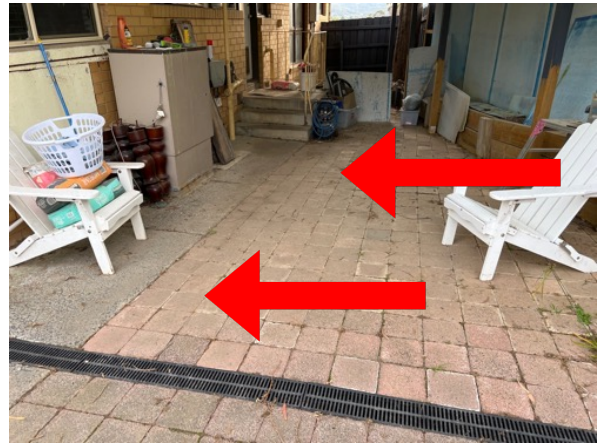
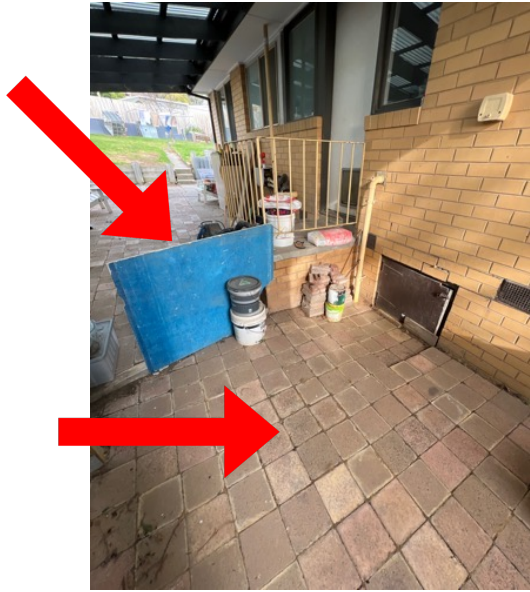
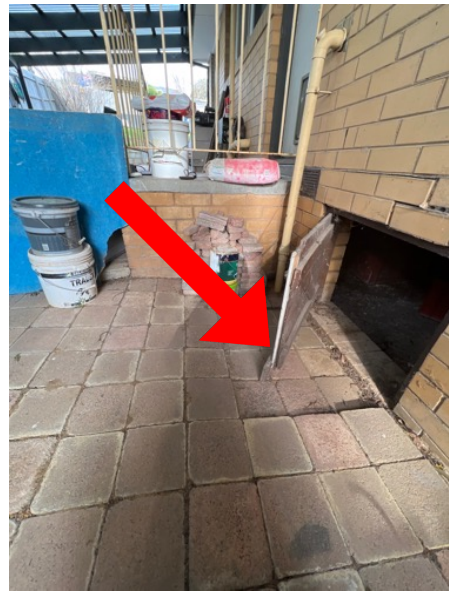
### Non Compliant 4.01

**Location:** Backyard  
**Finding:** Perimeter Paving - Insufficient Fall

The perimeter paving or ground levels were found to have an inadequate slope away from the adjoining building structure, creating potential for water pooling in this area.

Perimeter paving is required to fall from the building by a minimum of 25mm in the first metre and bare ground should fall away from the house by 50mm in the first meter. This standard ensures that excessive moisture does not pool in the subfloor and around the base of building structures, which creates potential for water and structural damage, as well as making the area susceptible to termite and timber pest activity.

Where paving or ground levels do not have adequate fall, a licensed paving contractor should be appointed to install or remove and re-level pavement.

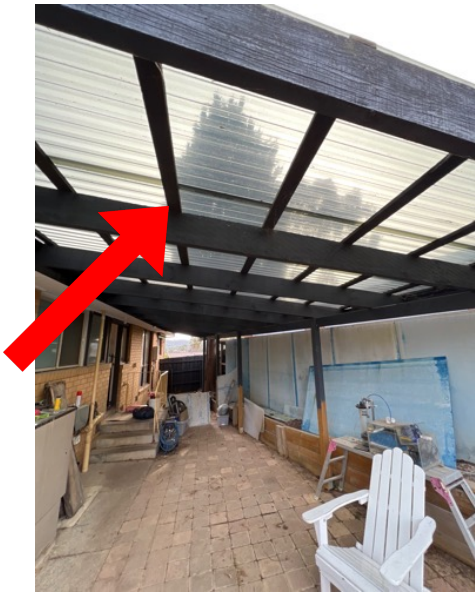
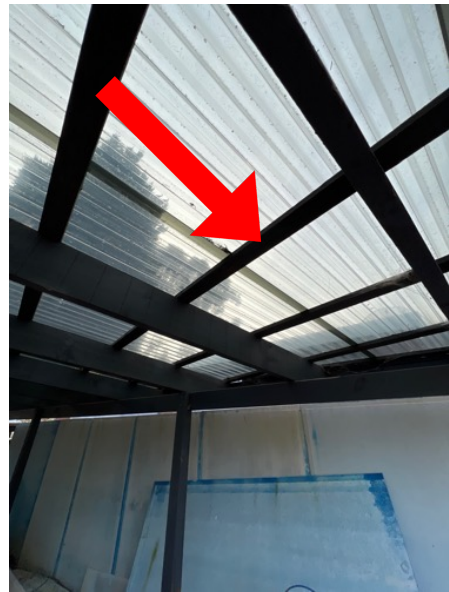
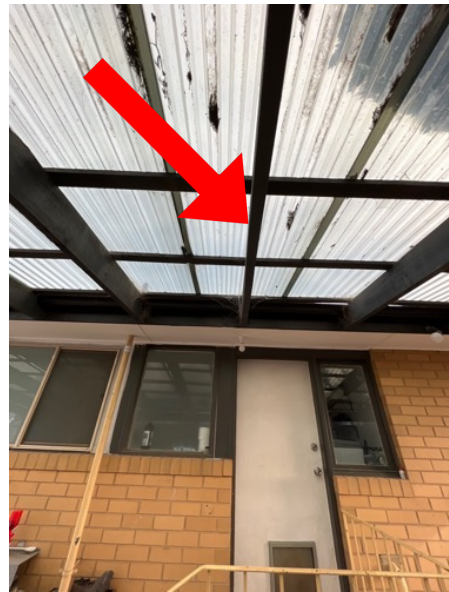
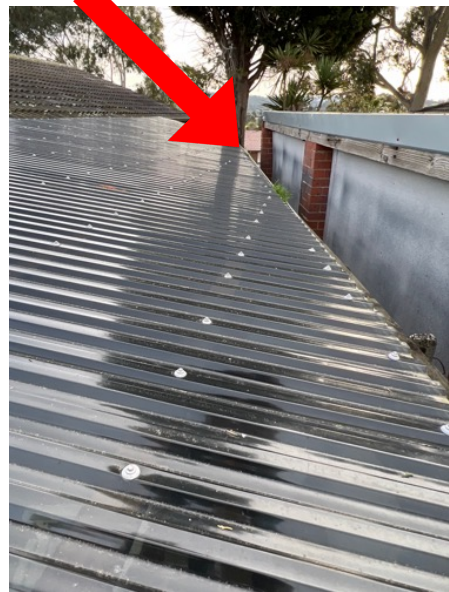
### Non Compliant 4.03

**Location:** Pergola

**Finding:** Pergola - Poor Workmanship

The pergola show a range of defects and non compliant works. A non compliant pergola structures is likely to create strain on associated building elements, creating potential for secondary damage. The pergola is also unlikely to have sufficient support, which will lead to sagging if left unmanaged. It is critical to ensure that the fastenings holding important roof elements together remain structurally sound, correct sized battens and sagging gutters should be replaced. Remedial works are highly advised and should be performed by a registered builder or roofing contractor as soon as possible.

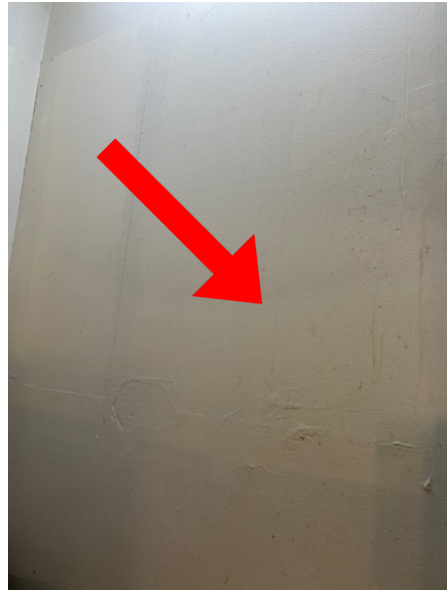
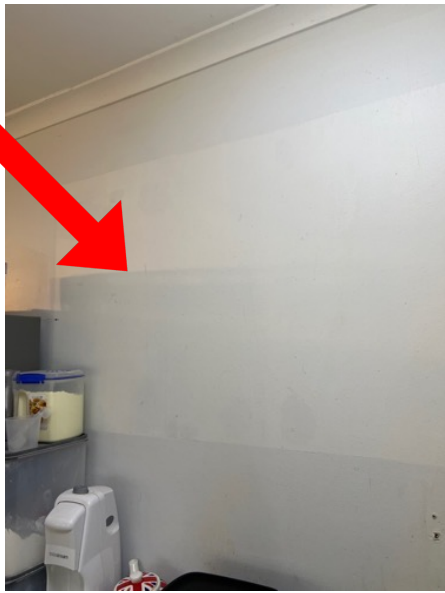
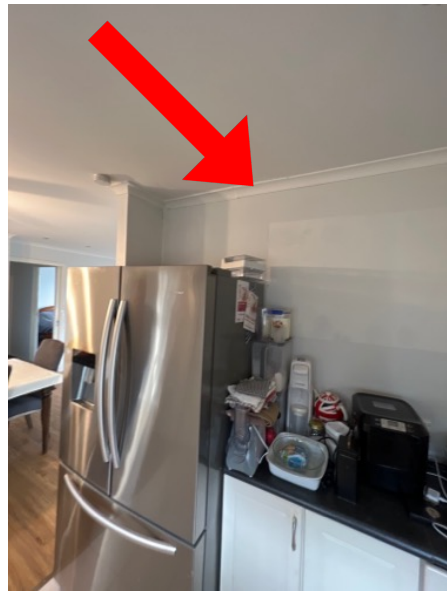
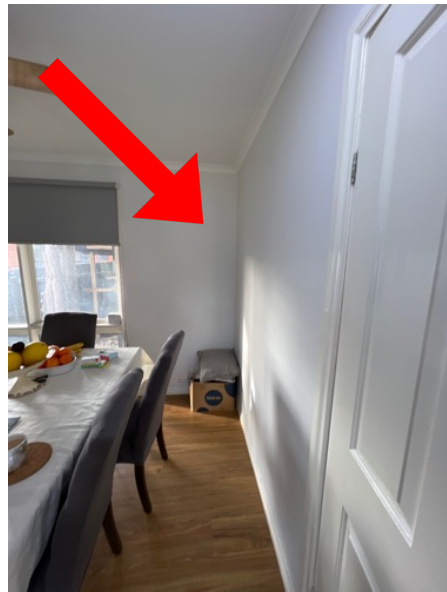
## For Your Information 5.02

**Location:** All areas

**Finding:** Handyman Works

These repair works including plaster and paint works have been conducted to a handyman level of work and appears to have been completed to a substandard level which doesn't comply with regular building practices. It is highly recommended that the substandard works be rectified by professional services. Works to improve this area are likely to increase the safety and the operation of the associated building elements. Rectification works are advised as soon as possible by the appropriate trades.

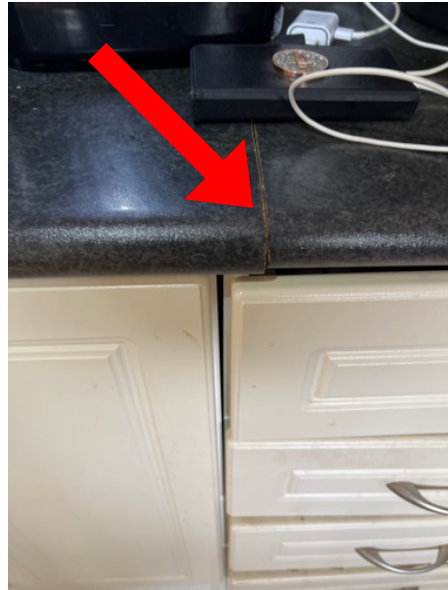
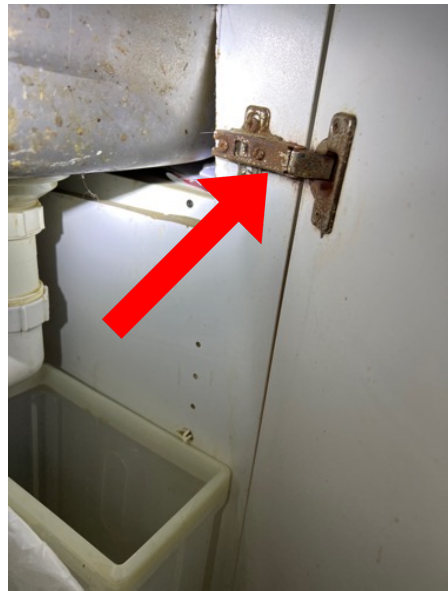
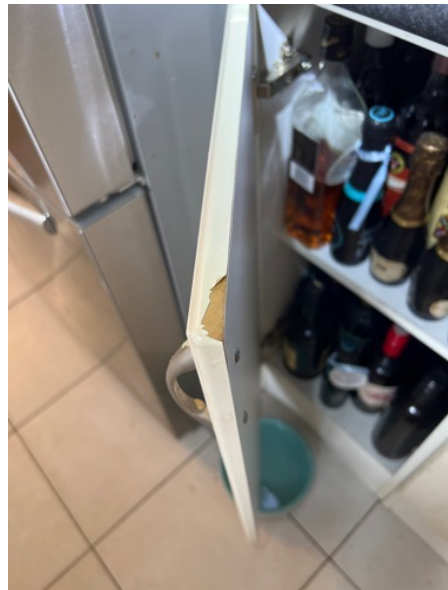
### For Your Information 5.03

Kitchen

Bench top - Water Damage

Damaged the to kitchen cabinets below the sink was evident at the time of the inspection. Due to the water ingress the cabinets have swollen and lifted the bench top. It's advise to consult with a cabinet maker for rectification works so no further damage is sustained. These works should be conducted as soon as possible.

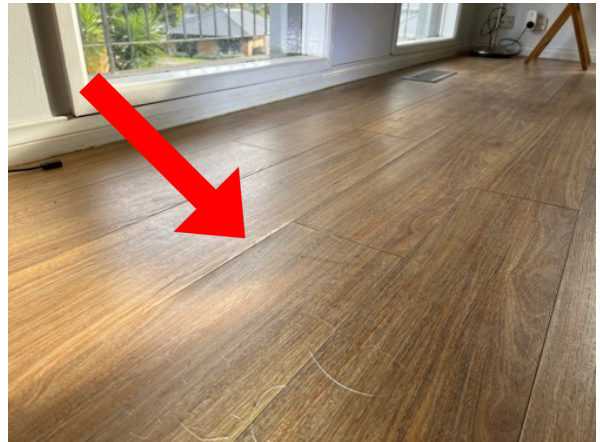
## For Your Information 5.04

**Location:** Lounge room

**Finding:** Timber flooring

Flooring, including tongue and groove strip flooring; structural plywood and particleboard sheet flooring, is defective if it is not installed according to AS 1684 and the manufacturer's installation requirements.
