# CAUSATION REPORT

**Insured:** James Dobbin  
**Loss Address:** 16 Aaran Close, Endeavour Hills, VIC, 3802  
**Claim Number:** 6210287371  
**Client Reference:** 1670192  
**CRD Reference:** 1678899  
**Prepared By:** Vincent Butler  
**Date:** 30 April 2020

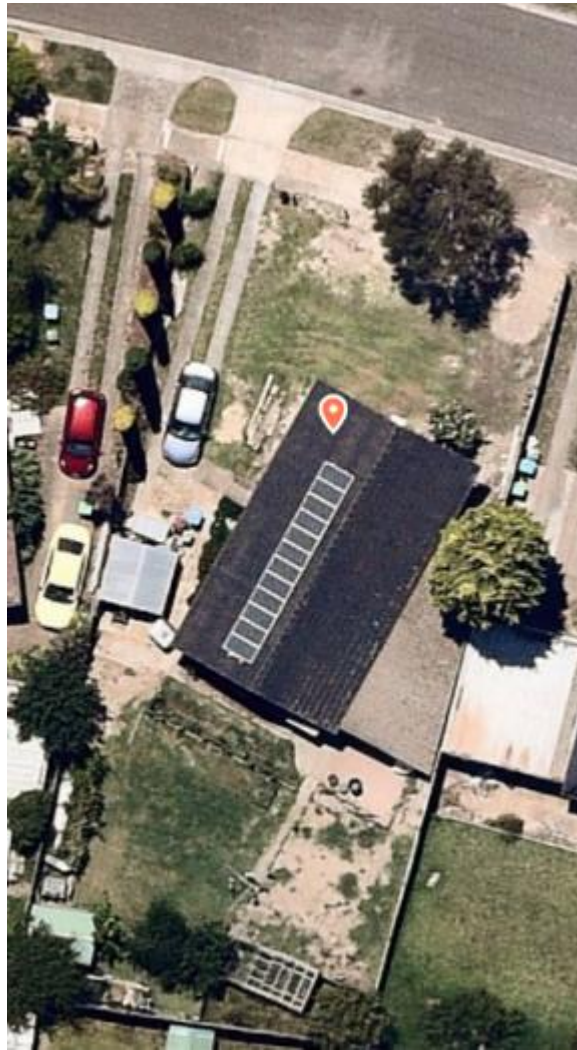
**Figure 1** – *Nearmap* aerial imagery of the Insured’s dwelling, dated 28 January 2020.

- 5.17 The author observed two significant trees adjacent to the Insured's dwelling. Refer Figure 1 below and Photos 1, 2 and 13 in Appendix A.
- 5.18 General Note: Section B2.3 – Class M, H and E sites of Appendix B in AS 2870 – 2011 – Residential Slabs and Footings – Construction, states that:

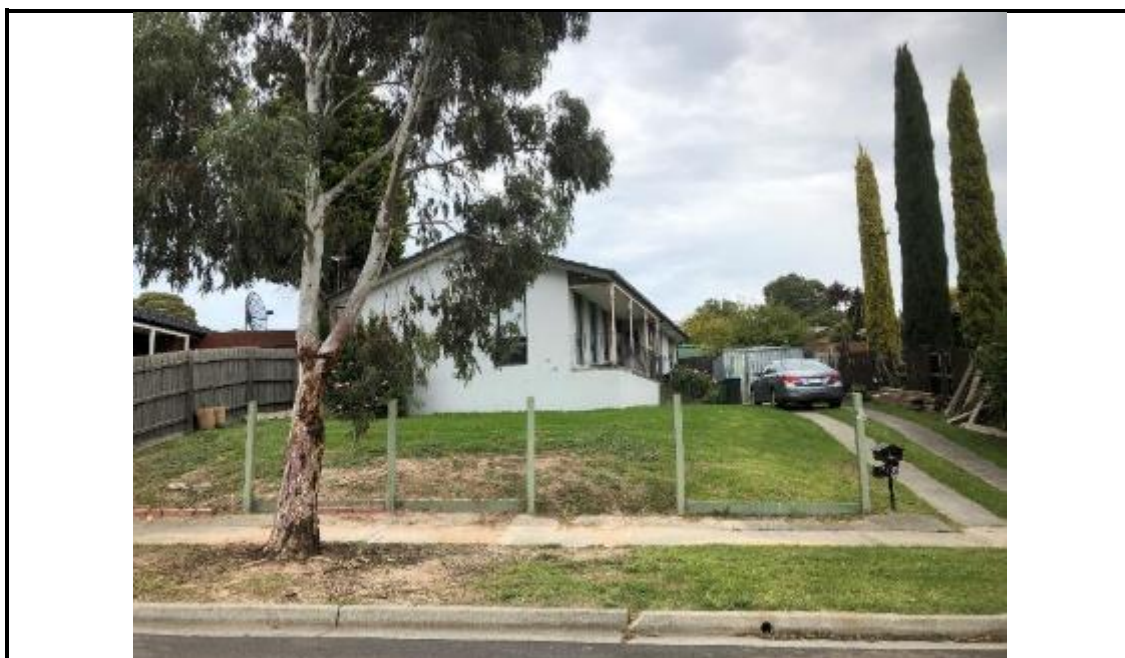
- 5.13 The external finished surface level immediately alongside the Insured's dwelling consists of pavers, grass and concrete. The grass (and areas of other paving which does not fall way from the dwelling) would allow surface water run-off to seep towards the founding soils of the dwelling. Refer to Photos 1 and 3 in Appendix A.

Photograph 1. Northern elevation of dwelling viewed from Aaran Close.

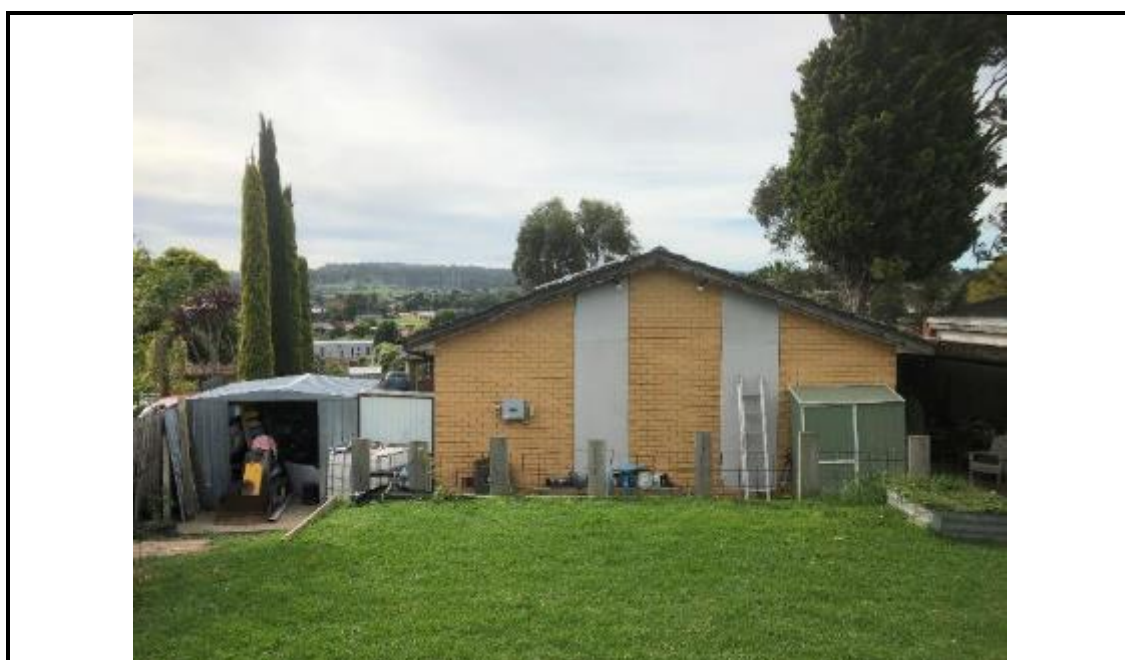
Photograph 2. Southern elevation of dwelling. Note tree immediately adjacent to eastern elevation.

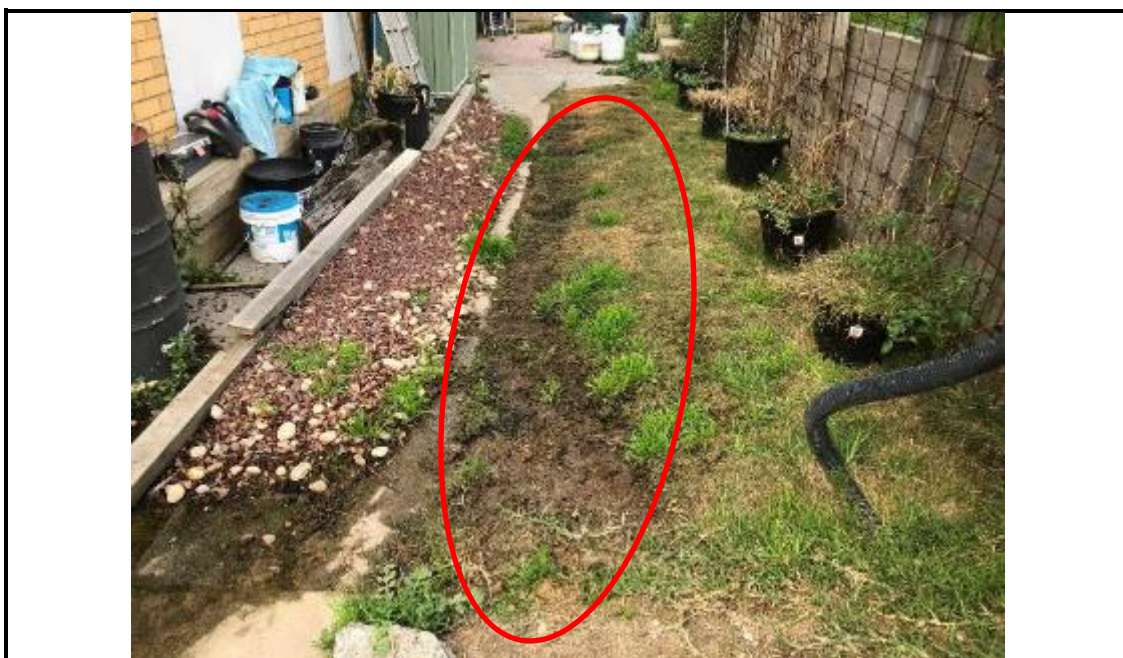
- 5.9 Water staining to gutters along the eastern elevation suggest past overflow.
- 5.10 The area immediately adjacent to the southern elevation of the dwelling was observed to be very wet, with poor drainage. Refer to Photo 3 in Appendix A.

Photograph 3. Wet area observed along the southern elevation of the dwelling.

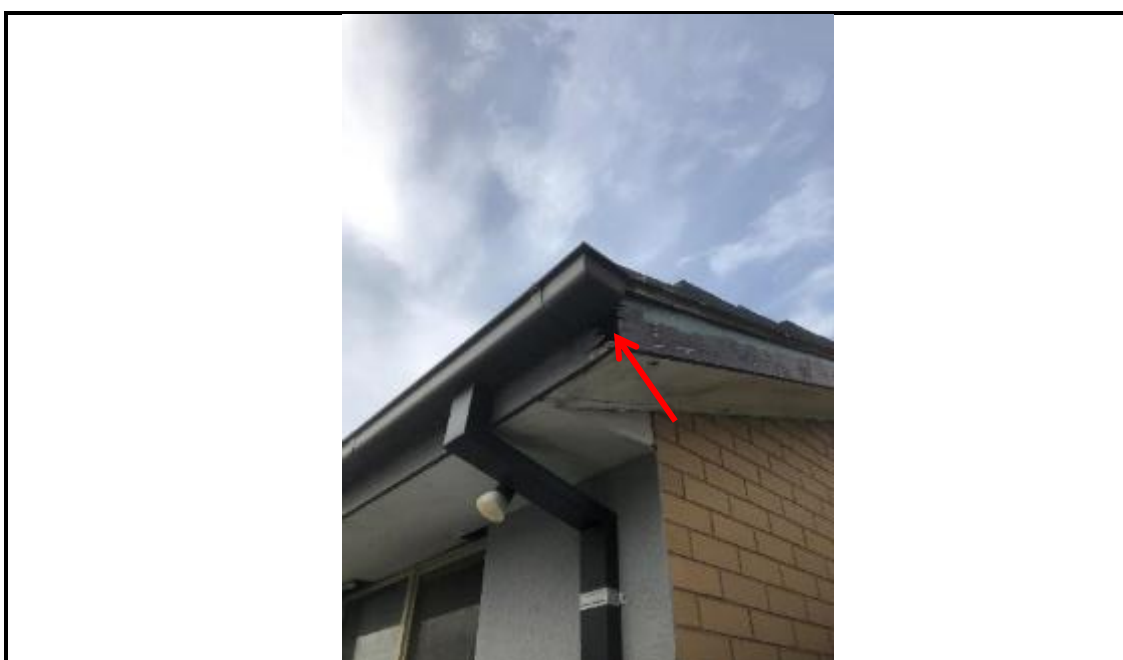
- 5.11 Rotting of external timbers was observed in several locations. Refer to Photo 4 in Appendix A.
- 5.12 The sub-floor area was generally observed via the eastern elevation access opening. Signs of previous high moisture within the sub-floor was observed to the ground surface. The stumps and timber floor members appeared in a serviceable condition. Refer to Photo 7 in Appendix A.

Photograph 4. Example of rot to external timber.

- 7.3 The Insured consider undertaking suitable maintenance to the observed dilapidated (rotten) external timbers.
- 7.4 The Insured be provided with a copy of the *CSIRO guide to Foundation Maintenance and Footing Performance: A Homeowner's Guide*, provided as Appendix B.

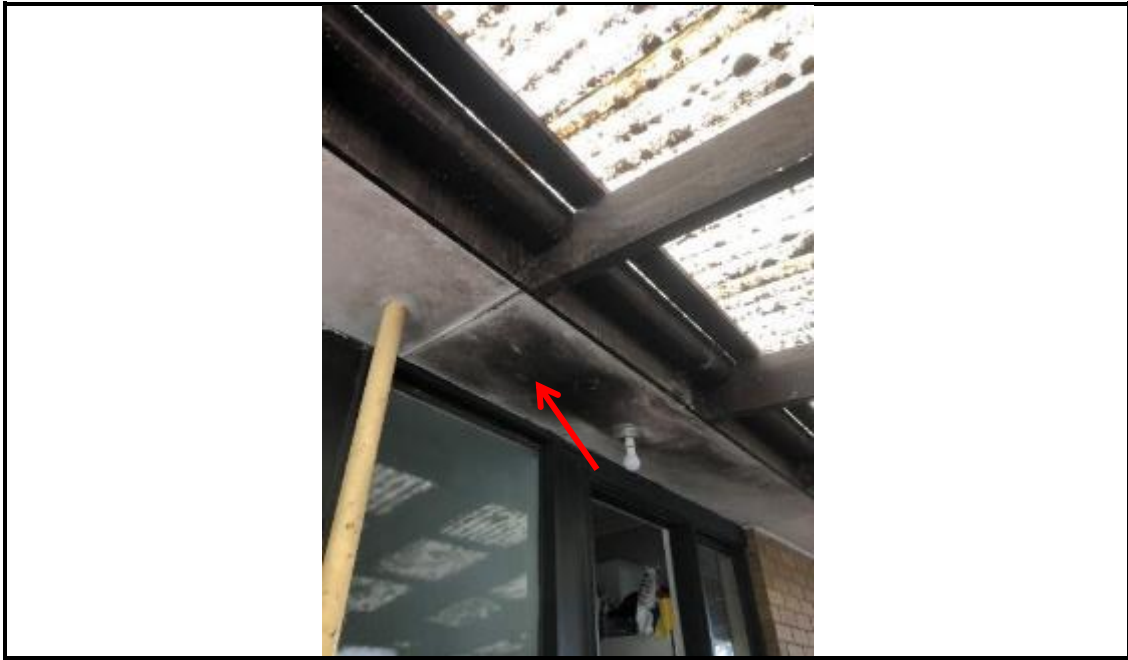
- 5.7 The flaking paint to the laundry and WC ceilings was observed. This was aged in appearance. Refer to Photos 8 and 9 in Appendix A.
- 5.8 Water damage was observed to the eaves lining along the eastern elevation. This was aged in appearance. Refer to Photo 5 in Appendix A.

- 6.6 The observed flaking ceiling paintwork and water damaged eaves lining to the eastern side of the dwelling was aged in appearance and has been occurring over a long period of time. It is not considered a result of the claimed February 2020 storm event.

Photograph 5. Example of water damage to the eastern elevation ceiling lining.

- 7.1 The Insured continue to monitor the dwelling for any signs of building movement damage.
- 7.2 The Insured, as part of routine building maintenance, ensure the plumbing at the dwelling is in a serviceable condition, this is to include roof gutters, downpipes and general roof weatherproofing.

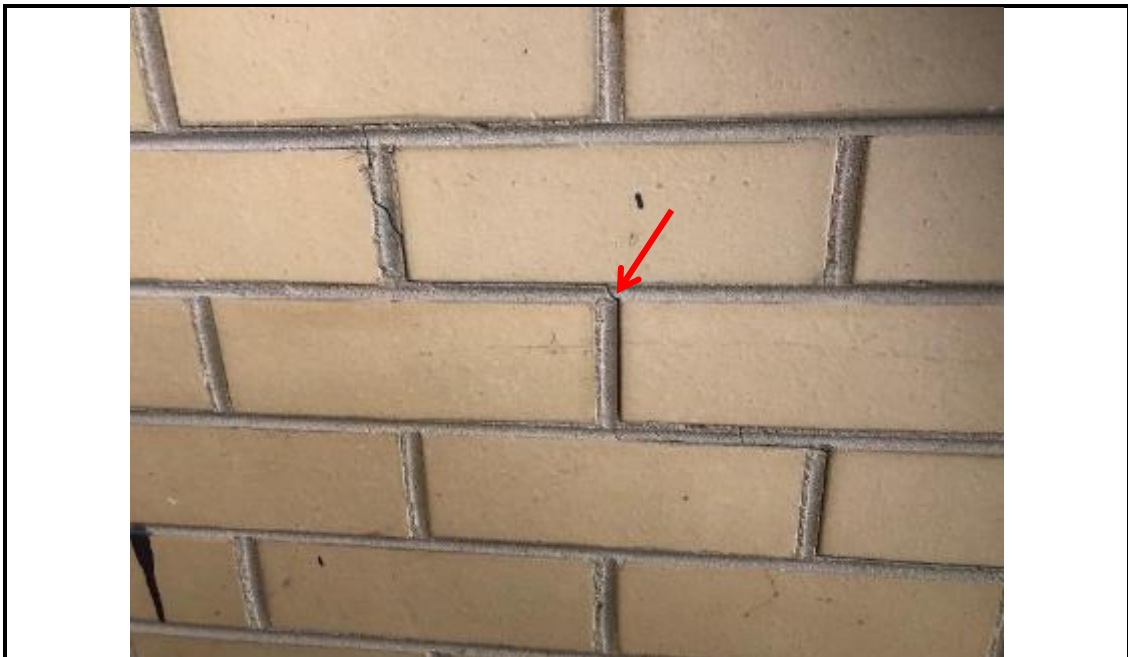
- 5.2 Very slight cracking was observed to the external render at the north-west corner of the dwelling and also to the brickwork along the eastern elevation of the dwelling. Refer to Photos 6 and 10-12 in Appendix A.

- 5.4 At the time of our inspection of the property, the cracking evident to the Insured's walls ranged from Damage Category 0-1 (i.e. crack width limit ranging from hairline to less than 1 mm), according to *AS 2870 Residential slabs and footings – Construction, Table C1: Classification of damage with reference to walls*. Category 1 "very slight" cracking is considered "fine cracks that do not need repair".

Photograph 6. Example of very slight cracking to eastern elevation brickwork.

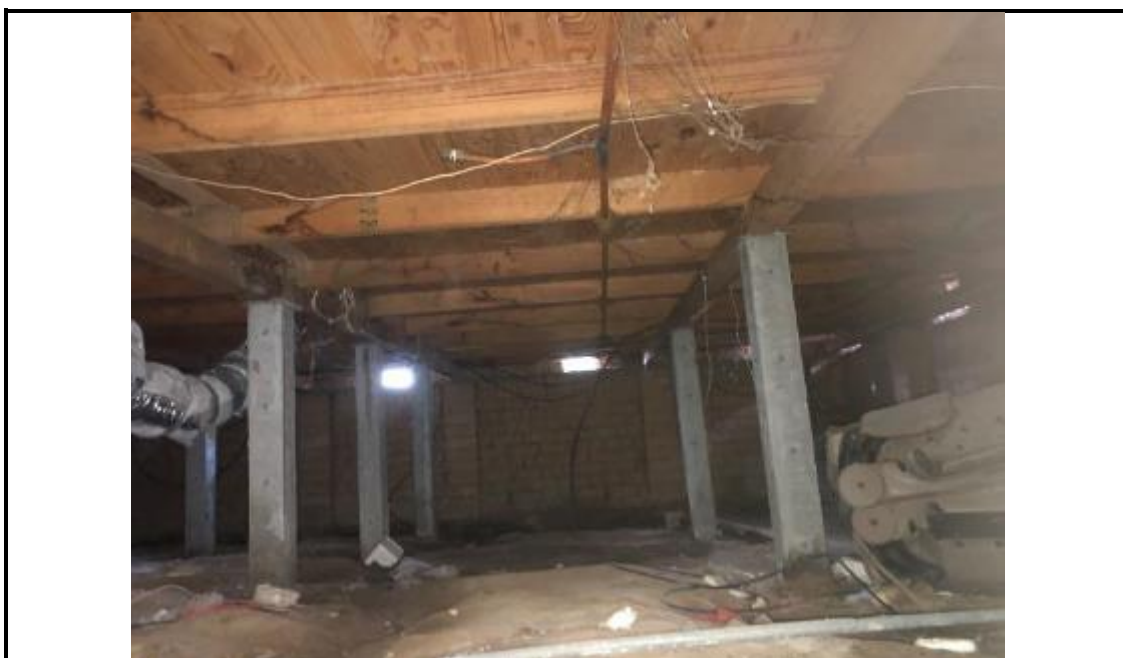
Photograph 7. Looking north from within sub-floor area.

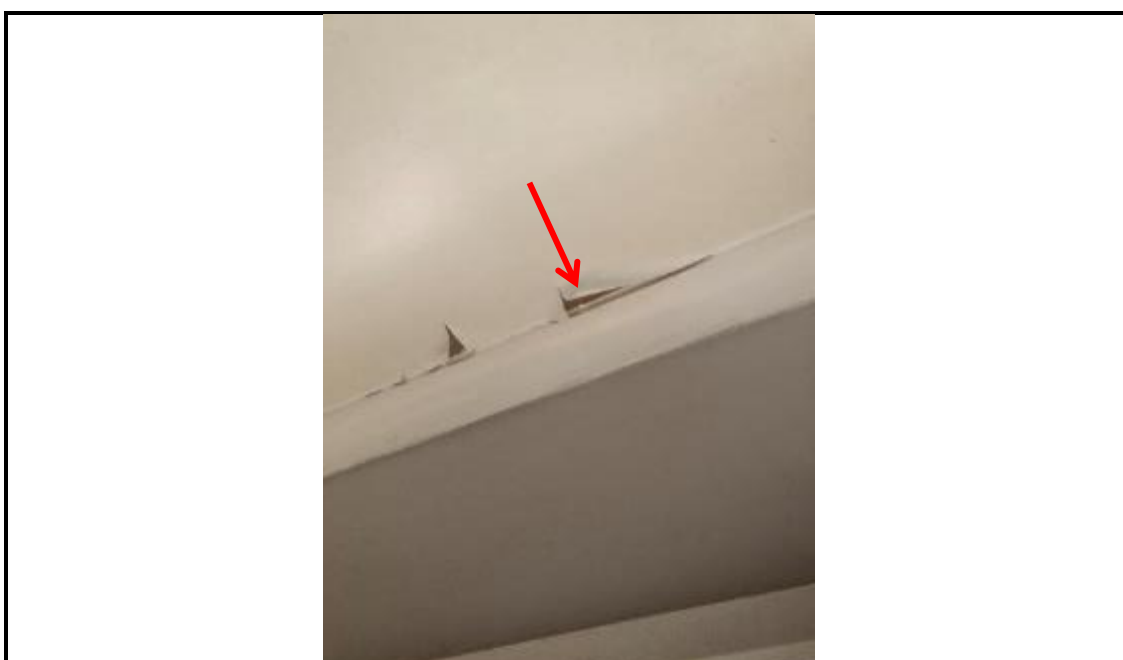
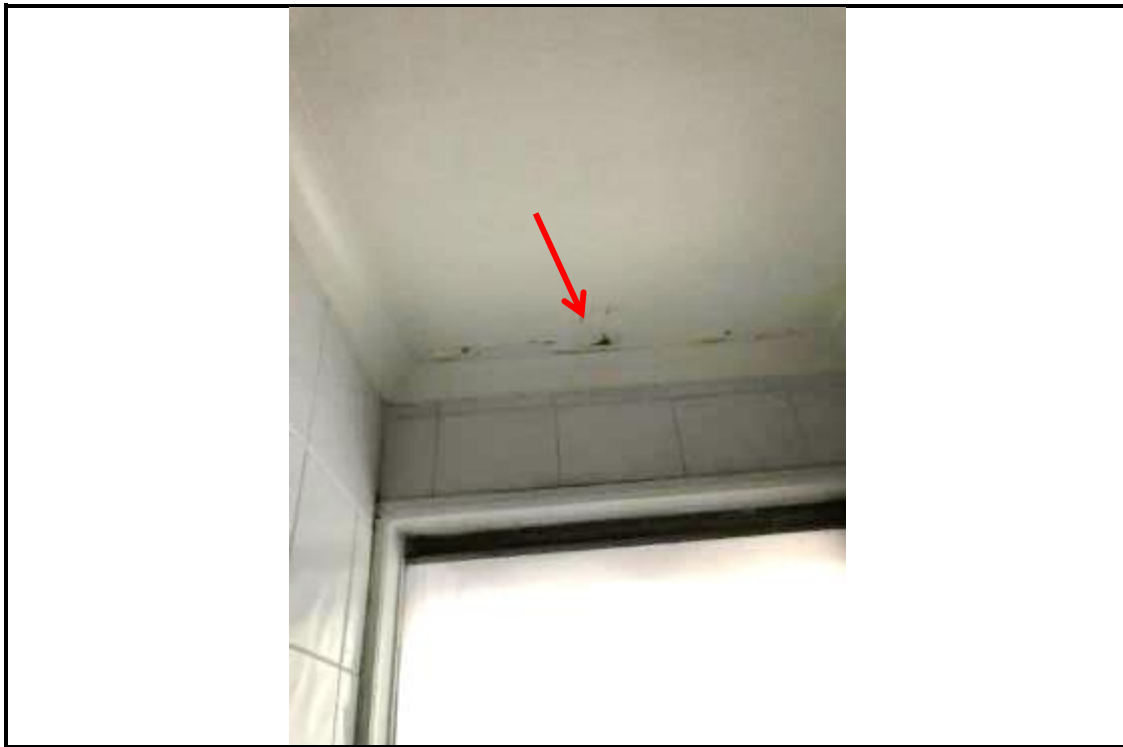
Photograph 8. Example of flaking paintwork to laundry/WC ceiling.

Photograph 9. Example of flaking paintwork to laundry/WC ceiling.

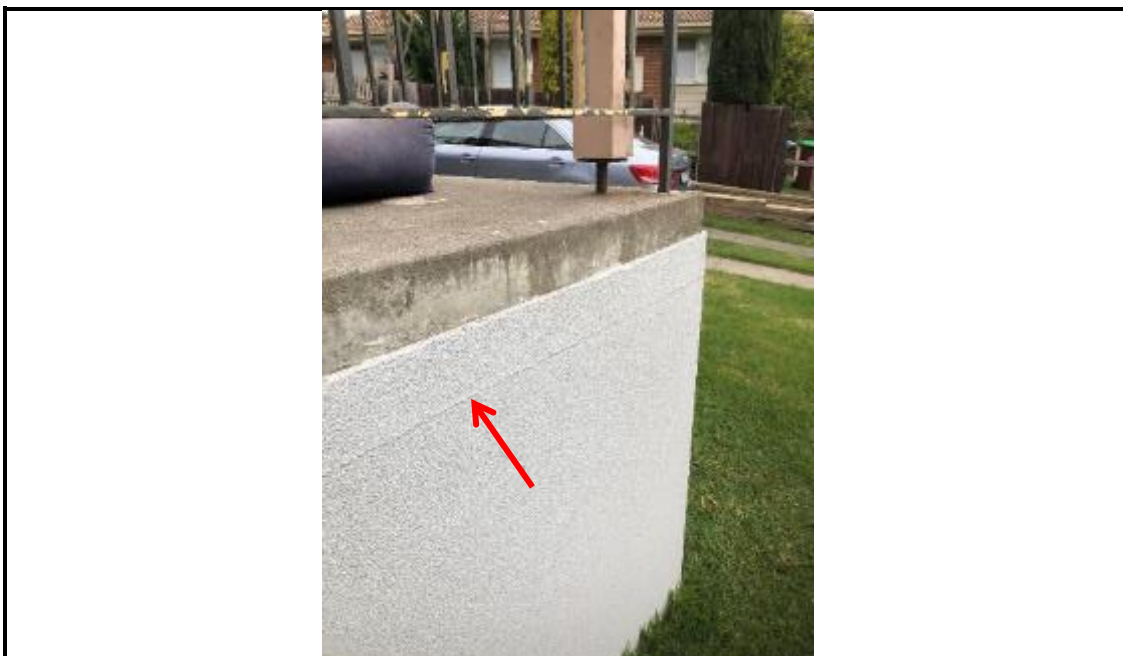
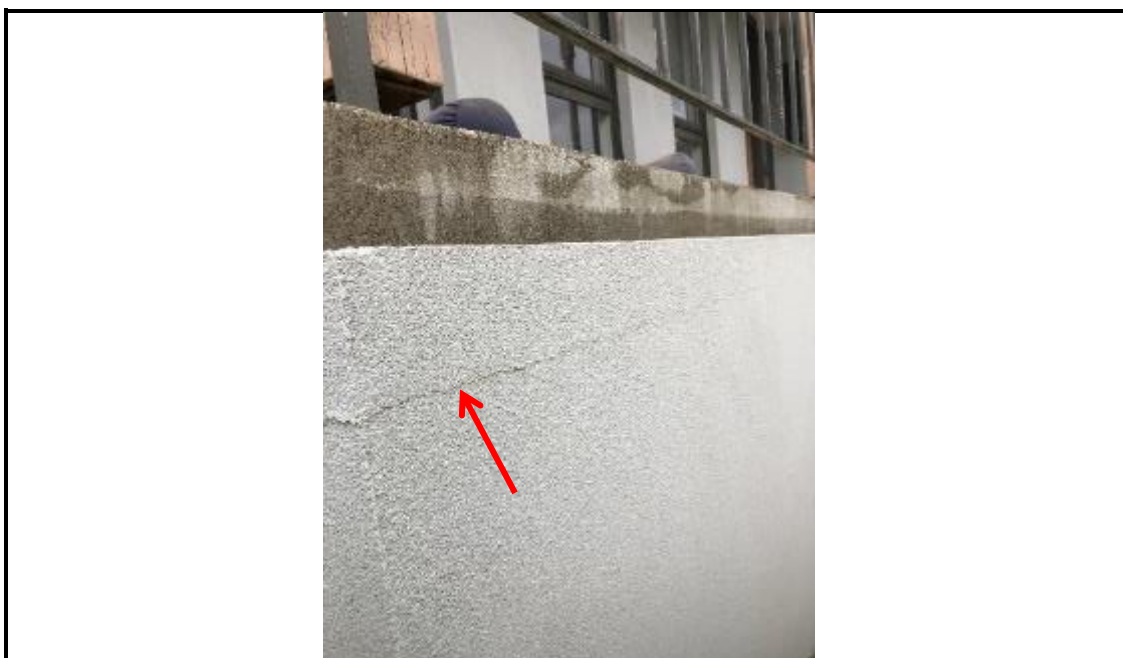
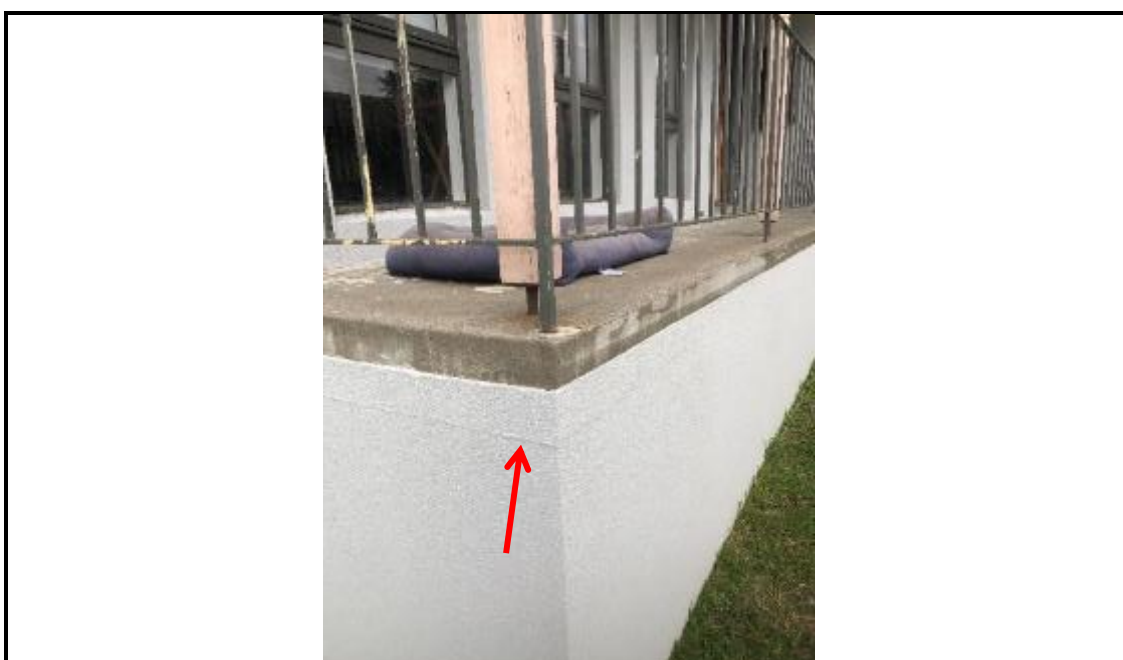
- 6.1 In our opinion, the observed cracking to the render at the north-west corner of the Insured’s dwelling was consistent with damage caused primarily by normal and expected thermal expansion and contraction of building materials and the quality of the original construction.
- 6.2 Cyclical changes in temperature will cause building materials to constantly expand and contract, which over time can cause cracks and separation gaps to occur, especially at the interface and joints between different building materials.
- 6.3 The observed crack to the Insured’s dwelling was minor and of cosmetic consequence only. The structural integrity of the building has not been affected.

Photograph 10. Very slight crack to north-west corner of dwelling.

Photograph 11. Very slight crack to north-west corner of dwelling.

Photograph 12. Very slight crack to north-west corner of dwelling.

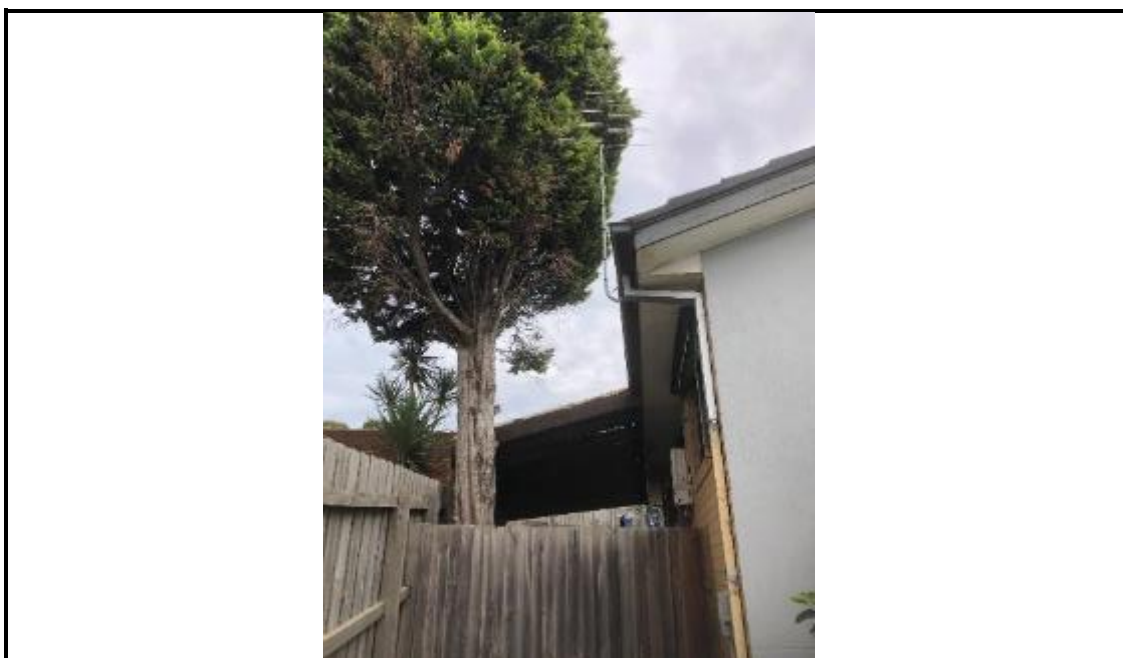
- 6.7.1 Poor surface drainage to the perimeter of the dwelling which directs surface water towards the dwelling and founding soils.
  - 6.7.2 Adjacent tree effects (long term drying of assumed reactive clay founding soils and subsequent differential ground movement).

Photograph 13. Tree adjacent to eastern elevation of dwelling.

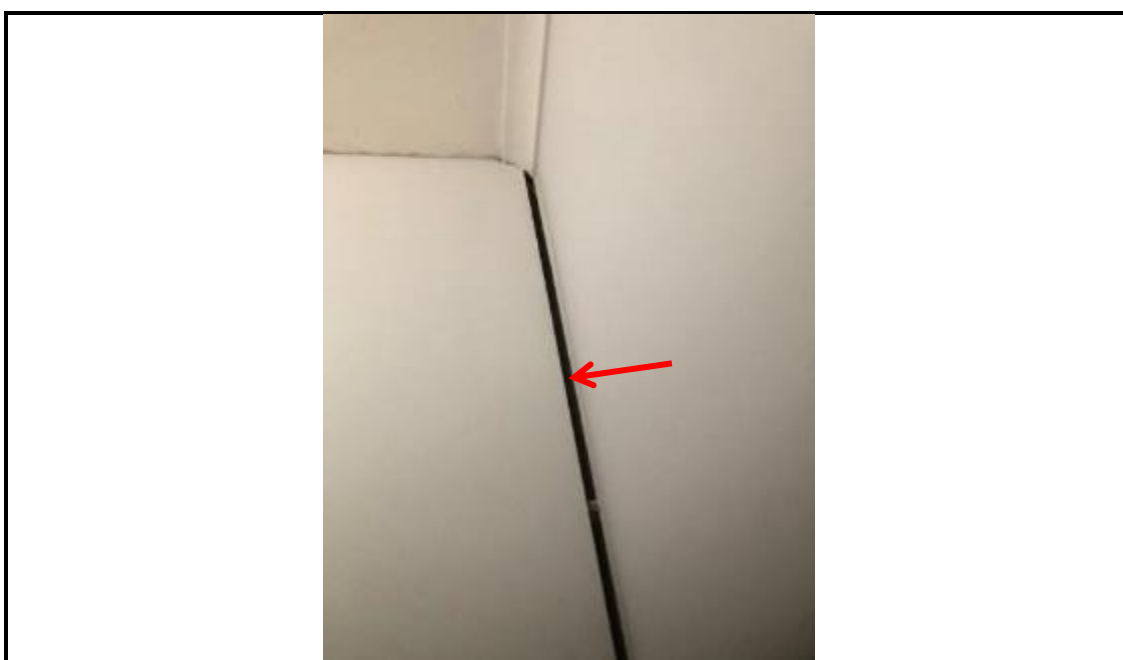
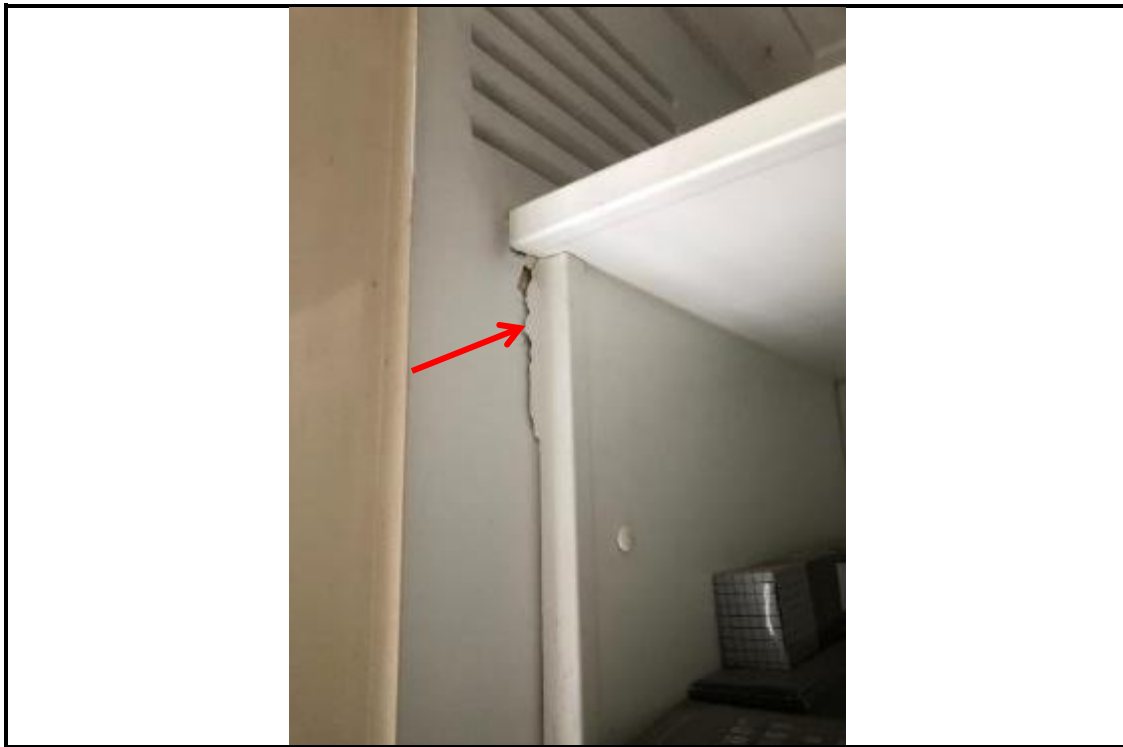
- 5.5.3 There were no concerning trends, or signs of significant building movement, in the floor levels observed.
- 5.6 Movement to the master bedroom built in robe was observed, as highlighted by the Insured. Refer to Photos 14 and 15 in Appendix A.

- 6.5 The observed movement to the master bedroom built in robe was not consistent with differential ground movement and is considered related to the quality of the original construction and ongoing usage. No significant floor level variations were observed in this region, or damage to wall linings, which would occur if differential ground movement related to the claimed event had occurred.

Photograph 14. Gap observed between master bedroom built in robe and adjacent wall.

Photograph 15. Movement between master bedroom built in robe and adjacent wall.
