Roof Report

Property Address 16 Aaran Close Endeavour Hills VIC 3802

Claim No. 6210287371

Builder Ambrose Construct Group Pty Ltd

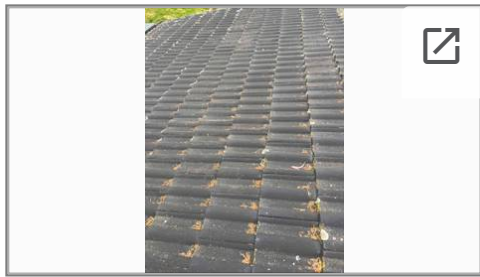
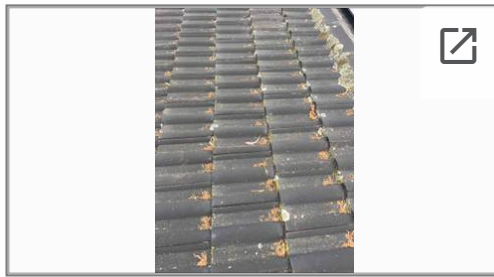
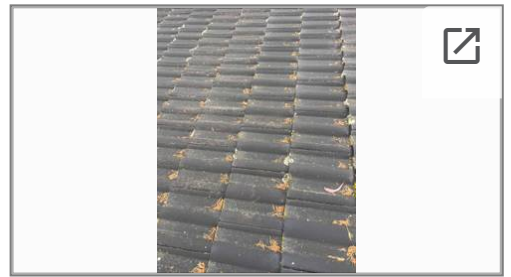
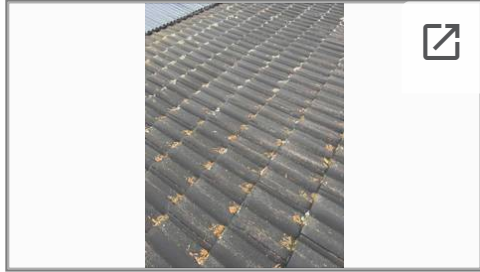
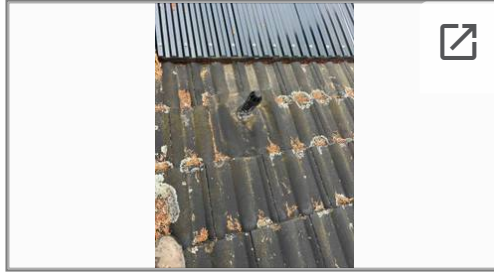
Roof sheeting images (with matching colour swatch if applicable):

After careful inspection and investigation I do not believe water ingress is occurring via the roof. Currently the roof looks to be in good condition.

- Ridge caps are in good condition
- Mortar and pointing are in good condition
- Solar panel penetrations are in good condition
- Penetration flashings are in good condition
