Engineers Initial Visual Report

Address: 16 Aaran Close, Endeavour Hills, VIC 3802
Client: ENData PTY Reference number: 6210261821
Clear Engineering Services Reference number: 12222007

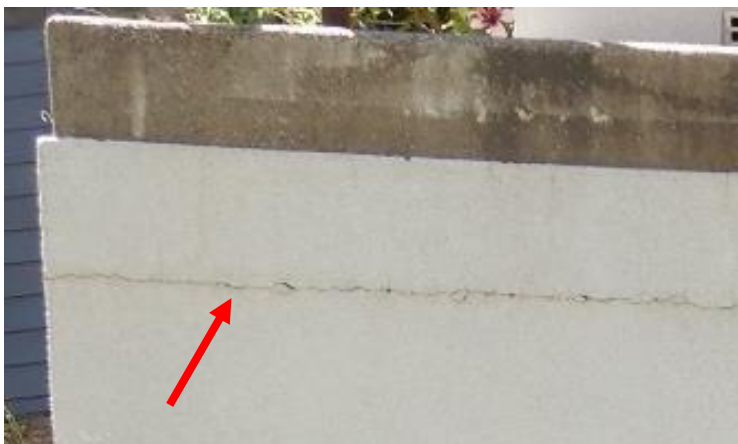
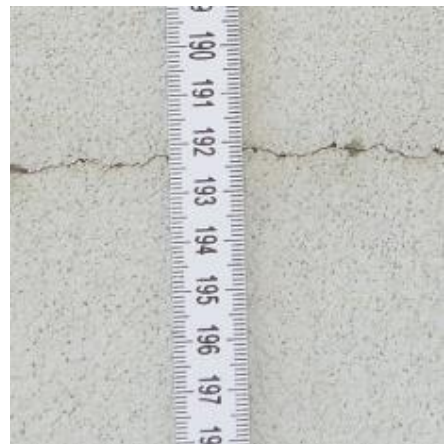
- Hairline horizontal crack in the render at the north-western corner of the porch that extends around from the northern side of the porch
- Stair-pattern hairline crack and horizontal hairline crack in the porch render.

Photos 6 and 7 show the crack in the cold joint through the render.

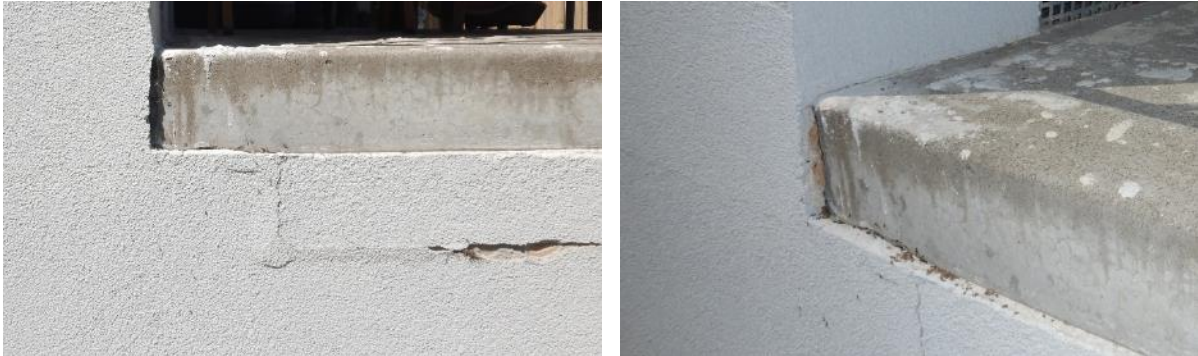
- Hairline horizontal crack and slight delamination in the porch render that extends to the western side
- Horizontal displacement of the porch slab from the rendered cladding
- Hairline cracks along the junction of the base of the western wall and the porch concrete slab. This wall is at the exterior of the lounge room wall.
- Hairline stair-patterned crack towards the north-eastern corner

Photos 8 and 9 show the crack and delamination in the porch render and horizontal displacement.

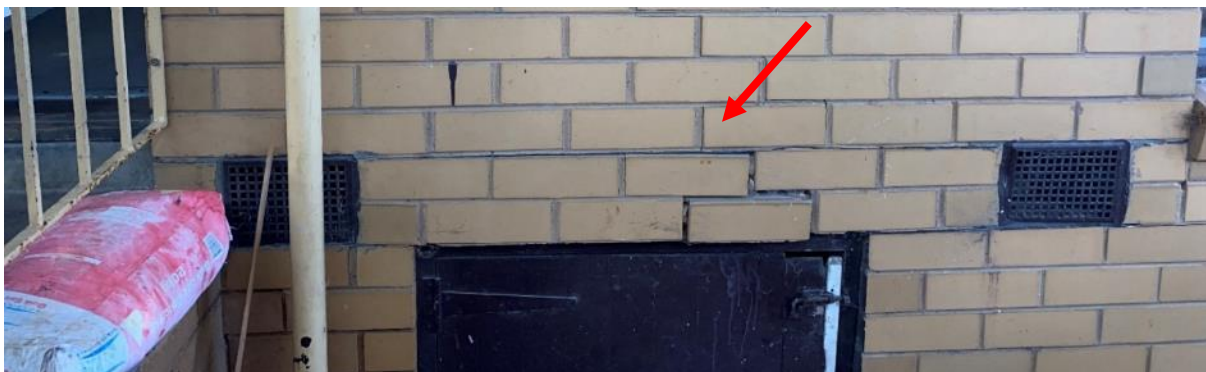
- Hairline to 2.0 mm stair-pattern crack through the mortar of the brickwork
- Loose brick above the subfloor hatch; the adjacent mortar is fretting.
- A gap of up to ~60.0 mm was noted between the footings and the paved ground starting adjacent to the subfloor hatch.
- Fretting of the brickwork adjacent to the window casing (southeast corner). The fretting is more severe on the southern side. Patching has been conducted here.
- Undulating masonry pavers along the eastern side of the building.

Photo 10 shows the stair-pattern crack and the loose brick.

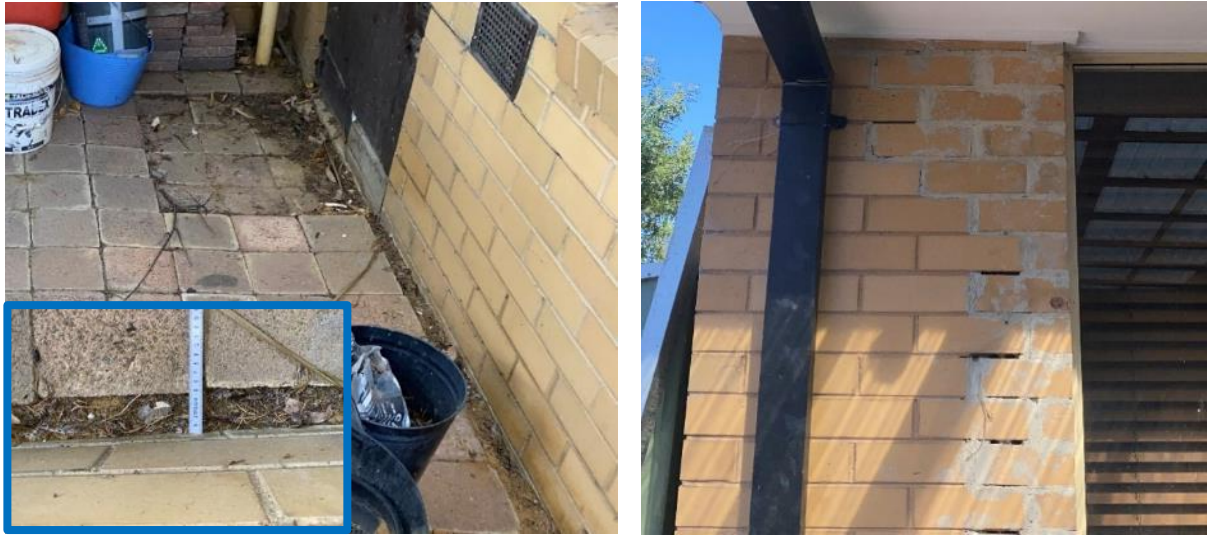
Photos 11 and 12 show the gap along the footings and the poorly repaired brickwork.

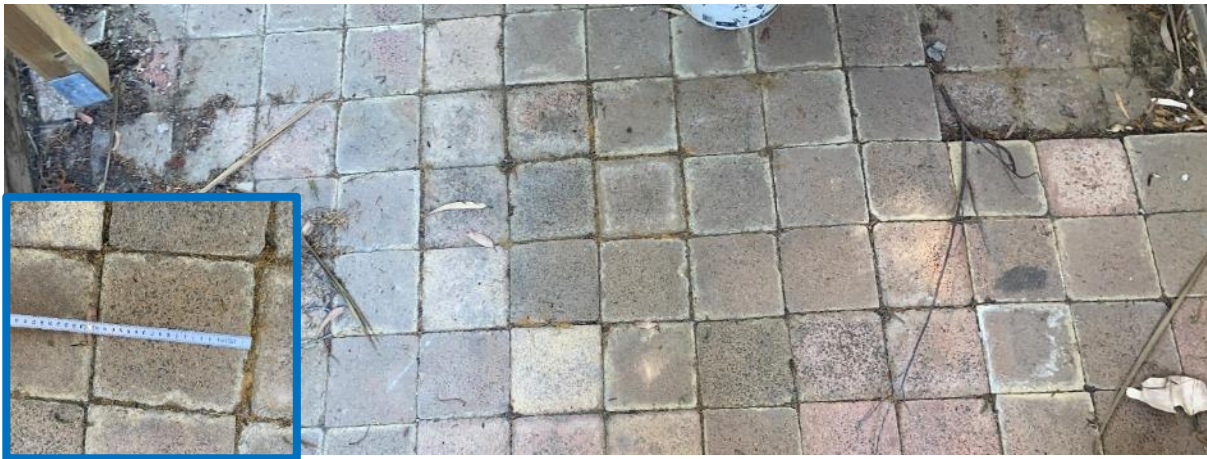
Photo 13 shows undulating pavers along the eastern side of the building.

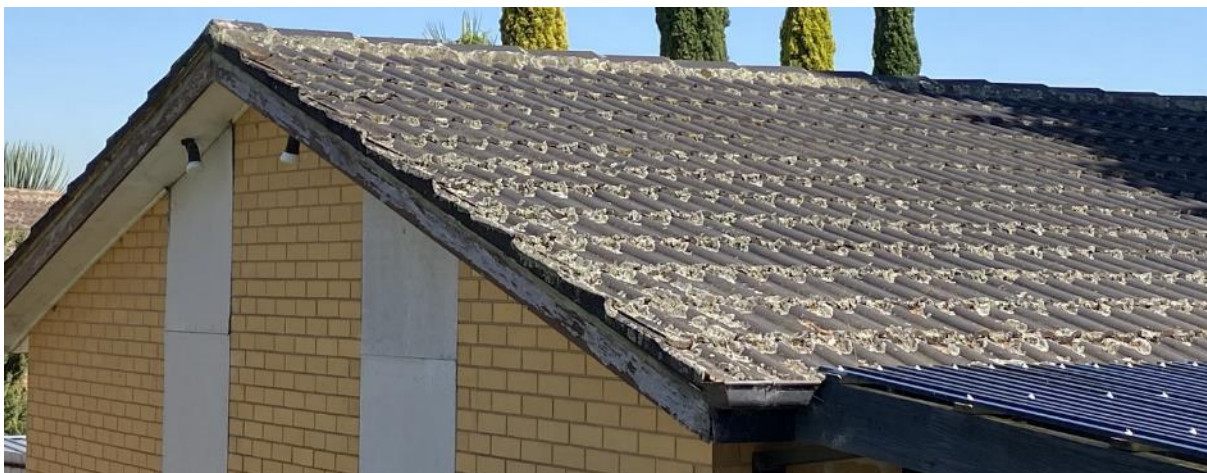
Photo 14 shows the condition of the tiled roof cladding at the south-eastern corner.

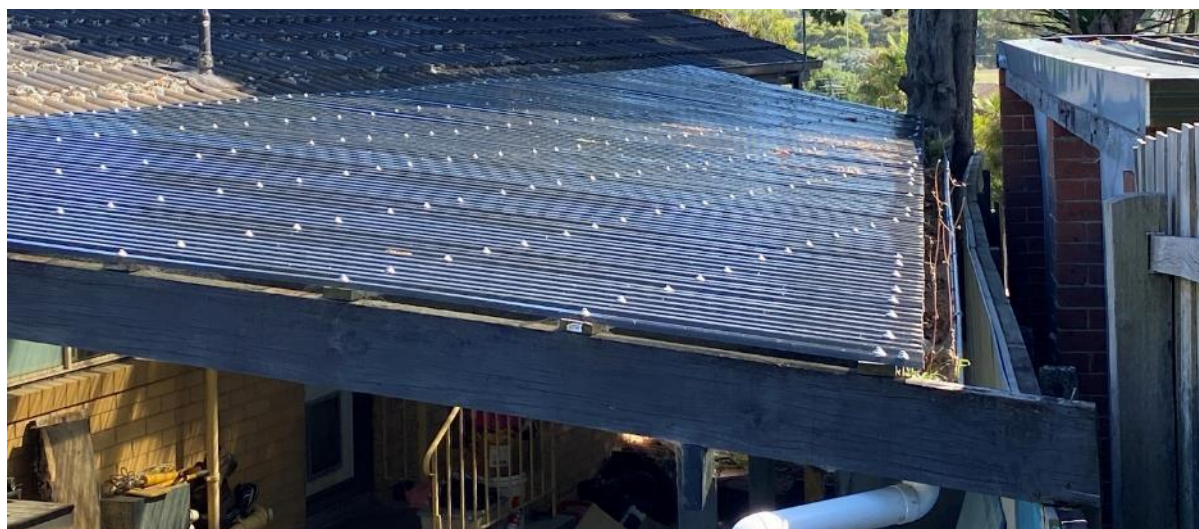
- The Insured claims that the sheet roof cladding of the eastern pergola leaks during regular rainfall.
- Roof battens are 25 mm thick, whereas the minimum in AS1684: *Residential Timber Framed Buildings* is 35 mm.

Photo 15 shows a typical view of the sheet roof cladding of the pergola looking north.

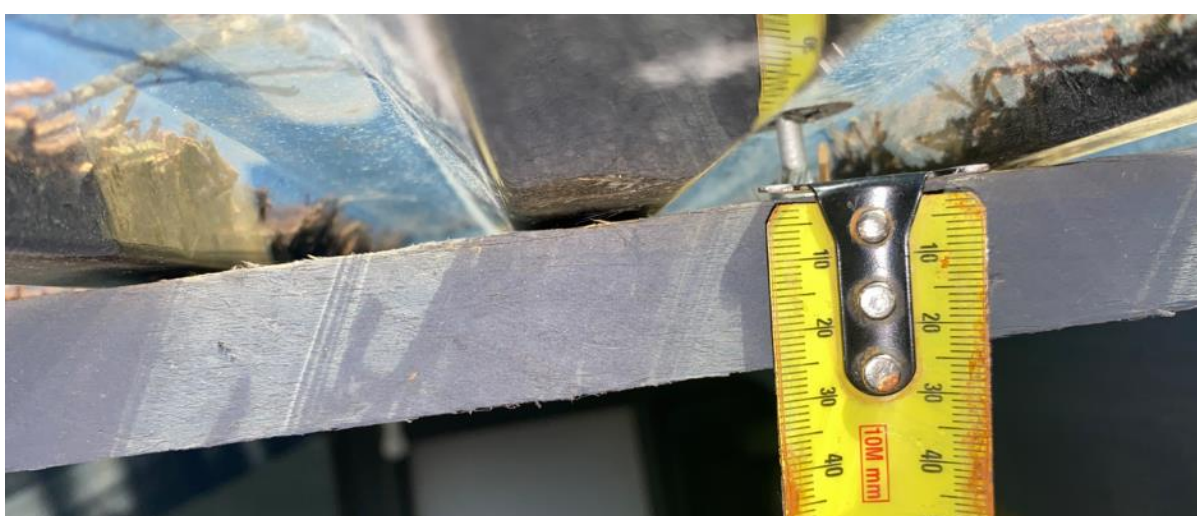
Photo 18 shows the screw connection and thickness of the roof batten.

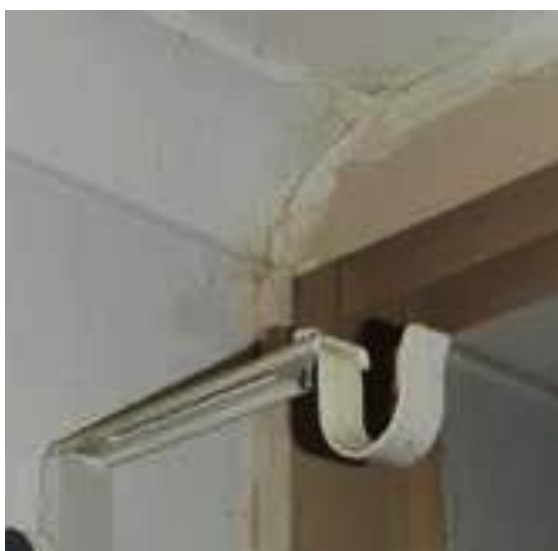
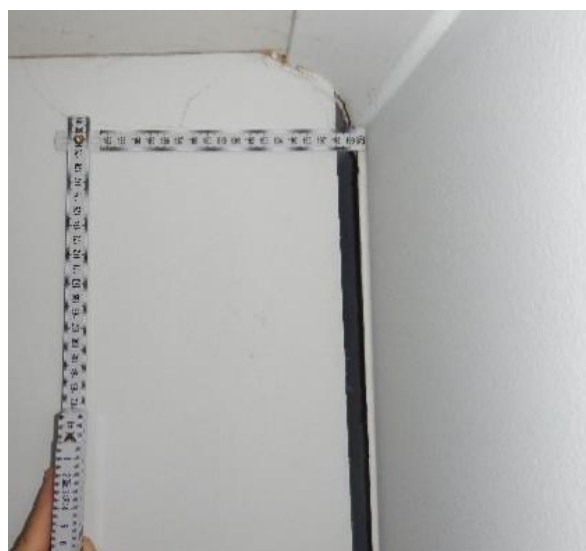
- Hairline to 20 mm gap between the plasterboard wall lining and the wardrobe
- Patching was noted along the junction of the wardrobe and wall lining.

Photos 20 and 21 show poorly finished repairs and movement of fixtures.

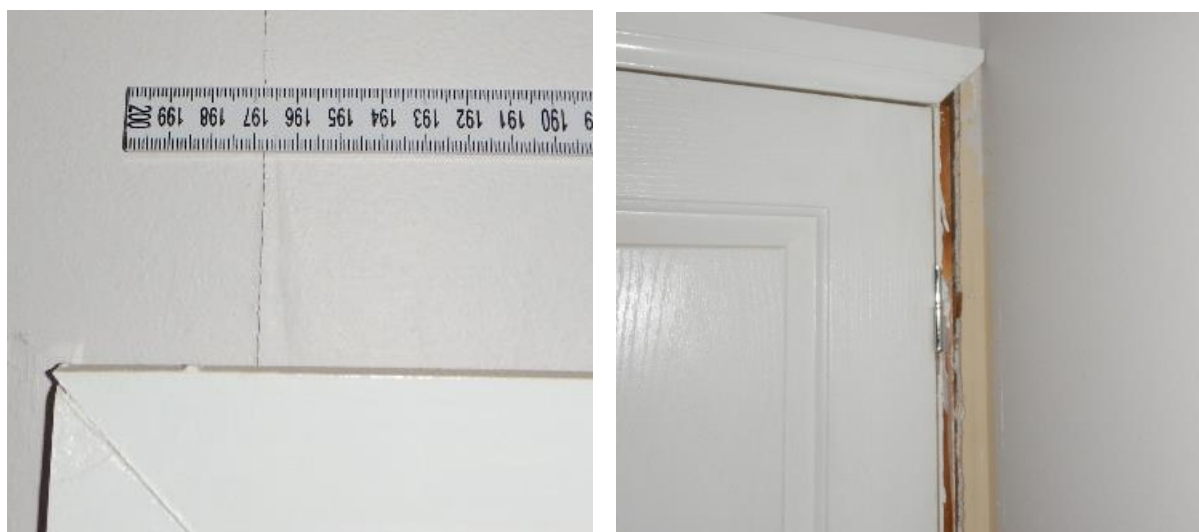
- A 1.0 mm vertical crack in the plasterboard wall lining extends across the height of the wall.
- Hairline vertical crack in the plasterboard wall lining extends from the door architrave.
- Dislodgement of the door casing at the entrance door
- Flaking paint/moisture damage to the plasterboard ceiling linings

Photos 23 and 24 show the hairline crack in the wall lining and the dislodged casing.

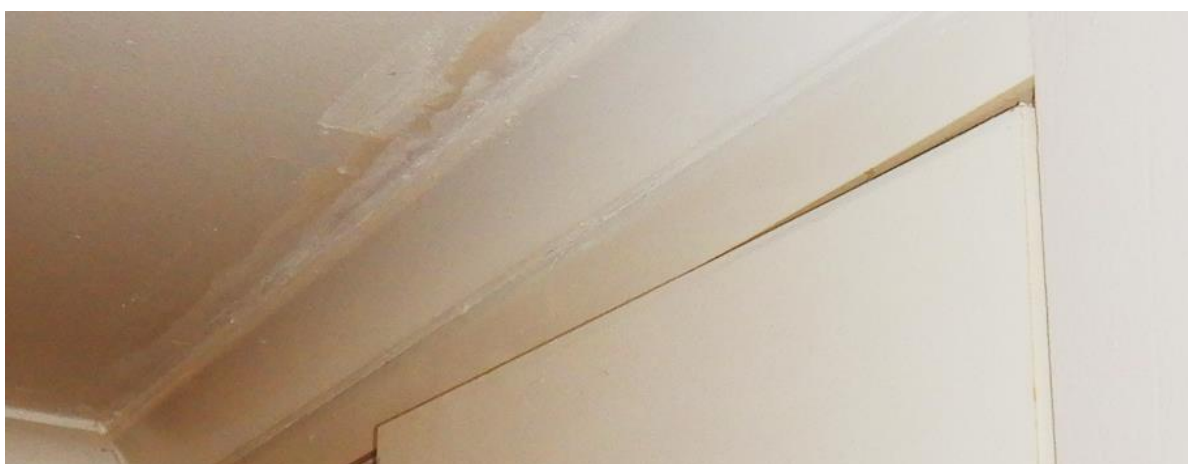
Photo 25 shows poor repair quality in bedroom 3.

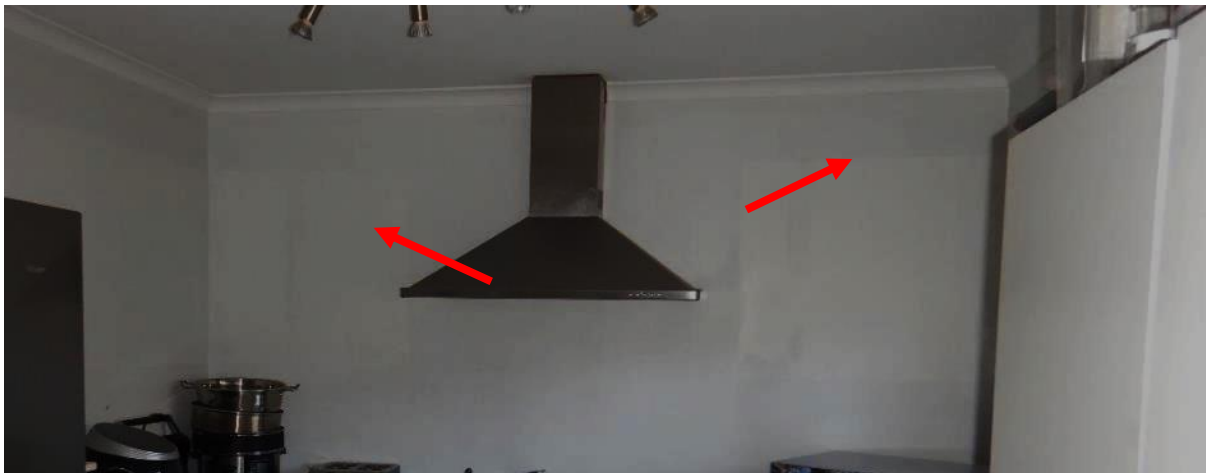
Photo 26 shows a typical view of the kitchen. Note the locations of the paint discontinuities where cabinetry was removed, and inadequate undercoat / primer was used.

- 6.10. Our inspection of the open plan area (lounge, kitchen, dining) found cracks to the internal plasterboard linings, cracks to the trims (cornices, skirting boards, architraves), and discontinuities in the paint finish where kitchen cabinetry was removed, and the paint finish has no undercoat/primer.

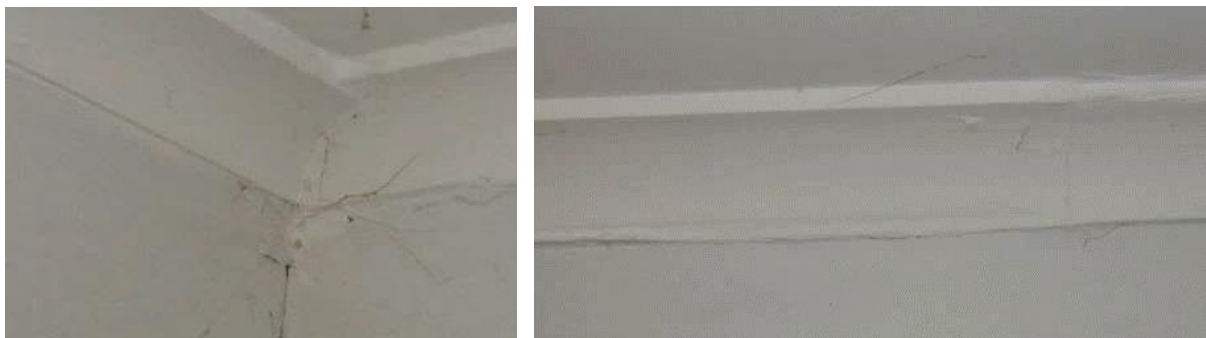
- Up to 1.0 mm vertical cracks in the plasterboard wall linings along the mitre joint of the wall
- Up to 1.0 mm horizontal cracks in the plasterboard linings at the wall-ceiling junctions
- Discontinuities in the workmanship of the paint and decorations
- Up to 1.0 mm cracks along the surface of the floor tiles

Photos 27 & 28 show a crack along the wall-wall junction and anomalies along the cornice.

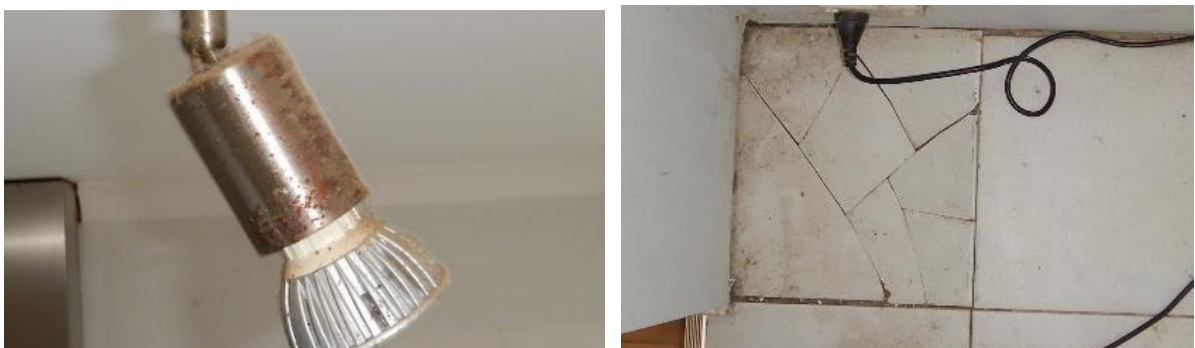
Photos 29 & 30 show rust to the lighting fixture and the damaged floor tiles.

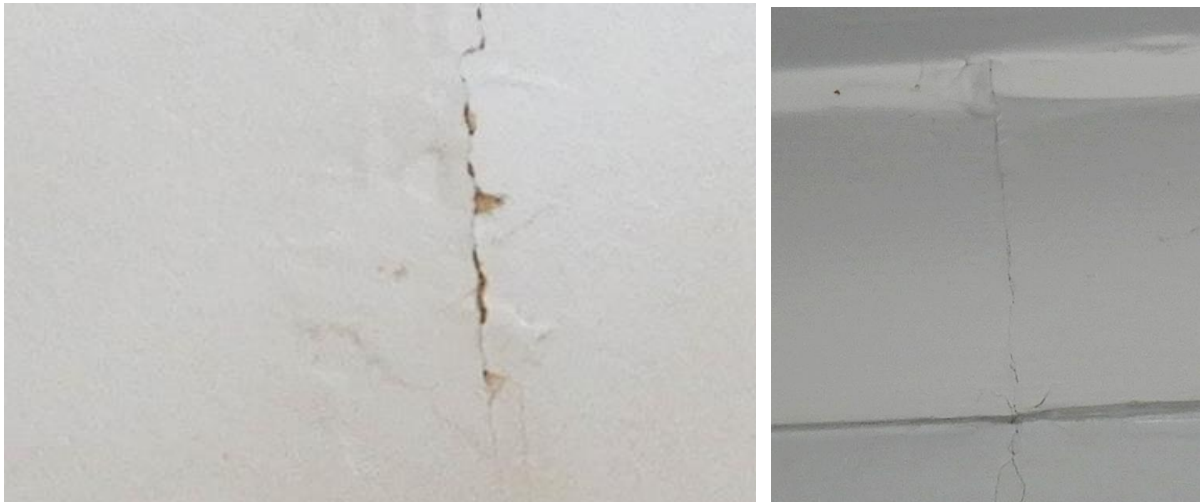
- Hairline vertical cracks in the surface of the wall lining that extend the height of the wall
- Hairline crack above the door architrave extending to the cornice
- The paint along sections of the cornice and ceiling has bubbled.
- Minor cupping at the junctions of the length and heads of several timber floor coverings in the north-western corner.
- ~3.0 mm gap between the window casing and plasterboard wall lining and along the skirting board
- The sliding door that connects the lounge to the hallway scrapes along the roller brackets and has resulted in a scrape mark forming along the lower section of the door.

Photos 32 and 33 show a typical view of poor crack repairs and unrepaired cracks.

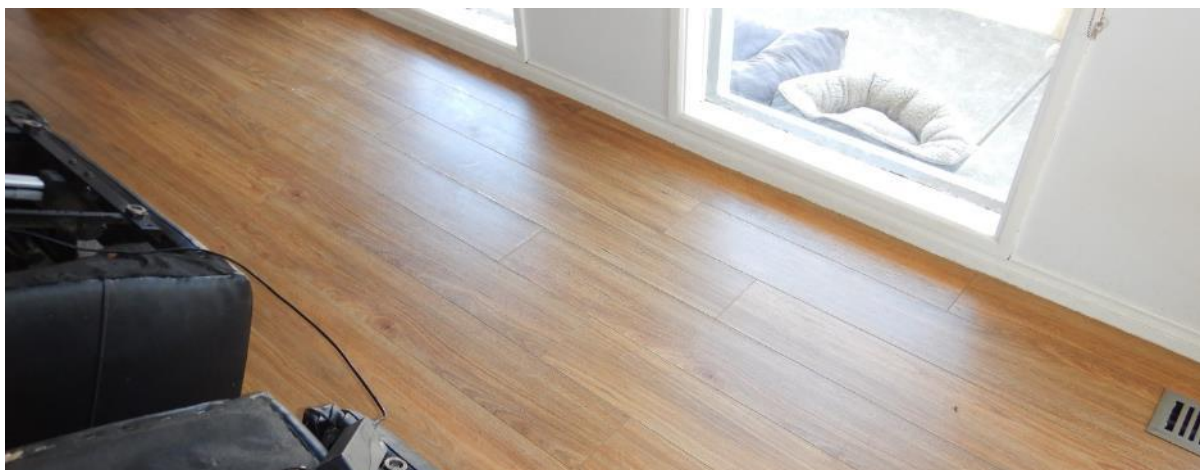
Photo 34 shows the area of the claimed damaged floorboards.

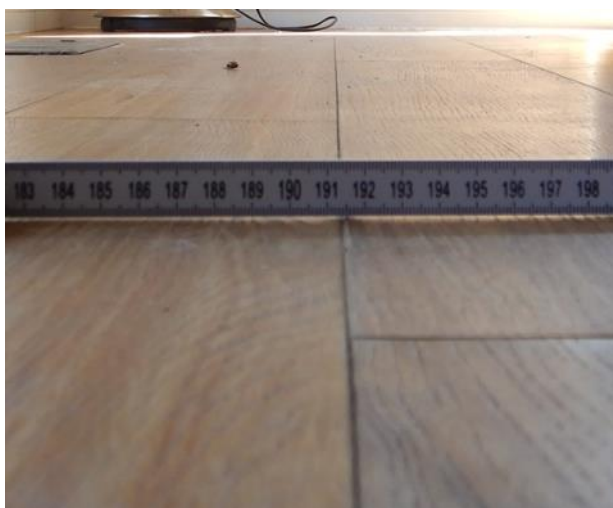
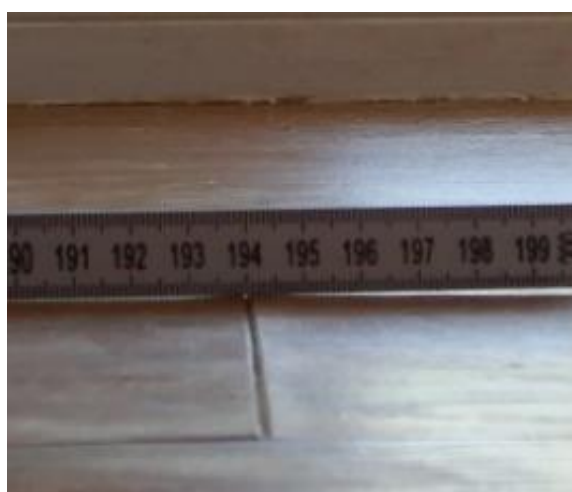
Photos 35 and 36 show examples of cupped floorboards.

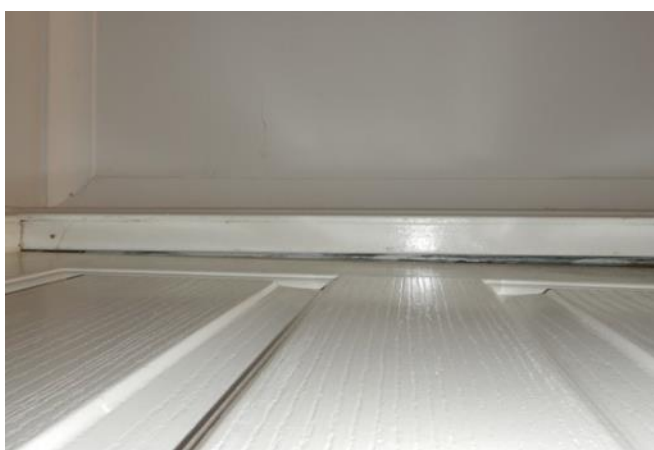
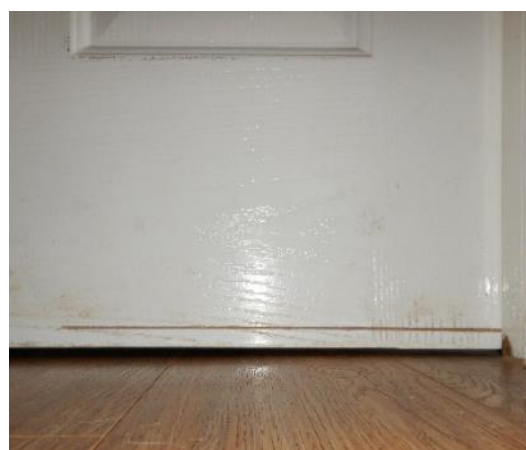
Photos 37 and 38 show misalignment of door trims.

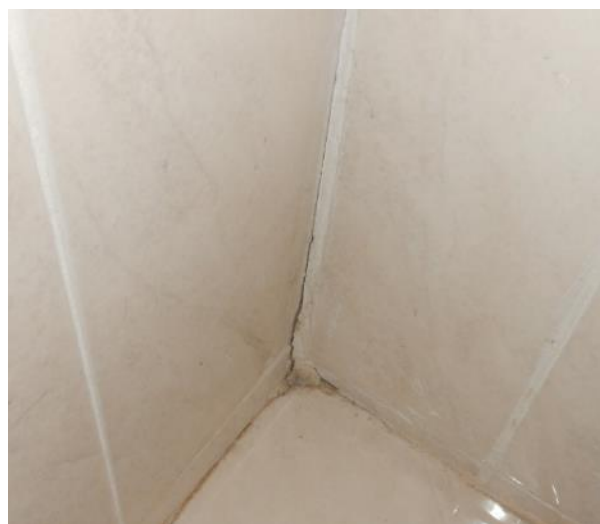
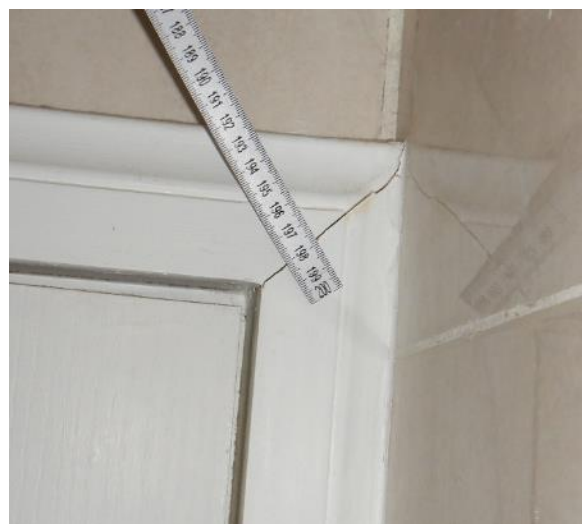
- Hairline to 1.0 mm crack in the tile mortar at the wall-wall junction and wall-floor junction
- Hairline crack along the mitre joint of the architrave

Photos 40 and 41 show the crack in the tiling and door architrave respectively.

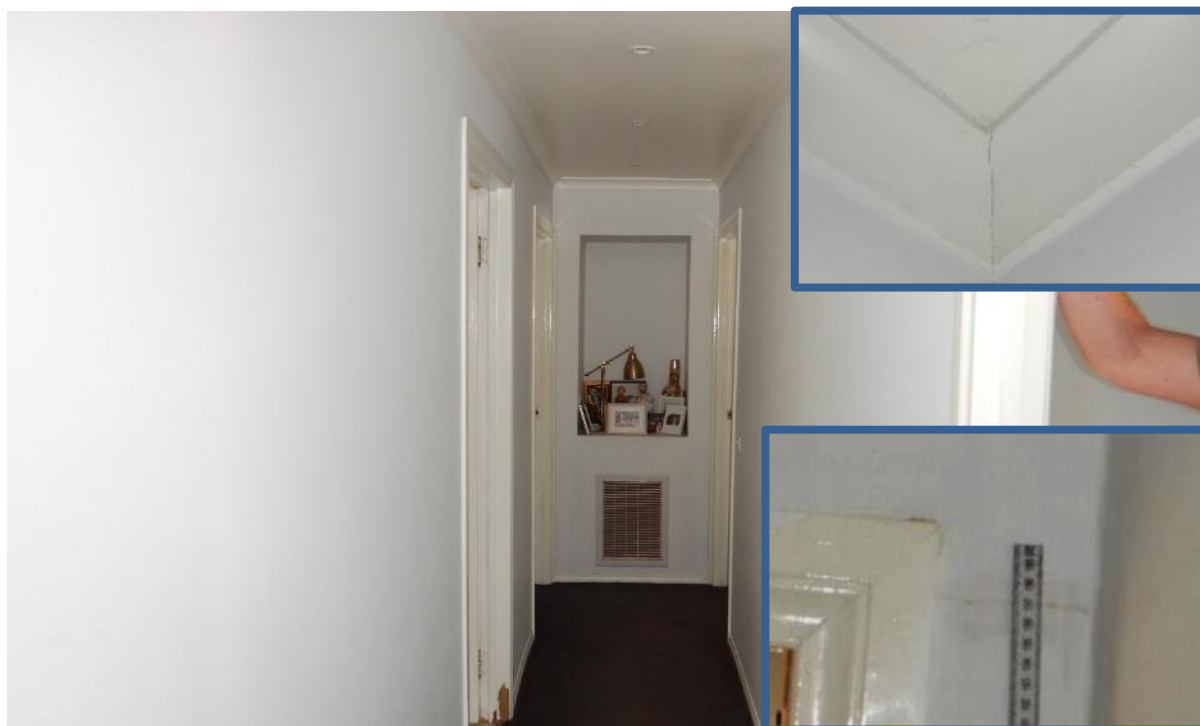
- A hairline to 1.0 mm horizontal crack in the plasterboard wall lining extends from the architrave leading to bedroom 1.
- A 1.0 mm vertical crack in the mitre joint of the cornice

Photo 42 shows a typical view of the hallway, and the inserts show the noted damage.

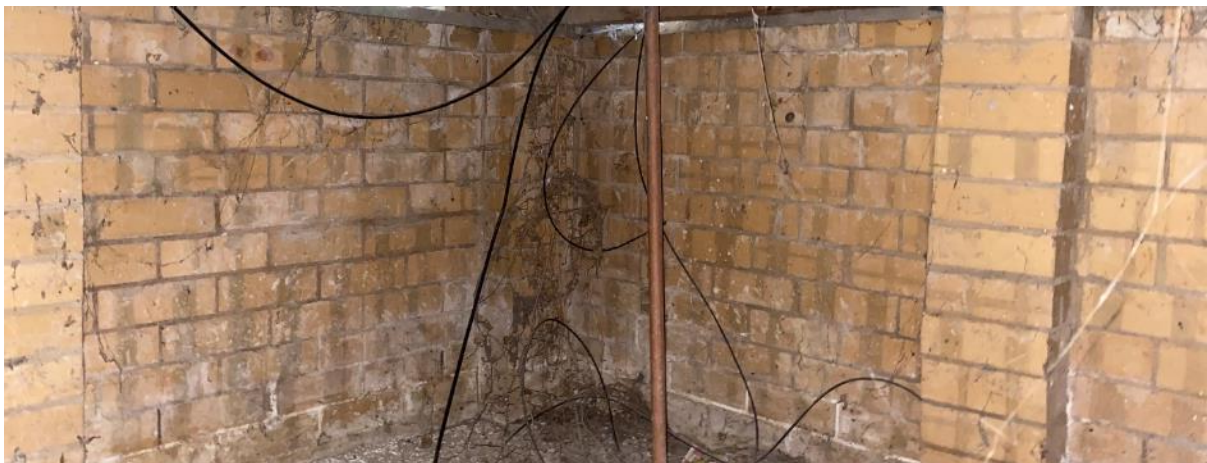
- 4.5.1. An inspection of the subfloor was conducted which was accessed through an external hatch on the east side of the building.
- 4.5.2. The subfloor is constructed of concrete stumps, timber bearers, and timber joists.
- 4.5.3. The perimeter is constructed of an engaged brick pier sub wall.
- 4.5.4. There is evidence of prolonged dampness along the surface of the ground in the north-western corner and efflorescence.

Photo 44 shows the north-western corner of the subfloor.

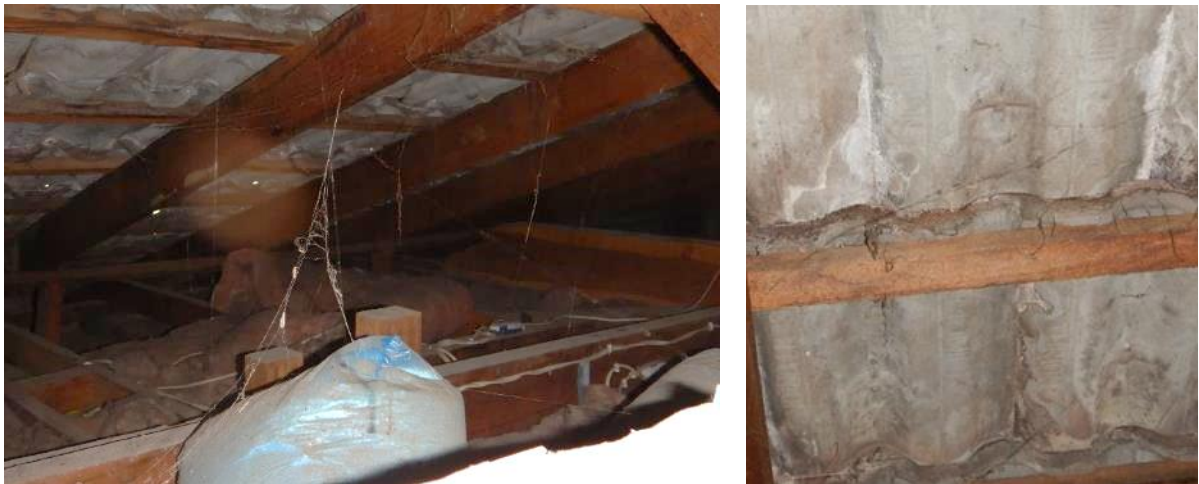
Photos 47 & 48 show daylight through the roof tiles and efflorescence on the underside.

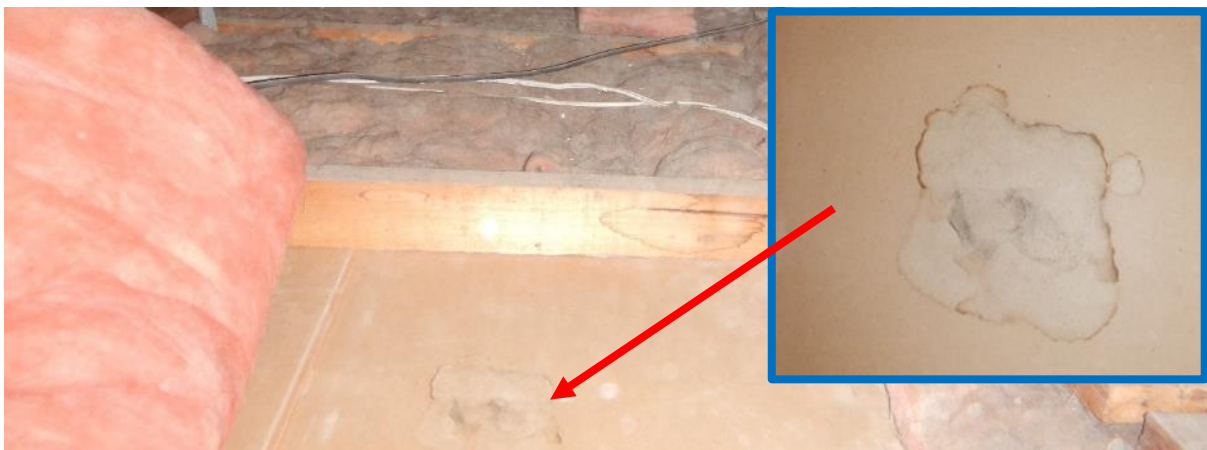
Photo 49 shows watermarks/mould along the internal side of the plasterboard ceiling linings.

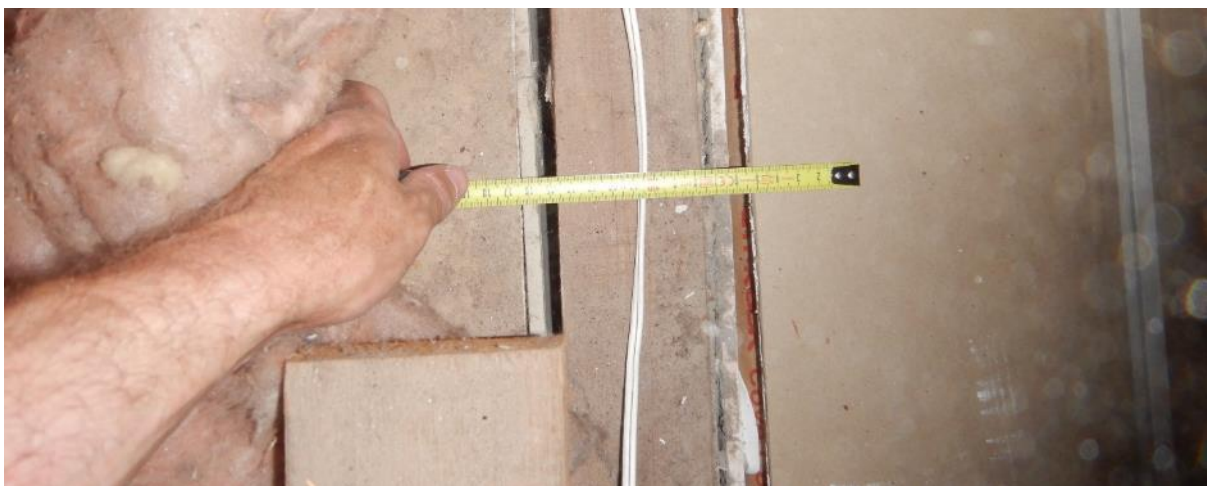
Photo 50 shows the newly installed plasterboard ceiling sheeting (right) and the original plasterboard ceiling sheeting (left) separated by the top plate of a wall frame.
