Quotation Number: JC23V145

Project Description: Underpinning and Stabilisation of concrete footings.

Project Address: 16 Aaran Close, Endeavour Hills

Date: 04/08/2023

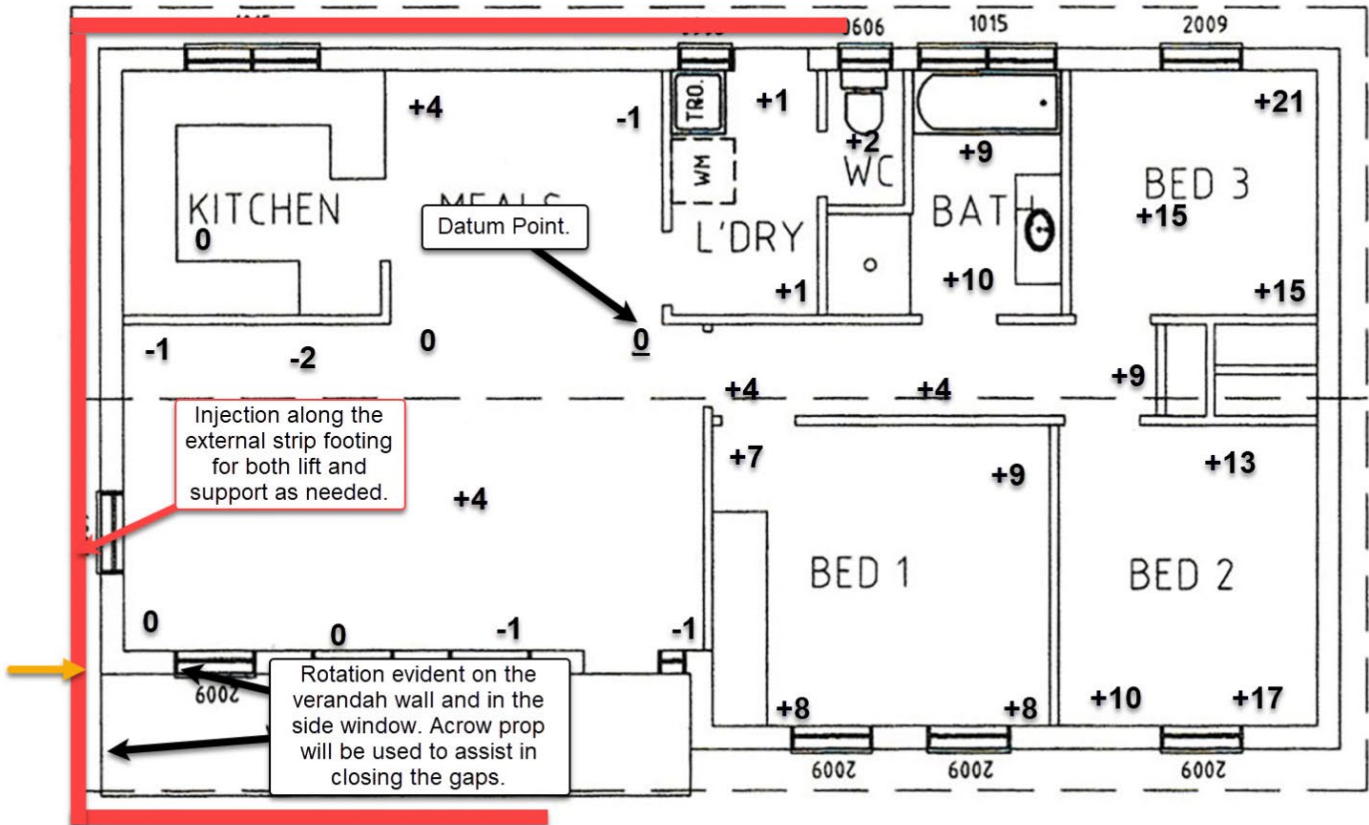
- The property contains a single-storey brick veneer dwelling on a strip footing with internal concrete stumps.
- The on-site inspection noted stepladder cracks on the Eastern and Western walls.

- The property owner has reported that a flood event occurred on the premises, resulting in water pooling against the Northwestern corner of the structure. Furthermore, it was found that the stormwater system in the Southwestern corner was improperly installed, leading to water saturation in the soil. As a consequence, heave has developed on the strip footing and internal stumps. To address these issues, immediate repairs are necessary, followed by a proper drying process. It is important to note that subsidence may occur after the completion of the repairs.

- Injection will be required along the Eastern, Northern and Western walls. Refer to the site plan for further information.
- The use of an Acrow Prop would be required to assist in the realignment of the Northwestern corner.
