# Building Inspection Report

Inspection Date: 9 Aug 2023

**Property Address: 16 Aaran Close  
Endeavour Hills 3802**

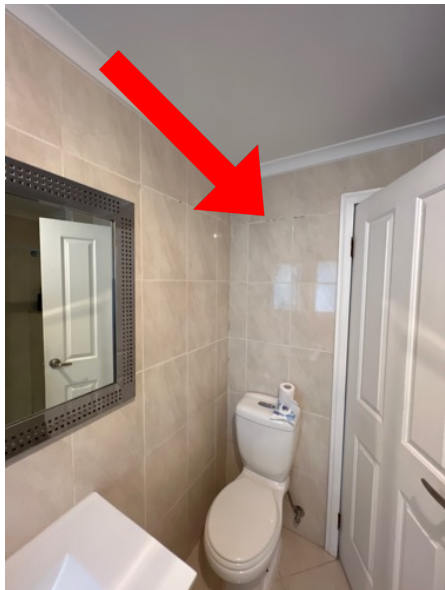
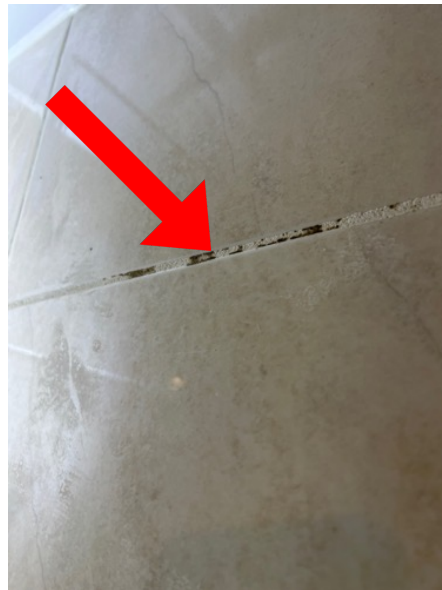
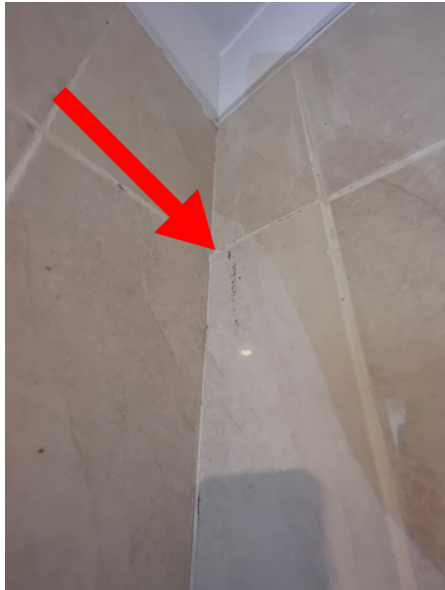
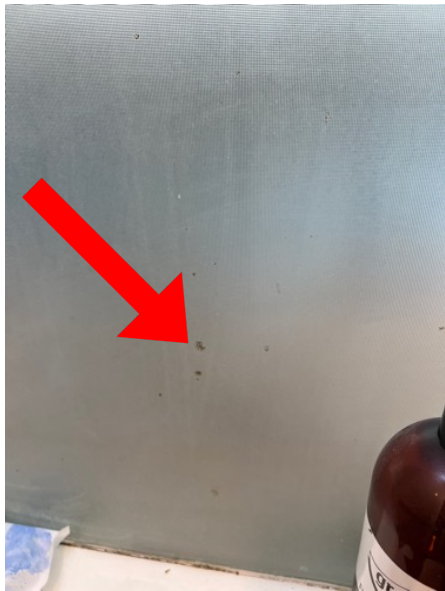
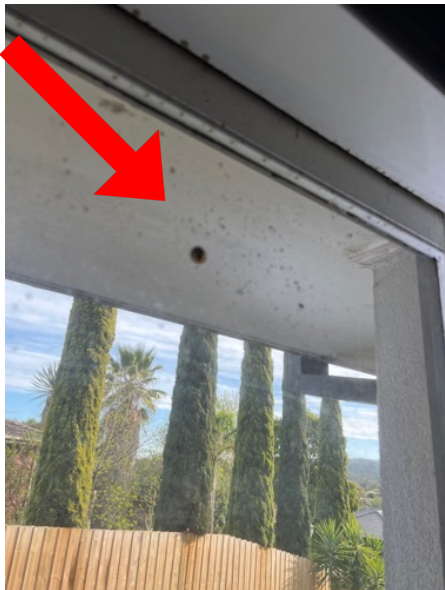
### Safety Hazard 1.01

Mould growth was evident in areas of the property which can be due to previous water leaks. Where evidence of mould growth was noted, there may be environmental, biological or health issues associated with the report. A specialist inspection by a suitably qualified environmental health inspector is warranted, where mould is extensive or where any queries regarding air quality spores or other related issues apply.

Any mould found during the inspection should be cleaned immediately by a cleaning contractor or the homeowner as applicable.

Please note that severely affected building elements will require replacement by a registered builder or qualified carpenter.

Once the mould has been removed, air quality samples should be collected to confirm the mould has been removed from the property.

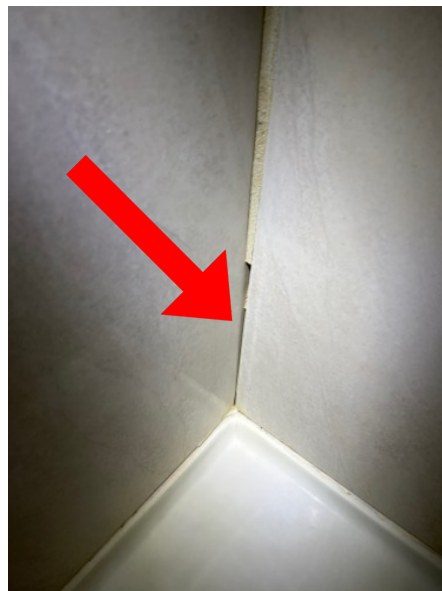
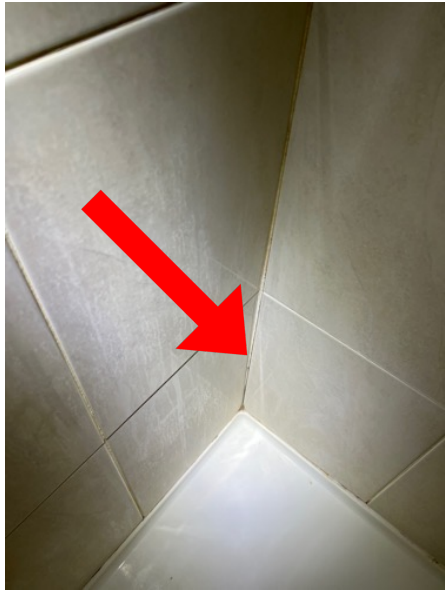
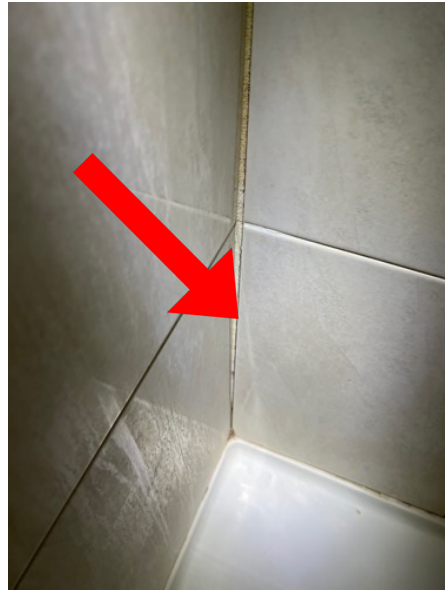
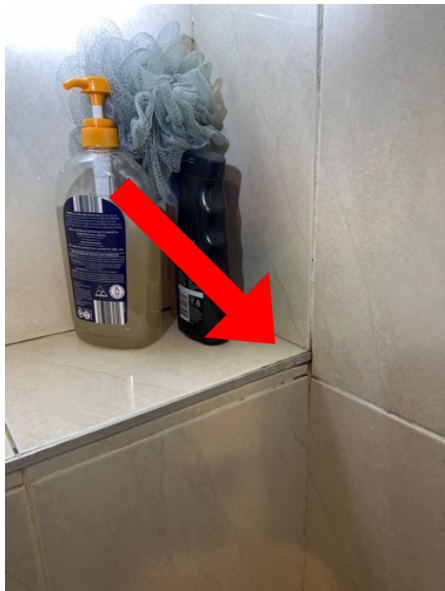
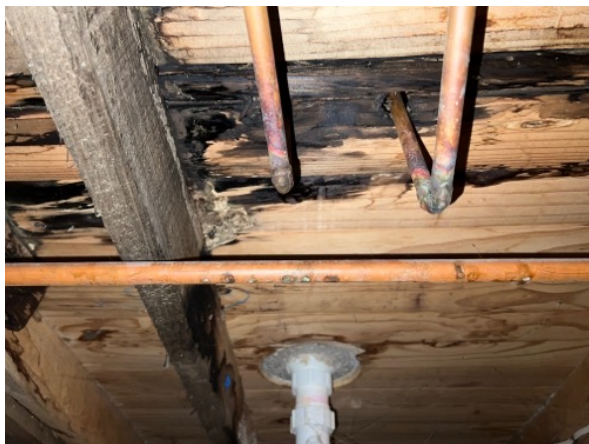
### Major Defect 2.01

**Finding:** Shower Area - Leaking

Leaking appears to be evident to the shower area at the time of inspection. It is suspected that the leaking has occurred as a result of a failing membrane, leaking pipes or general ageing of the building elements.

Leaking from the shower base, where left unattended, is likely to lead to water damage to adjoining flooring and walls. Such damage can lead to water damage and necessitate extensive remedial works being required. Active water leaks may also create an environment that is susceptible to the formation and development of mould and termite activity. It's advised to consult with a registered builder to repair or replace shower area. Such works should be performed as soon as possible to ensure that no further damage occurs.

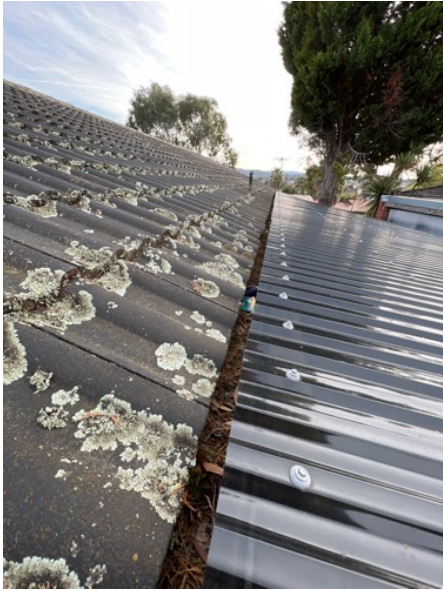
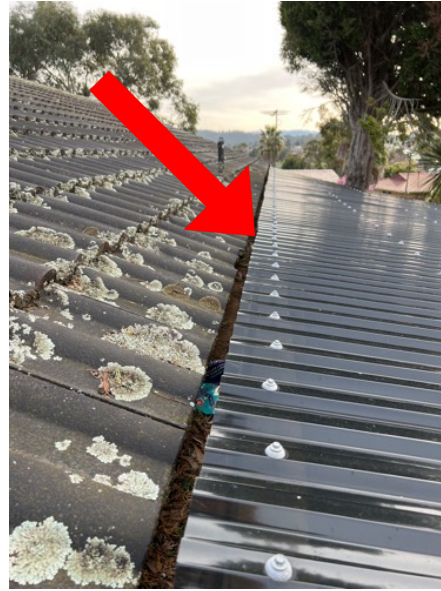
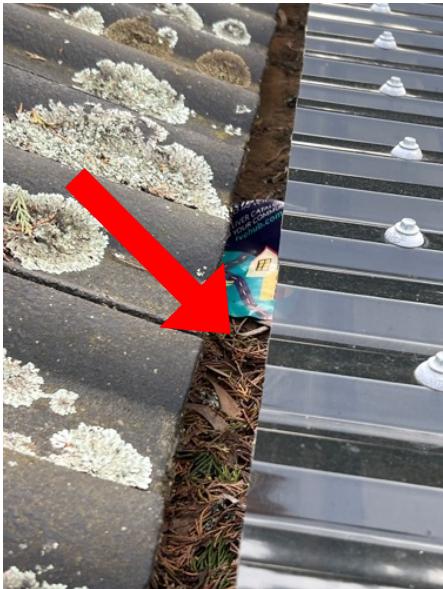
## Minor Defect 3.01

**Finding:** Gutters - Blocked

Roof plumbing structures such as guttering and downpipes should be free of all debris to prevent blockages. Blocked gutters are likely to lead to high levels of moisture in the affected areas and will not only cause rust and decay but can also provide conditions that are conducive to termite and timber pest activity. Blockages in gutters should therefore be removed immediately to ensure dry conditions are maintained. It is highly advised that blocked gutters be removed by the homeowner or a general handyperson as soon as possible.

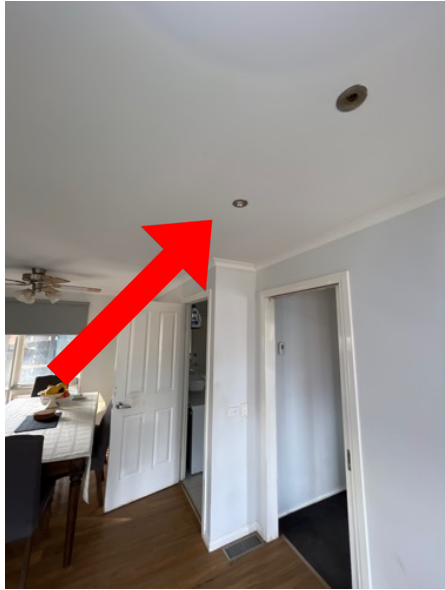
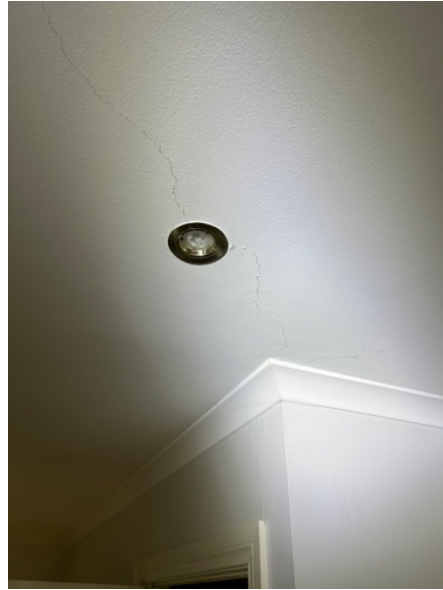
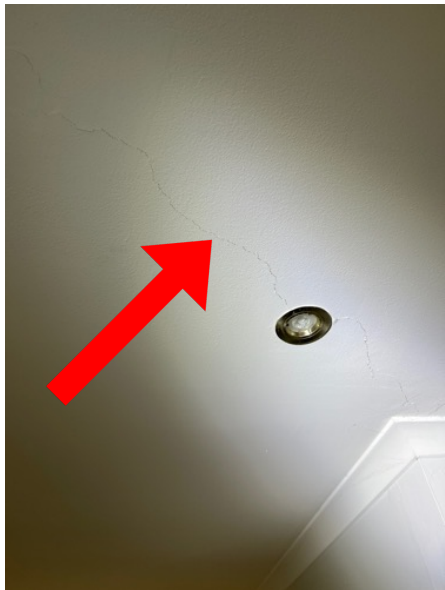
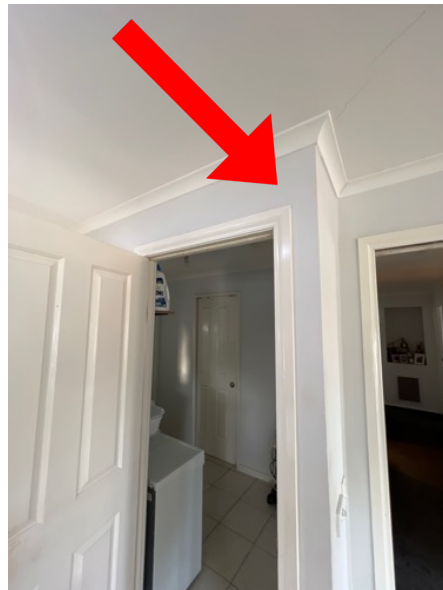
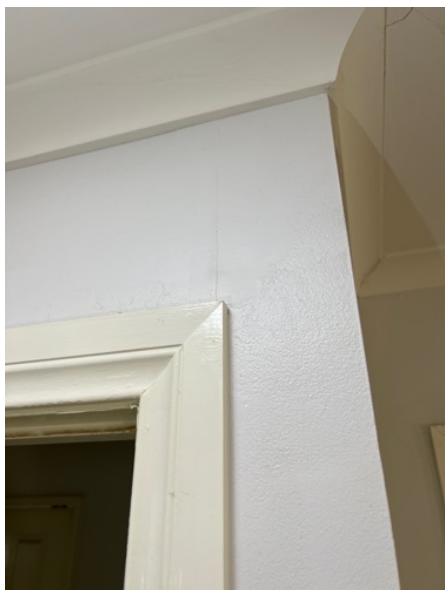
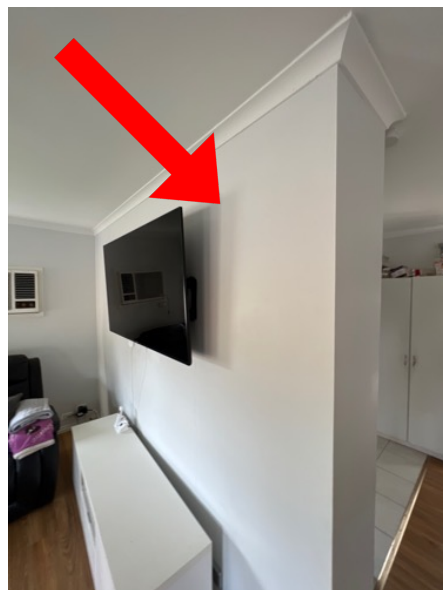
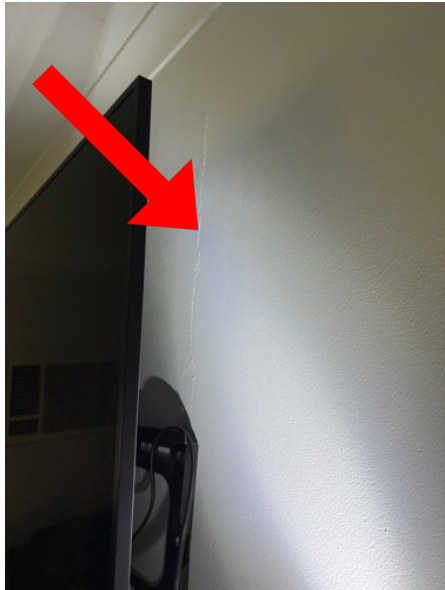
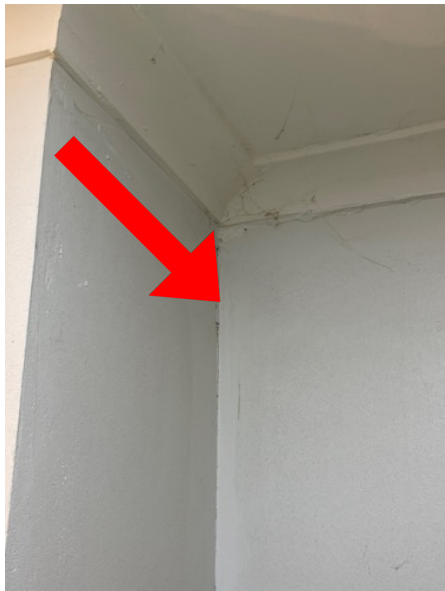
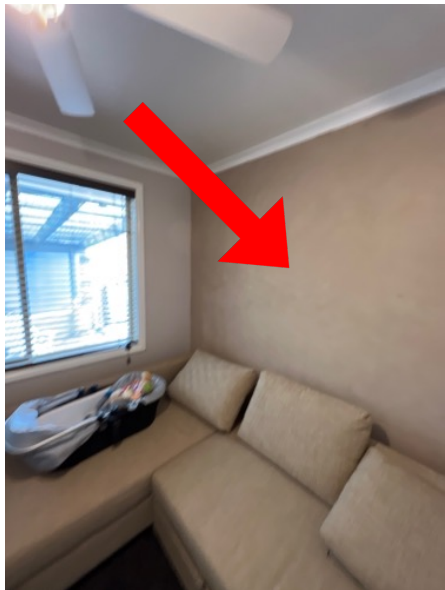
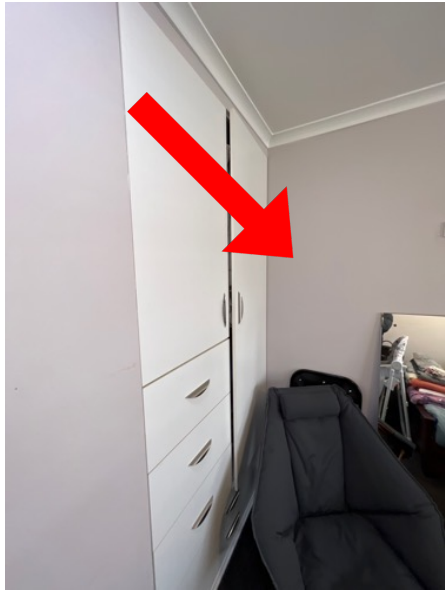
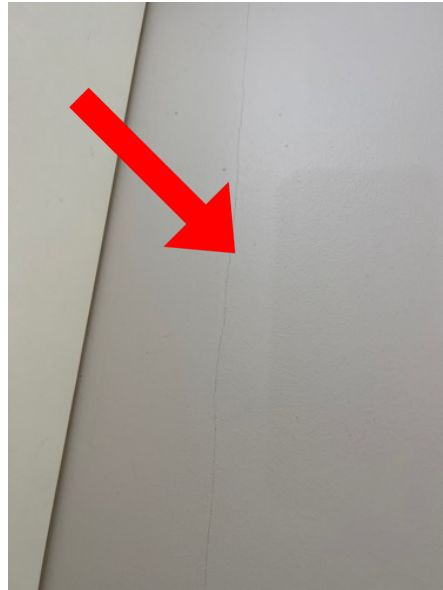
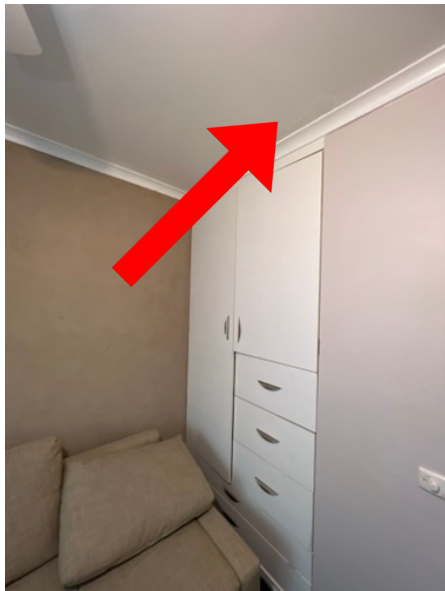
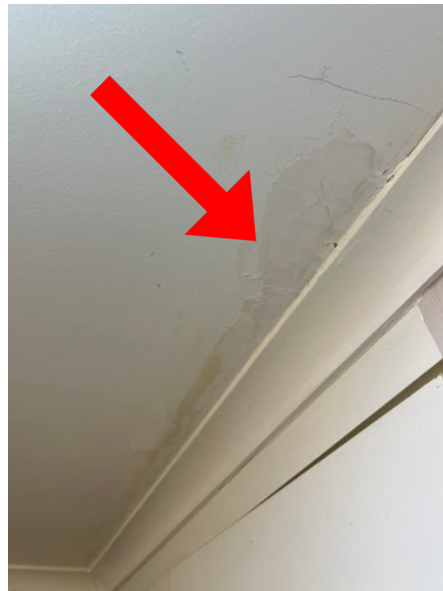
## Minor Defect 3.02

**Location:** All areas

**Finding:** Cracks - Plaster Work

Cracking was evident to the walls and ceilings throughout the property. Cracking of this nature is likely due to movement of the structure and poor workmanship during construction and renovations. It's advised to consult with a registered builder for rectification works.

Monitoring of all cracking should be conducted frequently. Always contact a building inspector should cracks widen, lengthen, or become more numerous.

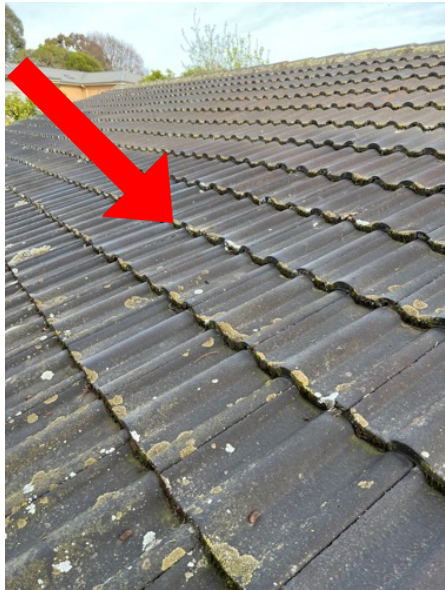
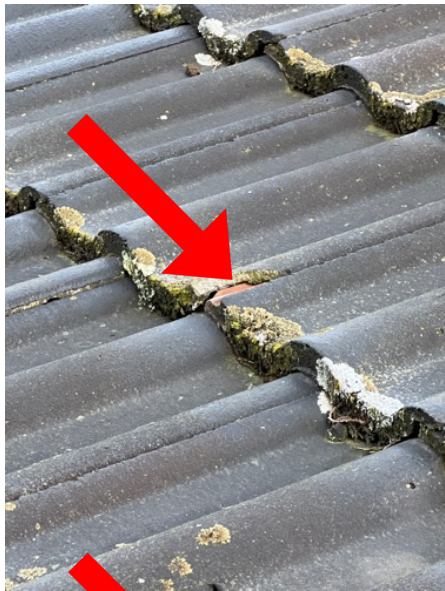
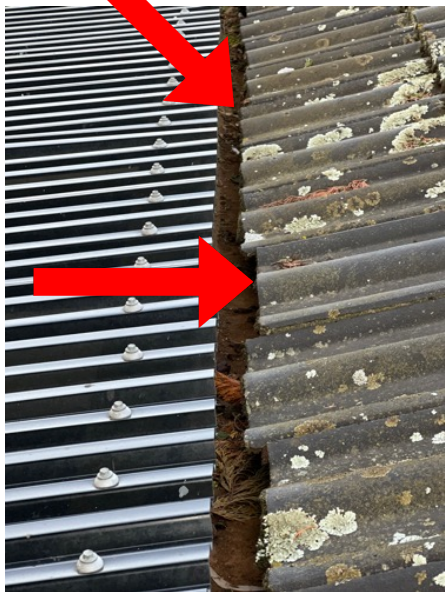
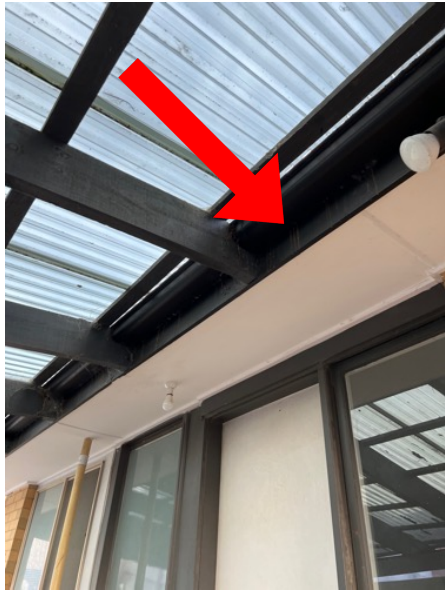
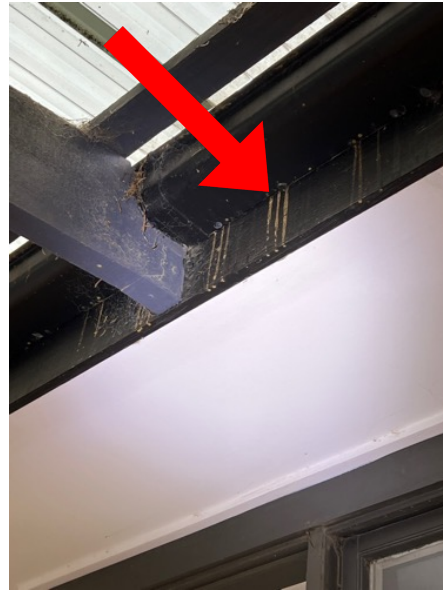
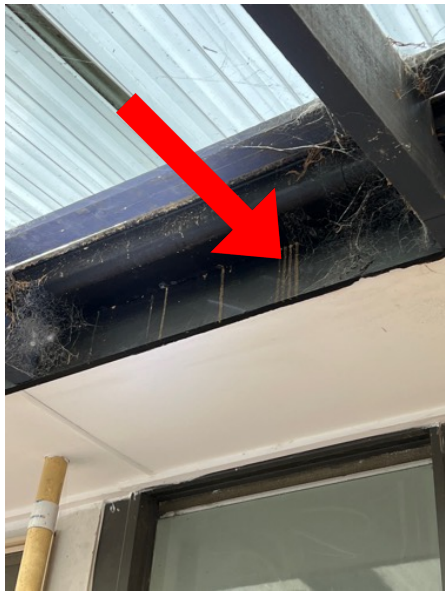
### Minor Defect 3.03

Overhang of roofing - Tiles roofing

Tiled roofing is defective in these areas as the tiles overhang the inside face of a gutter by less than 35 mm which has caused capillary action and allowed water to cause water staining on the roofing timbers. It's advise to consult with a registered builder and licensed plumber for rectification works. These works should be conducted as soon as possible.

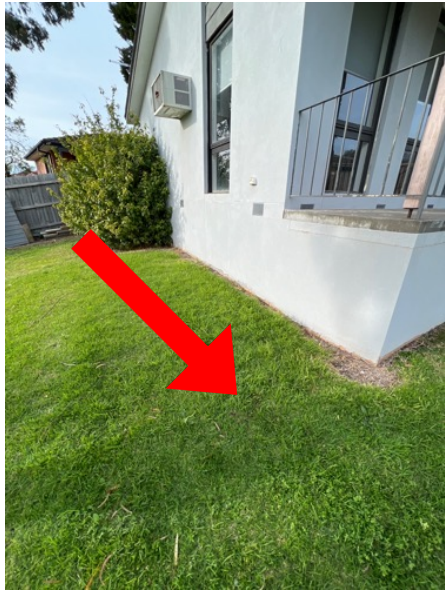
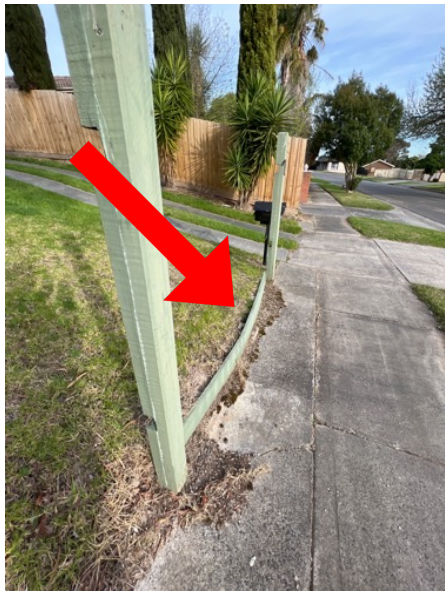
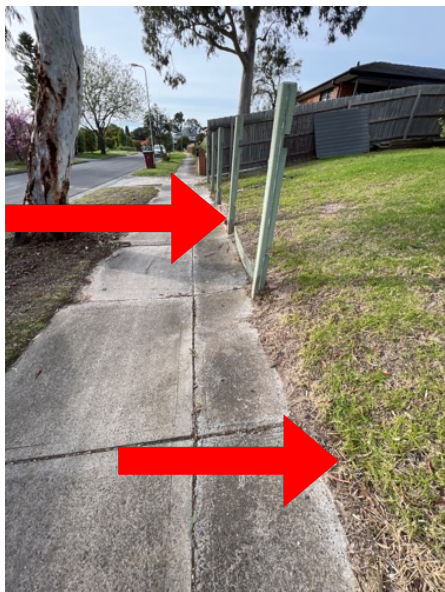
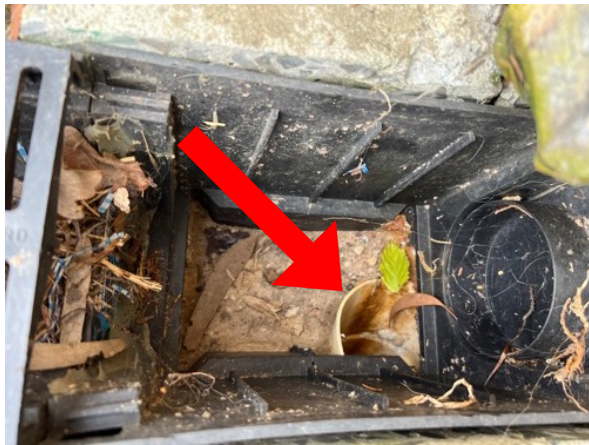
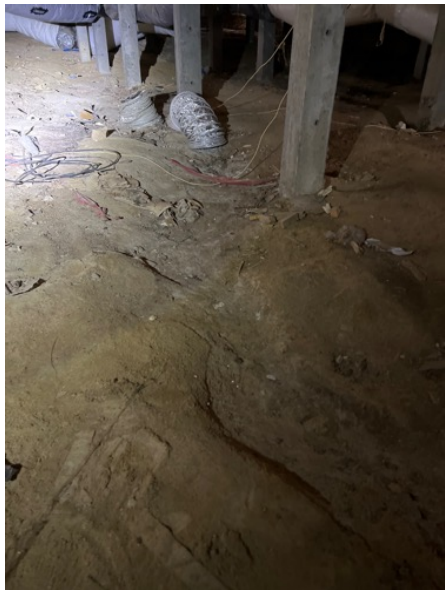
### Minor Defect 3.04

**Location:** All External Areas

**Finding:** Site drainage - Possible Damage

The site drainage around the property appeared poor and allows water to run into the subfloor during rain fall. Poor site drainage can create subsequent water damage to building elements. It is important that water does not lie against the base of walls; surrounding paths and ground levels should be sloped to drain water away from walls. Downpipes should not discharge stormwater onto lower walls or plinths. Stormwater should be carried away by drains. Due to the location of the property, evidence of water flowing, pooling in the subfloor damage to parts of the subsoil drainage should be expected and should be further inspected by a licensed plumber. Inspection of the drainage is excluded from this report.

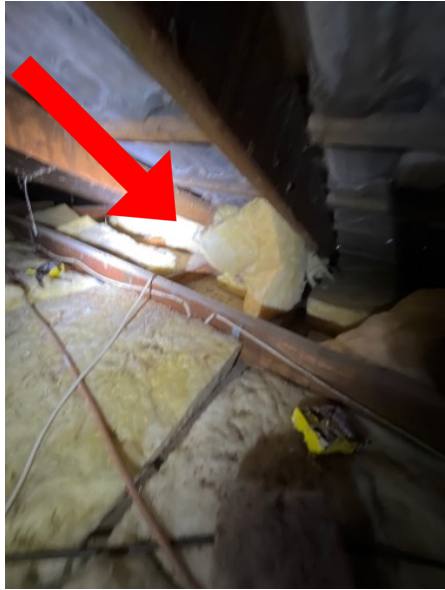
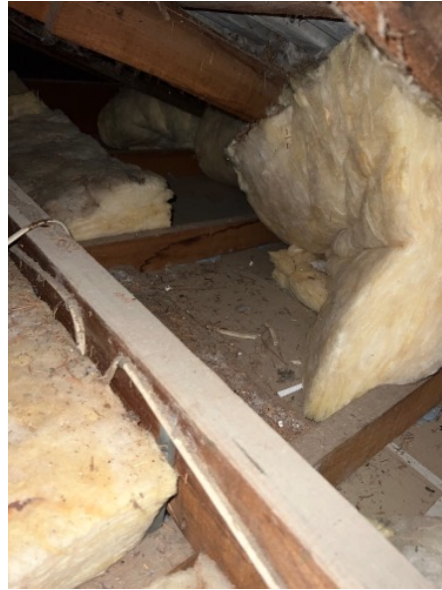
### Minor Defect 3.05

**Location:** Roofspace

Insulation batts - Inadequate coverage

Information: While the insulation batts have been installed, large gaps in the coverage were noted at the time of inspection due to poor workmanship.

Insulation is vital in maintaining the energy efficiency of the property. Where insulation has not been fitted correctly, the energy efficiency is drastically decreased, and insulation becomes worthless.

All insulation in the roof void should be reinstated. Coverage should butt all edges of the surface area and no gaps should be found.

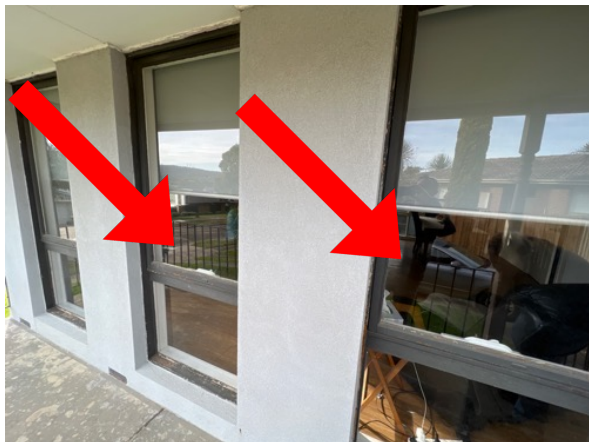
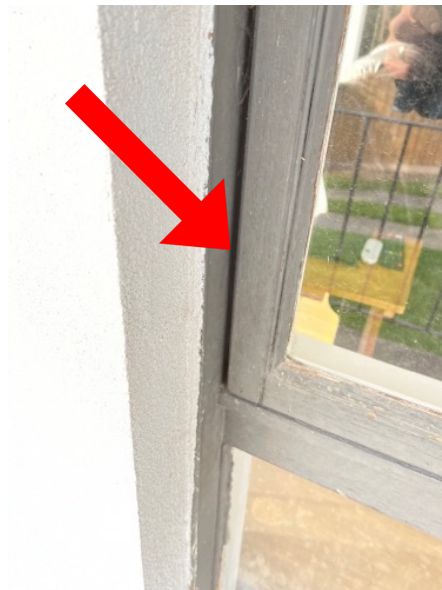
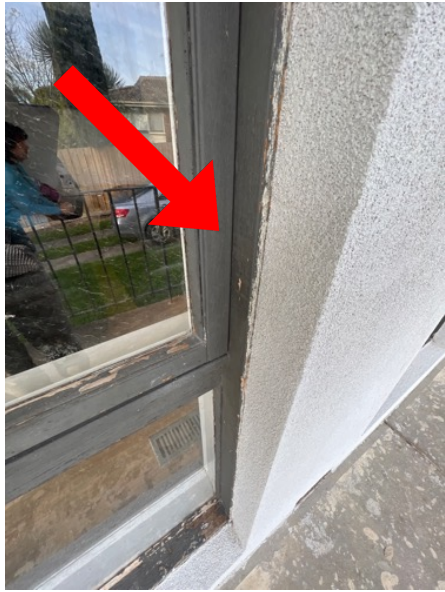
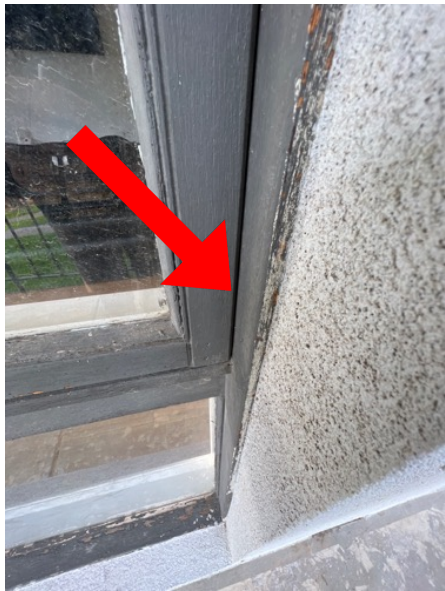
### Minor Defect 3.06

**Location:** All areas

Binding and/or jamming of these windows was evident during standard operation. This defect inhibits the functionality of the affected windows as well as creating potential for secondary defects to associated building elements, such as damage to the window jambs.

A window that binds to the frame may have several causes, ranging from minor defects, such as poor installation of the window or movements to building structures.

A qualified carpenter or general handyperson should be appointed to perform rectification works.

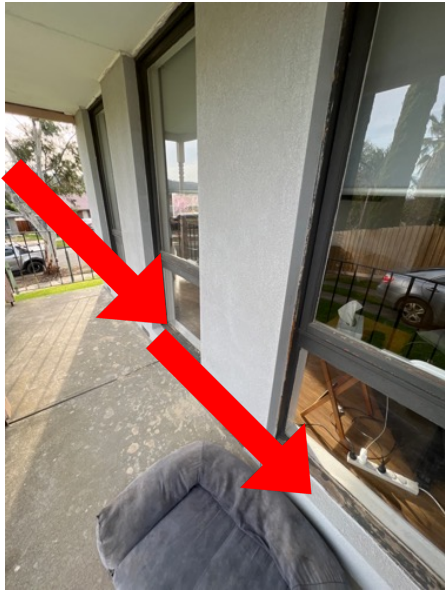
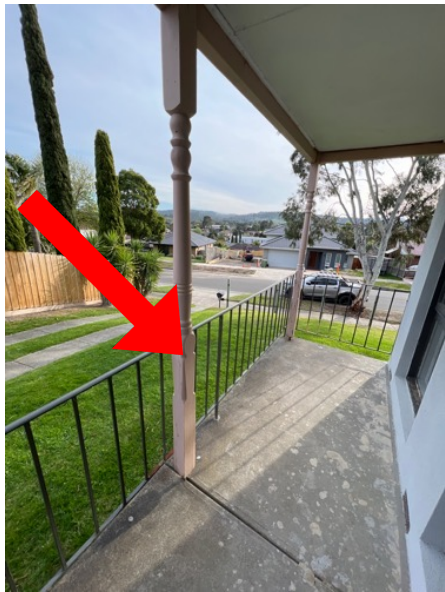
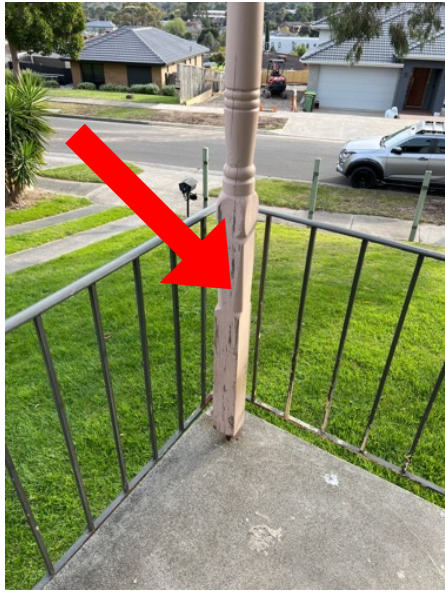
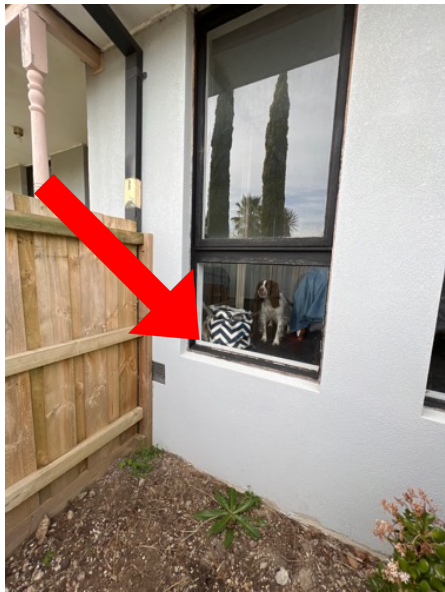
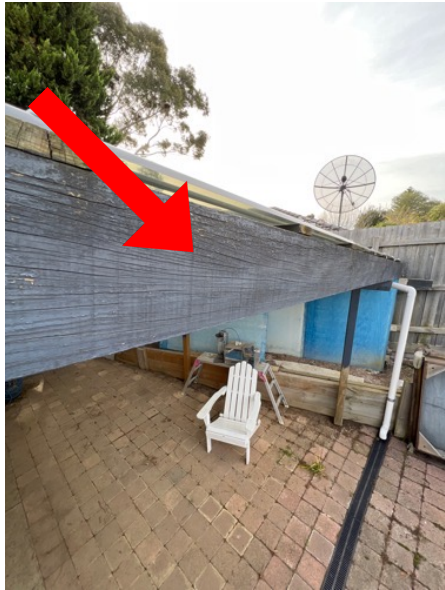
### Minor Defect 3.07

Timber - exposed to weather

All external timbers that are frequently exposed to harsh weather conditions require adequate protection in order to maintain their condition. Where timbers have not been painted or treated adequately, general deterioration is likely to occur at an accelerated rate. If left unattended, replacement of these timbers is likely to be necessary in the short-term future. Adequate treatment of these timbers is required as soon as possible by a painting contractor.

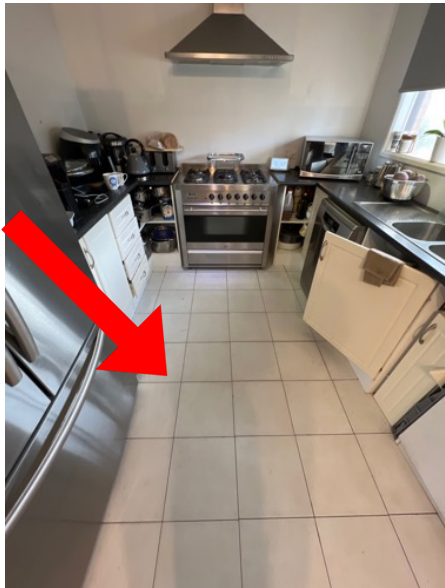
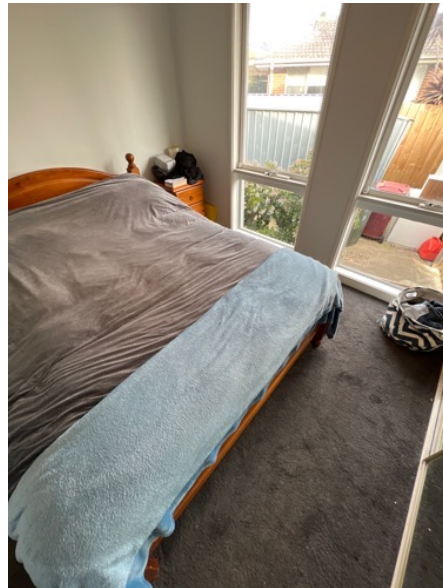
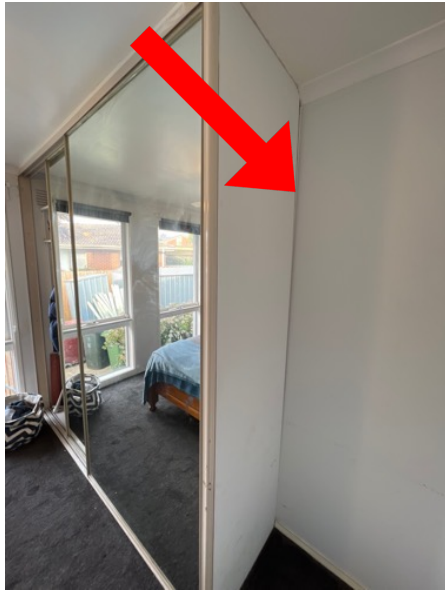
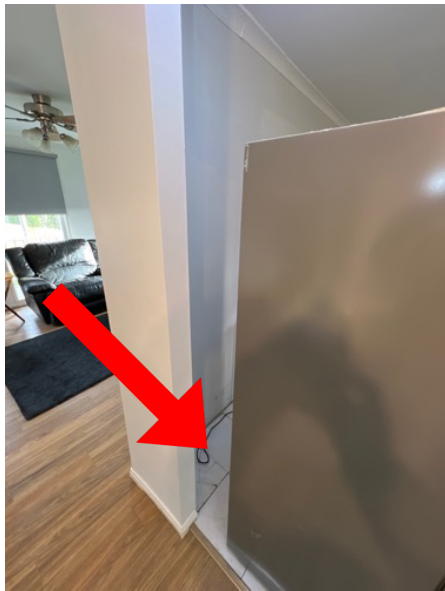
### Minor Defect 3.08

**Location:** All areas

**Finding:** Flooring - Uneven

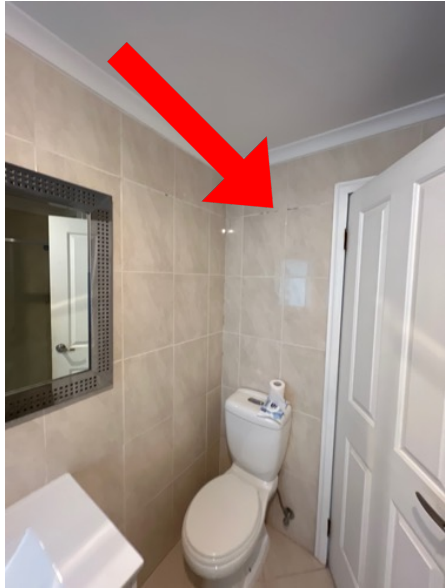
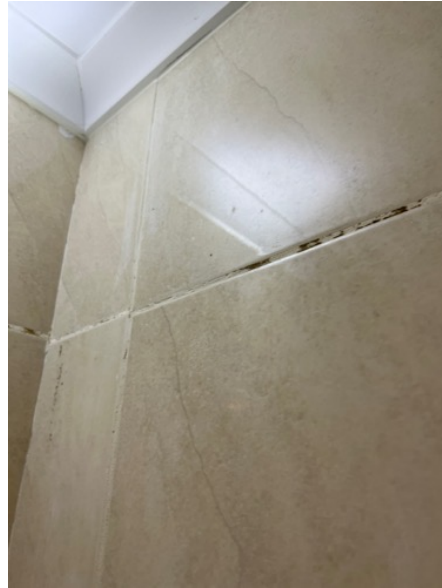
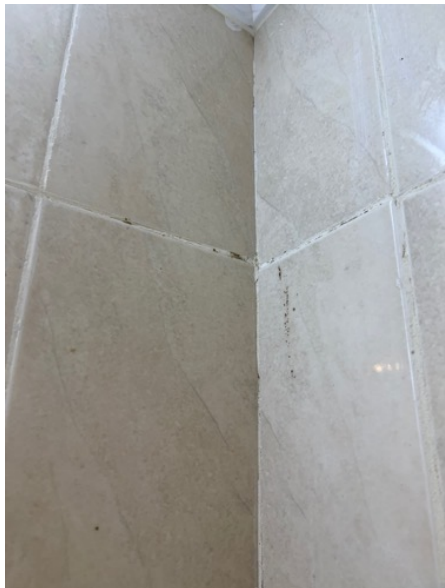
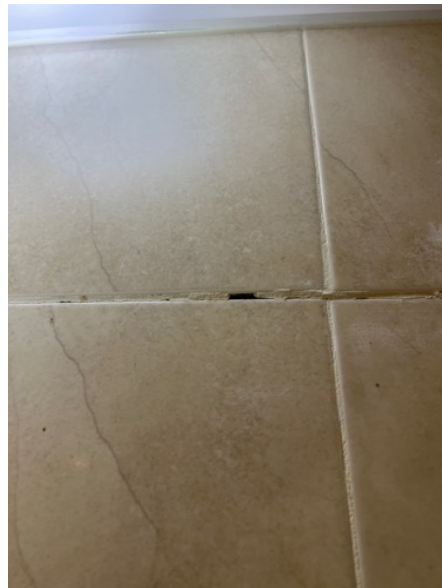
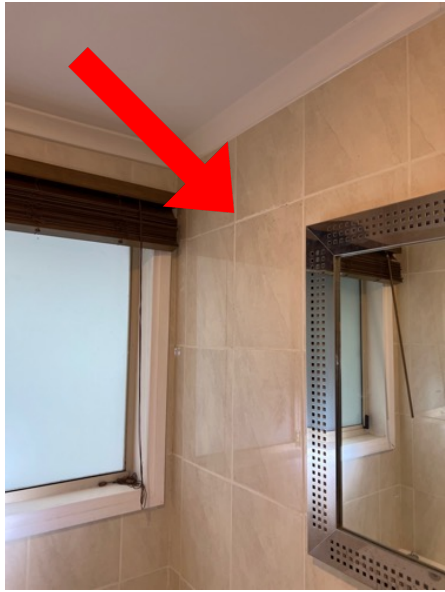
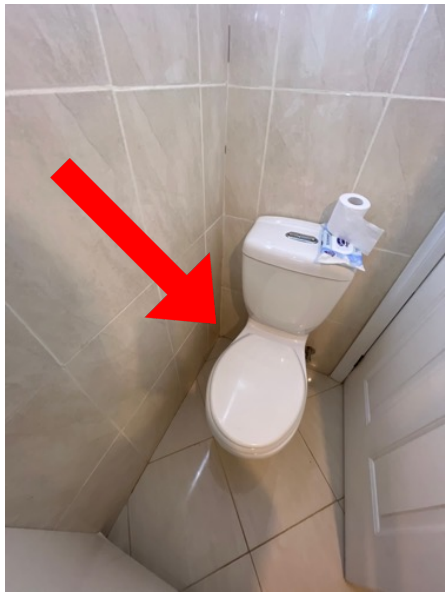
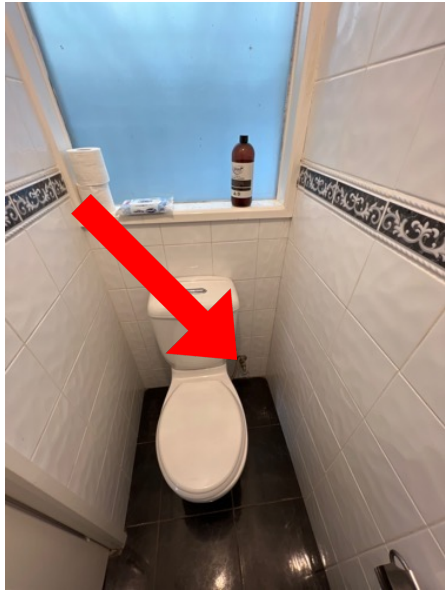
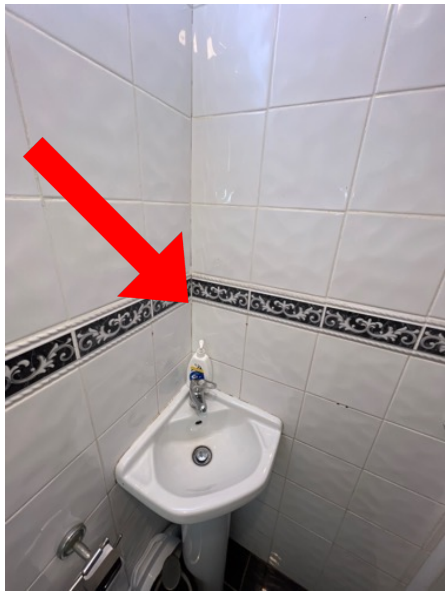
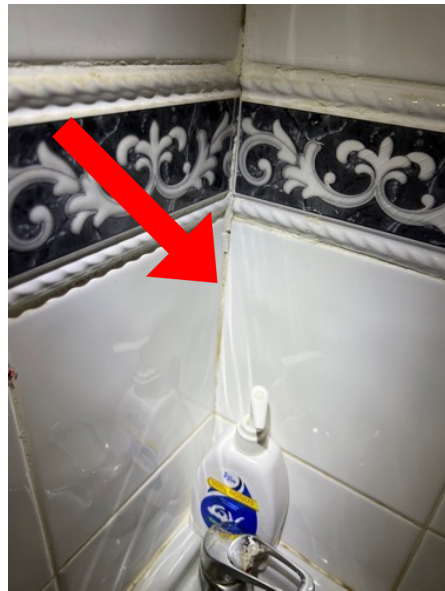
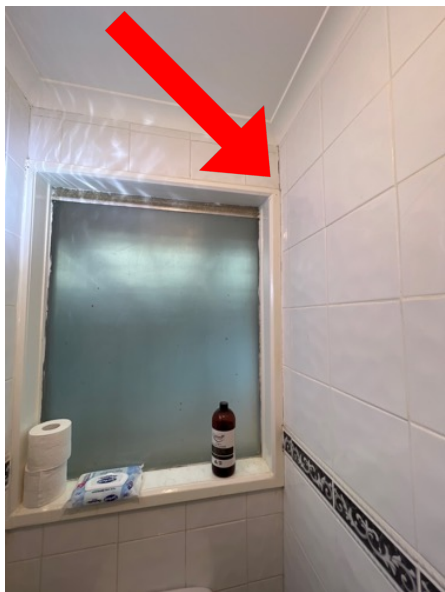
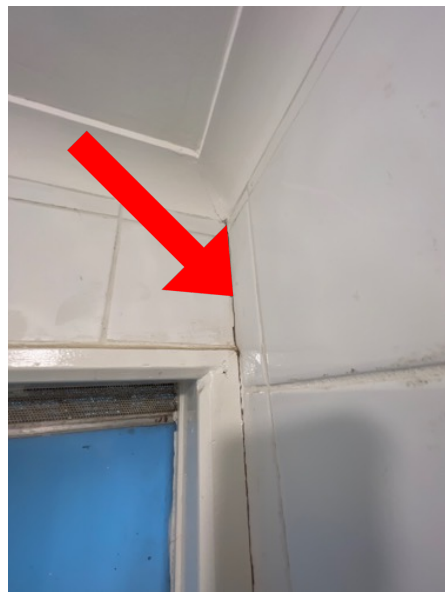
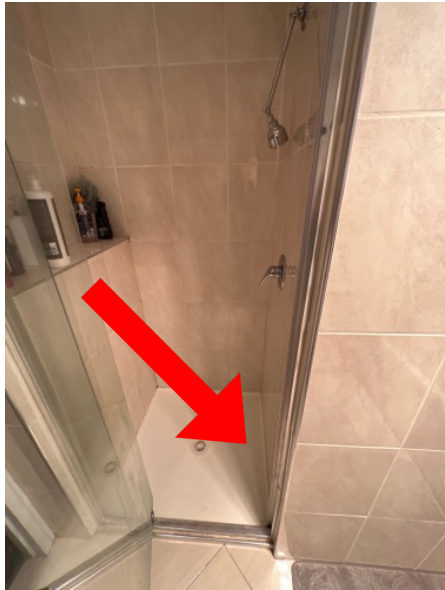
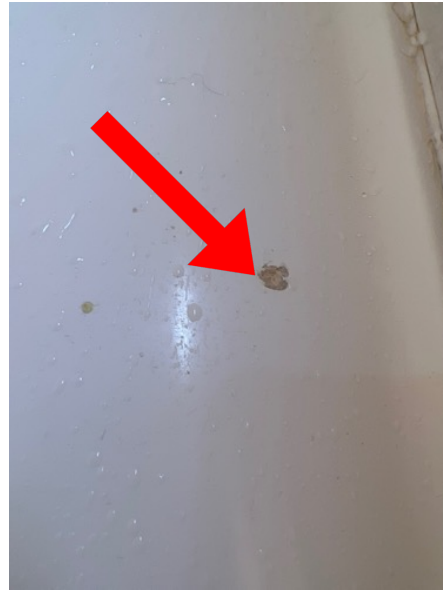
## Minor Defect 3.09

**Location:** Bathroom

**Finding:** Bathroom Area Tile - Cracked

Cracking was evident to the bathroom area tiles at the time of inspection which appears to be due to poor workmanship and water damage. This area is frequently exposed to water and any cracking and loose tiles is likely to allow water penetration. If left unmanaged, water penetration may cause water damage to other elements, and necessitate significant rectification works. Appointment of a registered builder and tiling contractor is required to repair the cracked tiles, so as to ensure no water penetration occurs. These works should be conducted as soon as possible.

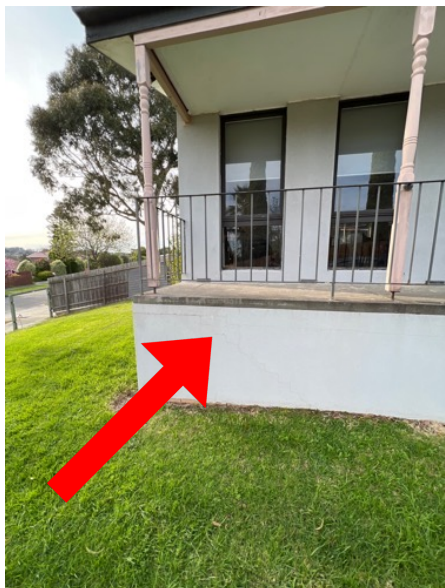
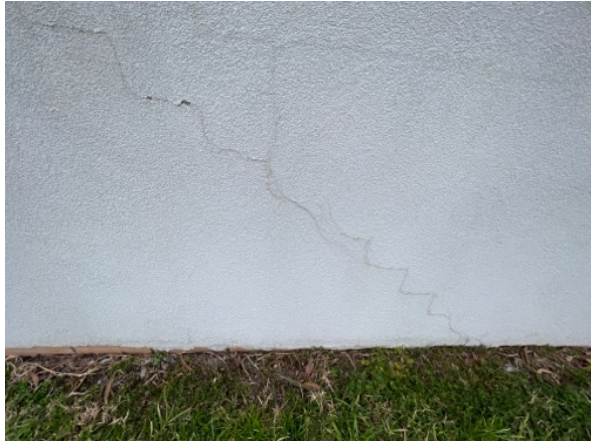
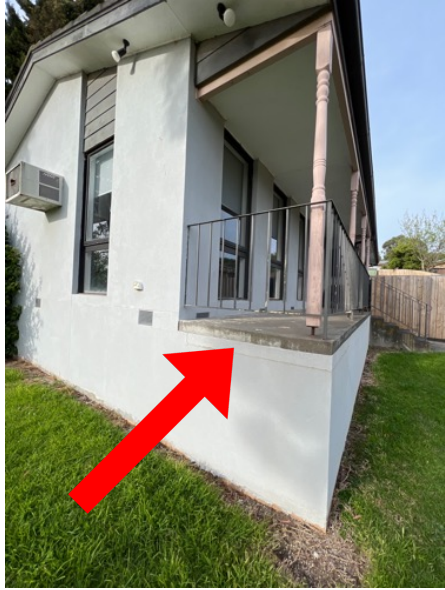
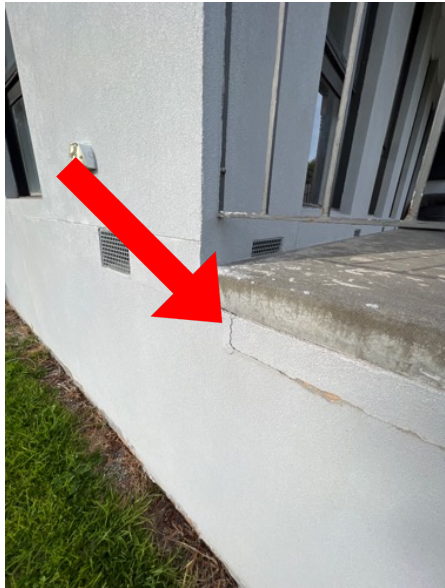
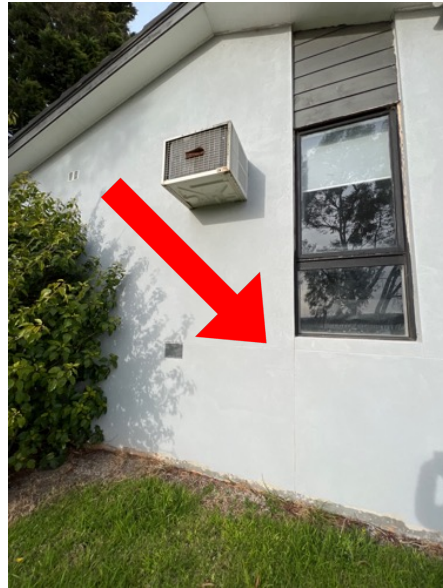
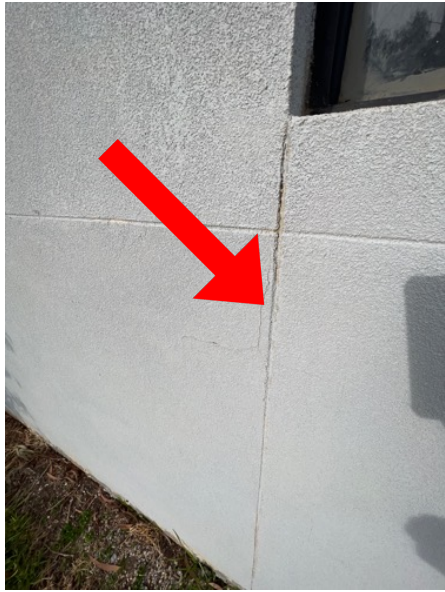
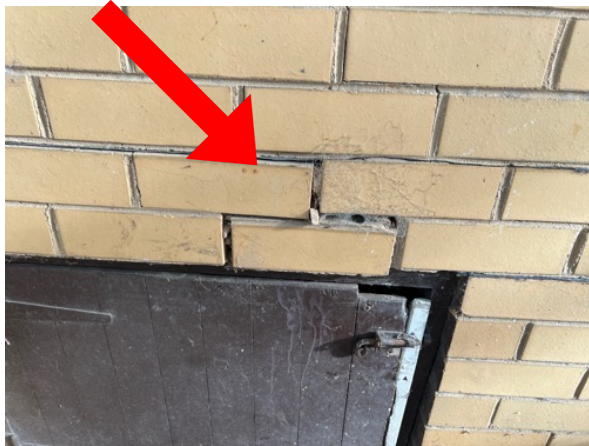
### Minor Defect 3.10

**Location:** Exterior Walls  
**Finding:** Brickwork cracking

There are several cracks evident to the sections of brick walls. These cracks usually coincide with openings (windows and doors) however they can present in other areas also. Cracks of this type are likely to have been caused by poor site drainage and flooding which causes deterioration of the bricks, mortar and footings allowing movement of building elements, but may also have a structural cause that is more significant. Noticeable cracks in walls may develop if left unattended with the potential of necessitating remedial works or replacement of sections of brickwork. Consultation with a structural engineer is required to further access the property and where structural instability is found to be the underlying cause of the cracking major rectification works should be expected. Always monitor these cracks and contact a building inspector should cracks widen lengthen or become more numerous.

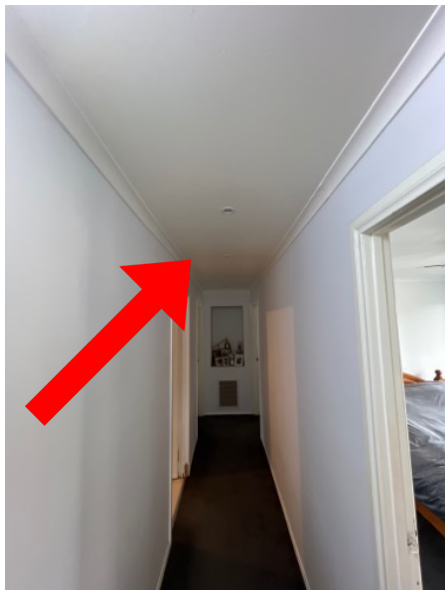
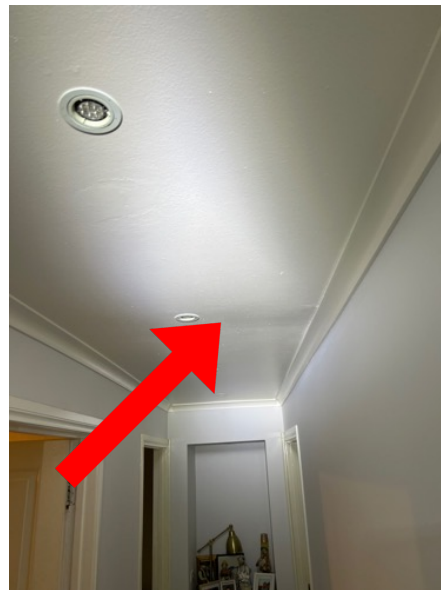
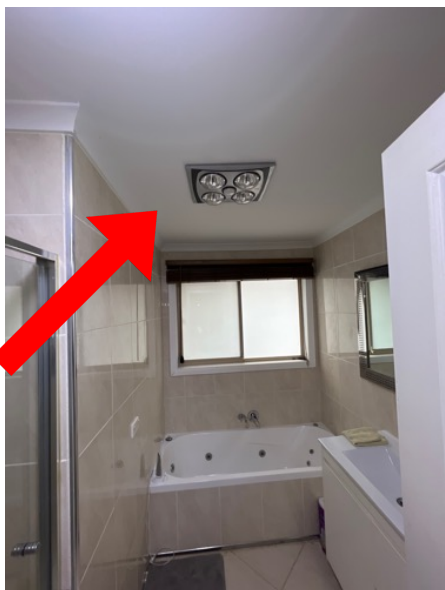
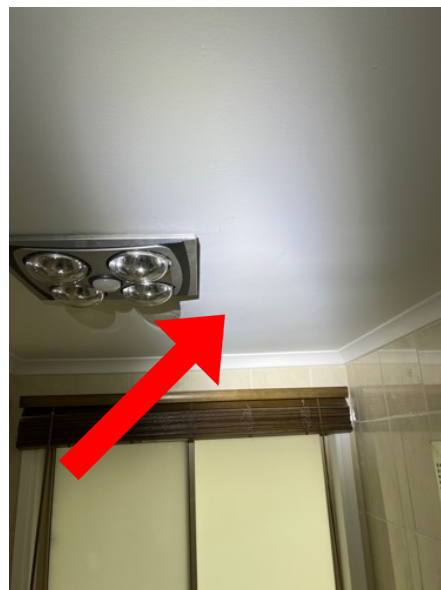
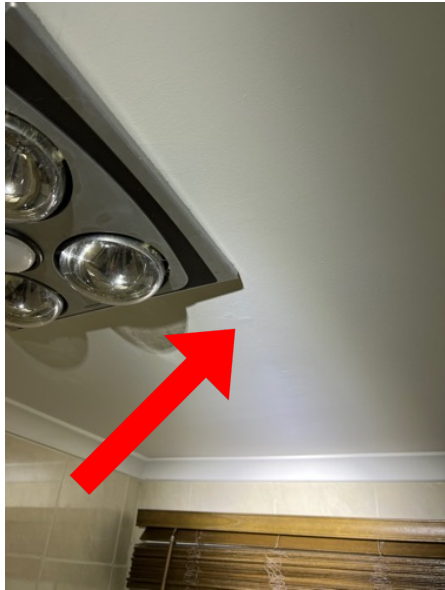
**Location:** Hall wall

Sections of the hallway ceiling was found to be sagging at the time of inspection. Sagging to the fixed ceiling structure indicates that the building materials have swollen, due to contact with roof leak and water, and that fixings (e.g. nails or glue) have become loose and require reattachment.

Where minor sagging is evident, comparatively minor works, such as re-gluing of ceiling sheets, may be required, however replacing the ceiling sheets may also be required. Such works may be performed by relevant tradespeople, such as plasterers and painters.

While damage is minimal at this stage a licensed plasterboard contractor should be appointed to repair the ceiling as soon as possible. Insulating the area could be considered by the client once repaired.
