# Building Inspection Report

Inspection Date: 9 Aug 2023

**Property Address: 16 Aaran Close  
Endeavour Hills 3802**

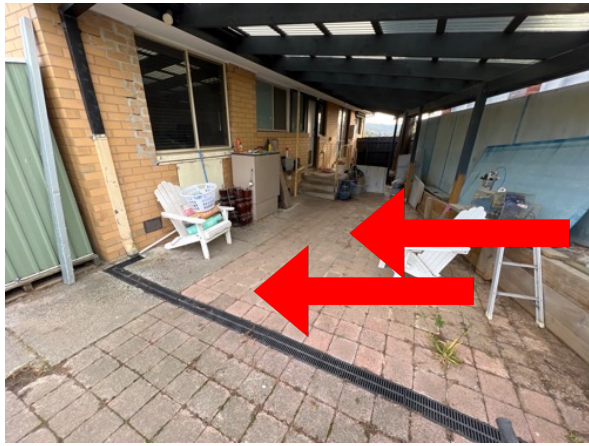
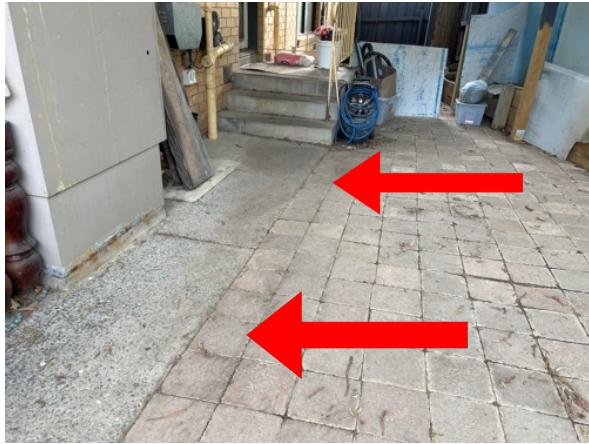
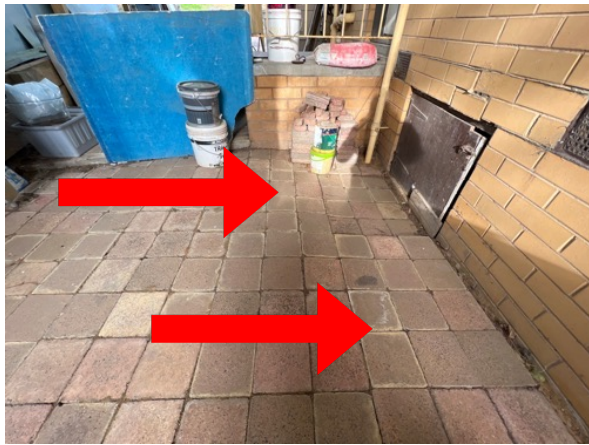
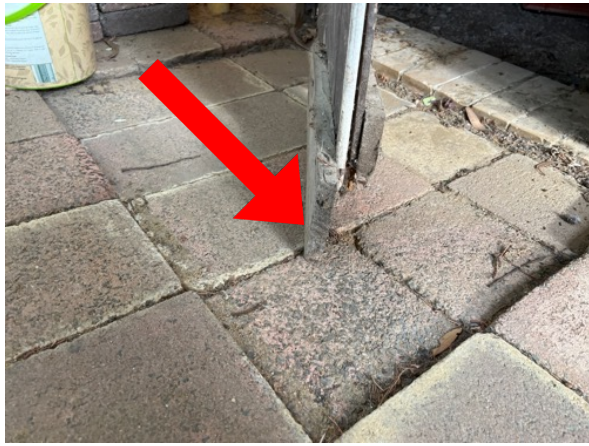
The perimeter paving or ground levels were found to have an inadequate slope away from the adjoining building structure, creating potential for water pooling in this area.

Perimeter paving is required to fall from the building by a minimum of 25mm in the first metre and bare ground should fall away from the house by 50mm in the first meter. This standard ensures that excessive moisture does not pool in the subfloor and around the base of building structures, which creates potential for water and structural damage, as well as making the area susceptible to termite and timber pest activity.

Where paving or ground levels do not have adequate fall, a licensed paving contractor should be appointed to install or remove and re-level pavement.

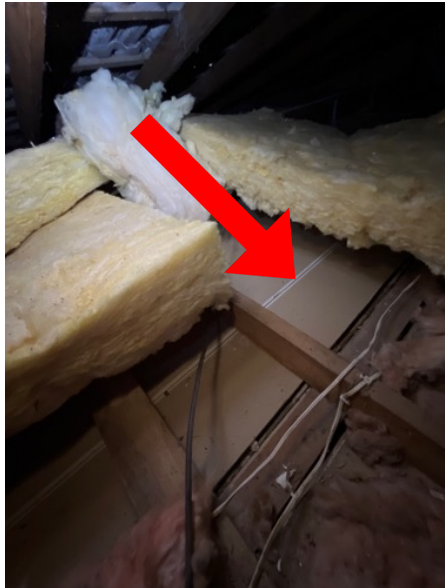
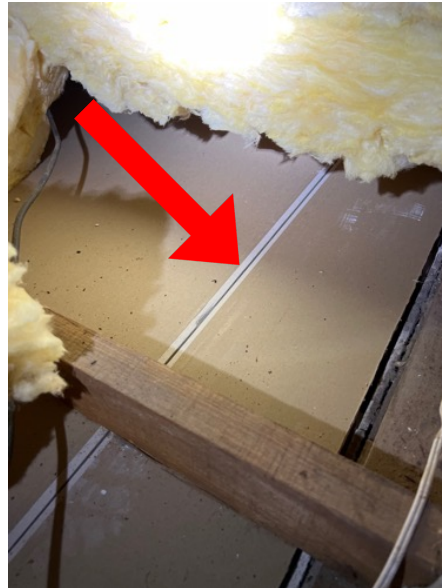
**Location:** Bathroom

**Finding:** Back Blocks - Missing

The lack of back blocking to the plaster work was evident in the roof space due to poor workmanship. Back blocking is the process of reinforcing wall and ceiling joints with cut to size pieces of plaster board adhered across of the plaster board joints. Lack of back blocks can lead to cracking and sagging of the plaster board. Further works such as re-gluing of wall and ceiling plaster joints should be conducted and should be performed by a qualified plasterer as soon as possible.

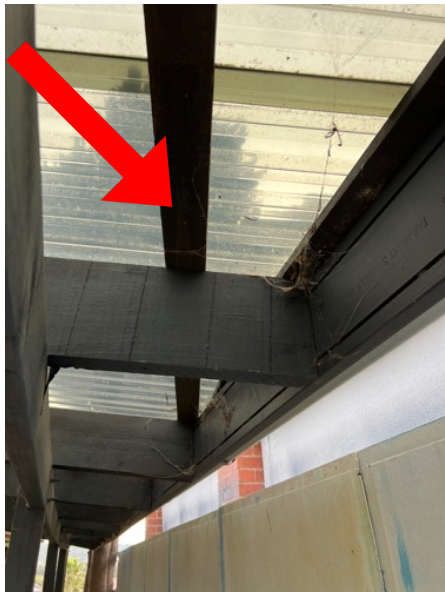
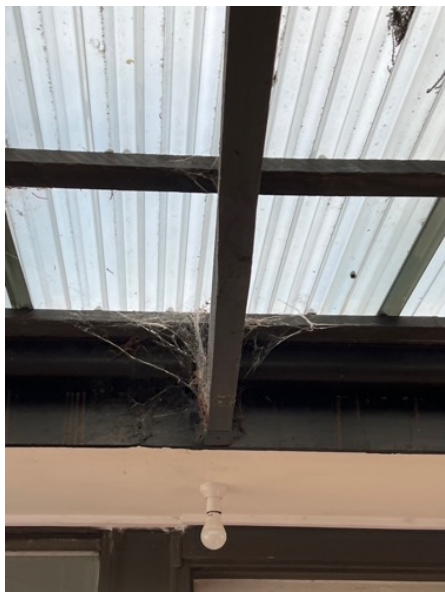
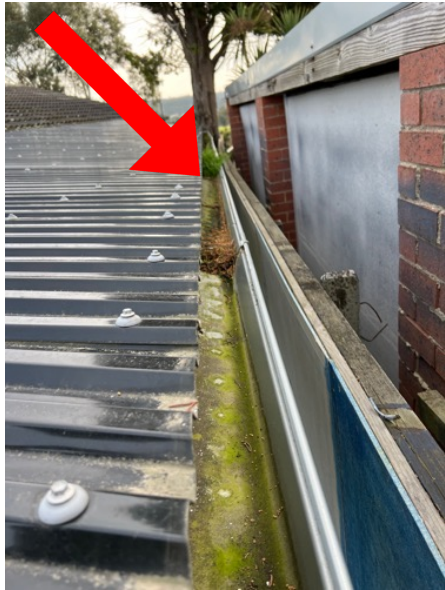
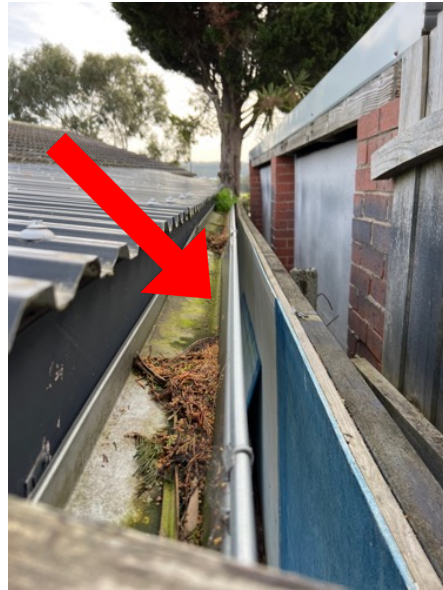
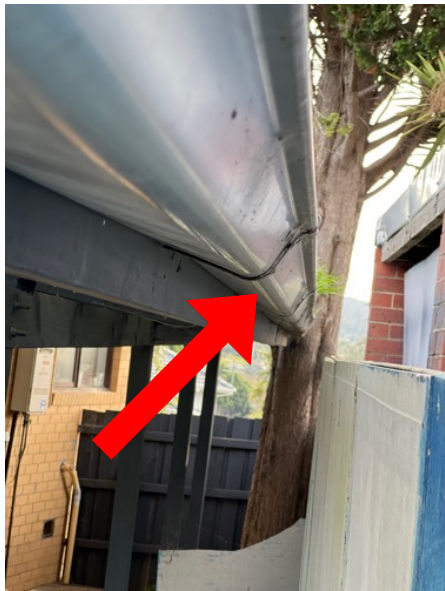
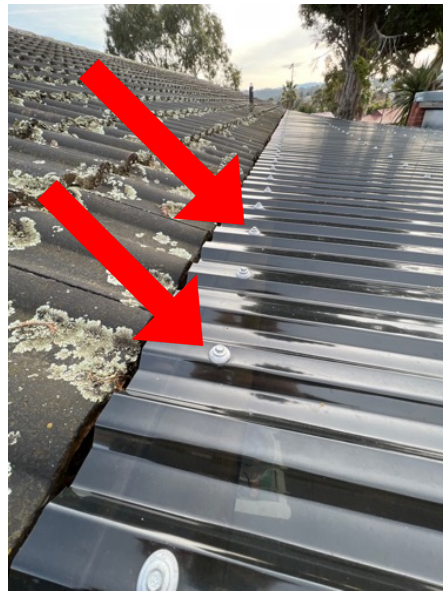
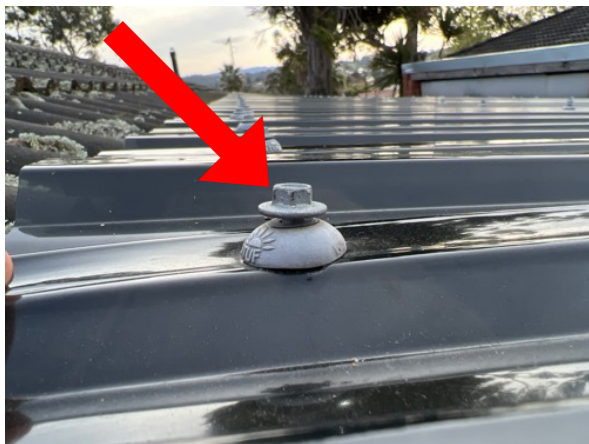
**Location:** Pergola

**Finding:** Pergola - Poor Workmanship

The pergola show a range of defects and non compliant works. A non compliant pergola structures is likely to create strain on associated building elements, creating potential for secondary damage. The pergola is also unlikely to have sufficient support, which will lead to sagging if left unmanaged. It is critical to ensure that the fastenings holding important roof elements together remain structurally sound, correct sized battens and sagging gutters should be replaced. Remedial works are highly advised and should be performed by a registered builder or roofing contractor as soon as possible.

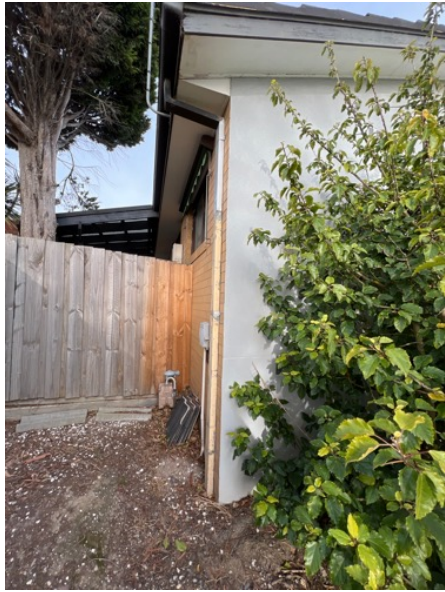
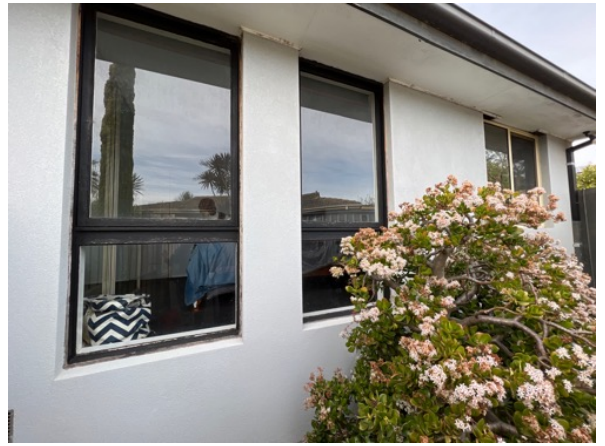
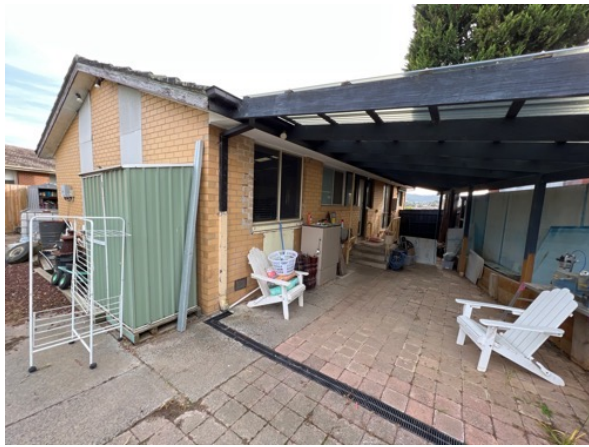
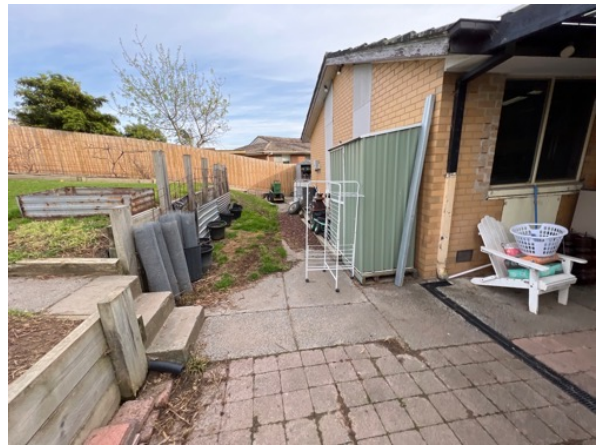
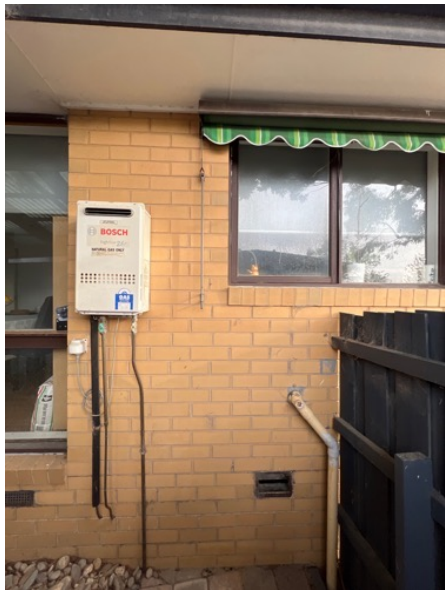
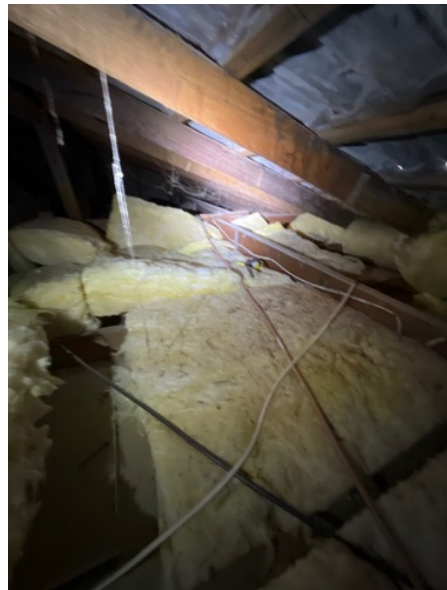
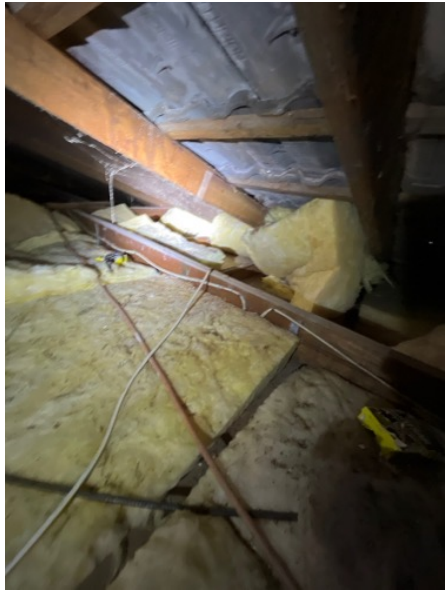
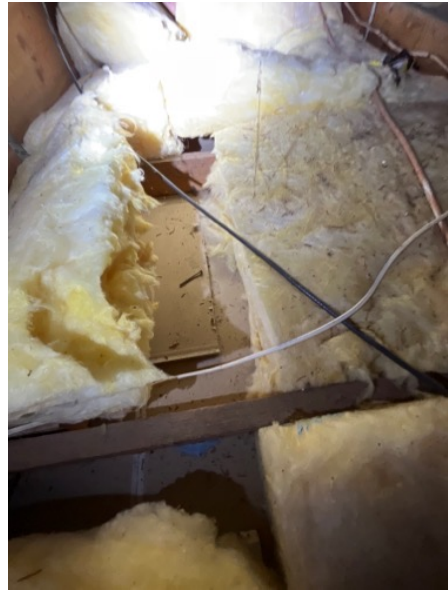
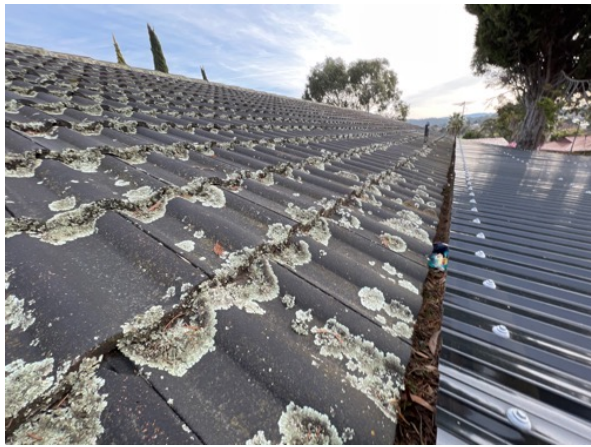
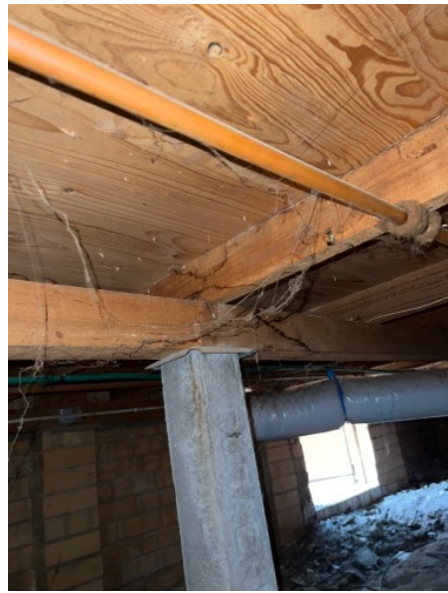
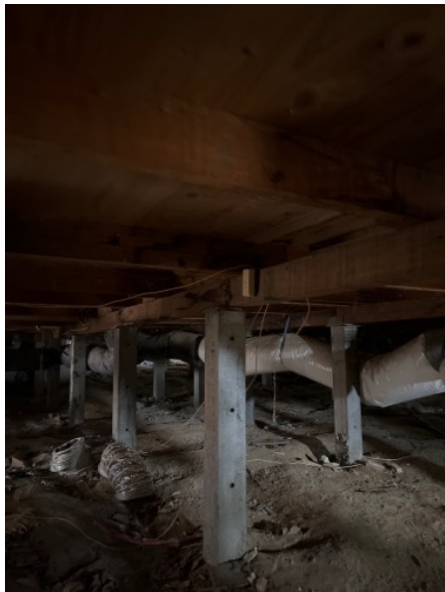
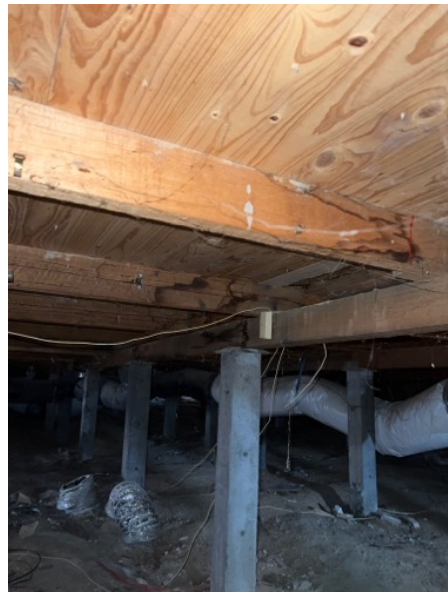
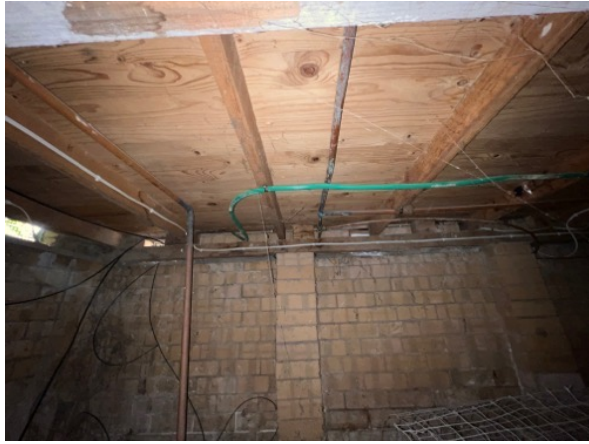
The additional photographs are an indication of the obstructions, stored items, limitations, health and safety limitations, which impeded full inspection of the property at the time of inspection. Obstructions as see in the photos can hide an array of defects and should be removed to allow full inspection to be carried out. A re-inspection is recommended once the areas are made accessible.

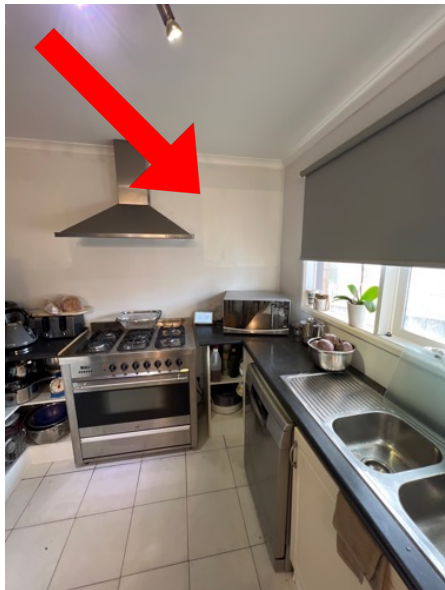
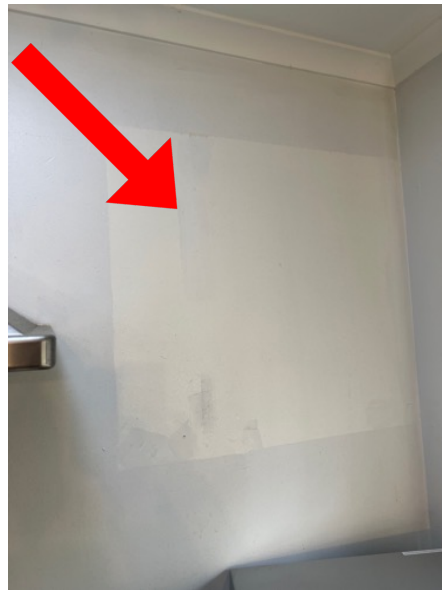
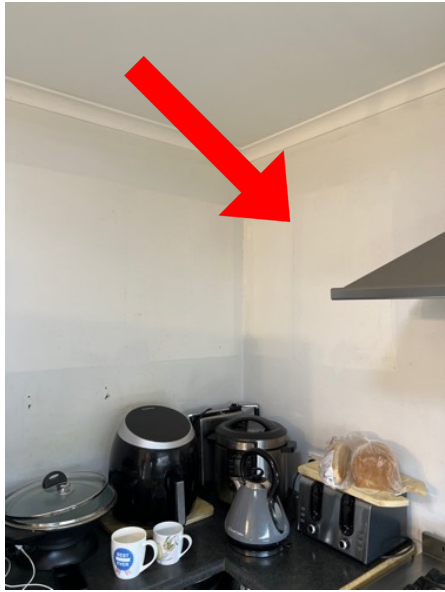
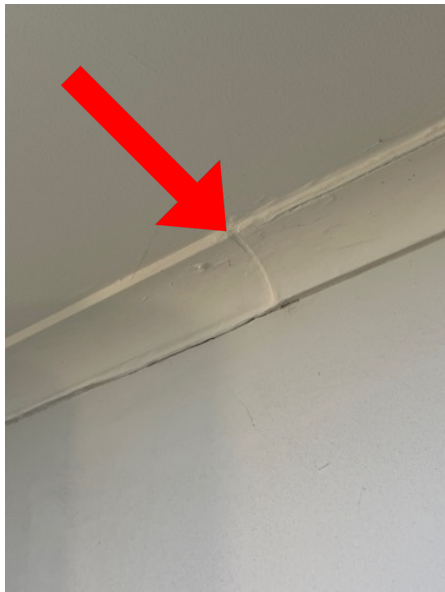
## For Your Information 5.02

**Location:** All areas

**Finding:** Handyman Works

These repair works including plaster and paint works have been conducted to a handyman level of work and appears to have been completed to a substandard level which doesn't comply with regular building practices. It is highly recommended that the substandard works be rectified by professional services. Works to improve this area are likely to increase the safety and the operation of the associated building elements. Rectification works are advised as soon as possible by the appropriate trades.

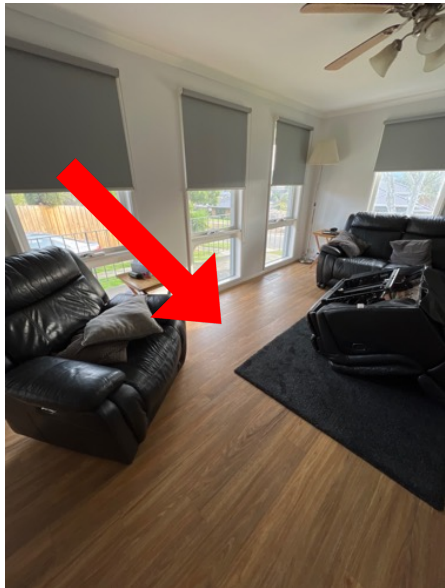
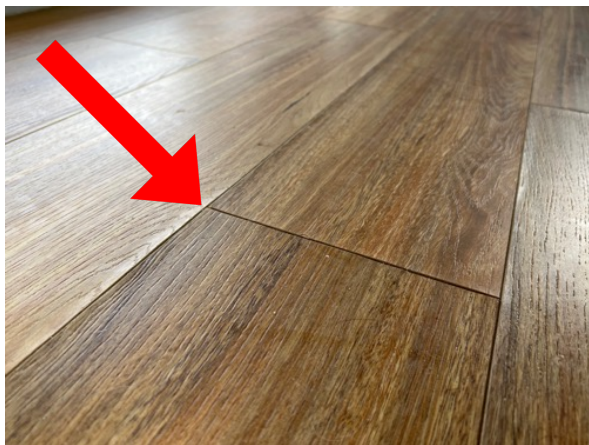
## For Your Information 5.04

**Location:** Lounge room
