Roof Report

Property Address 16 Aaran Close Endeavour Hills VIC 3802

Claim No. 6210287371

Builder Ambrose Construct Group Pty Ltd

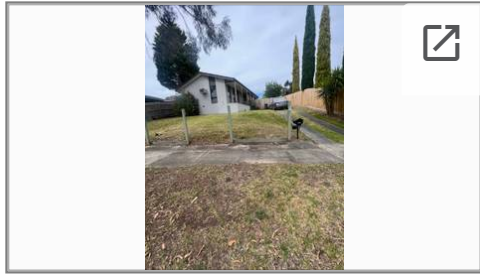
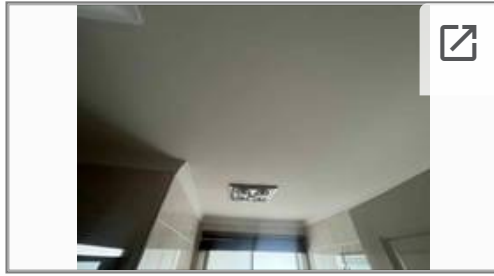
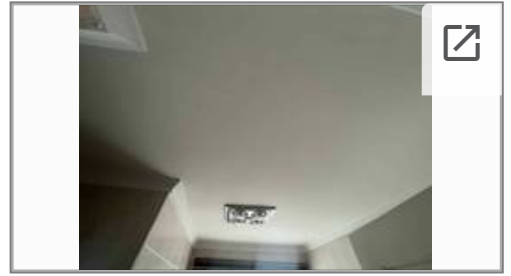
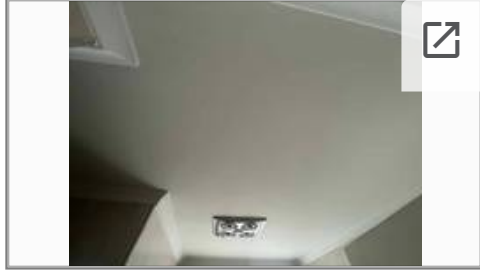
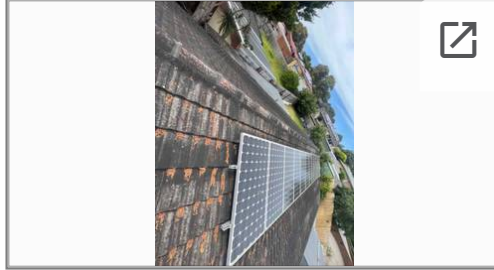
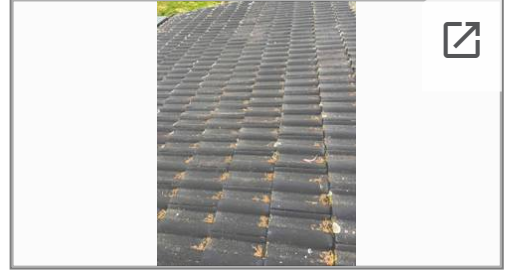
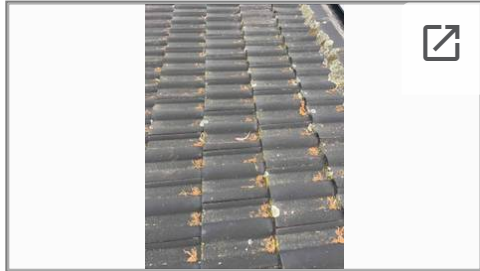
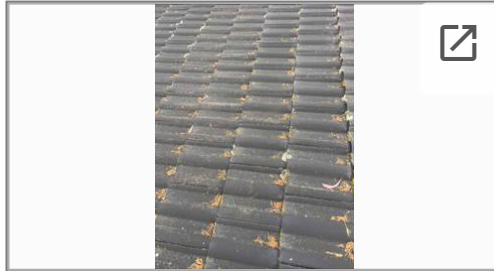
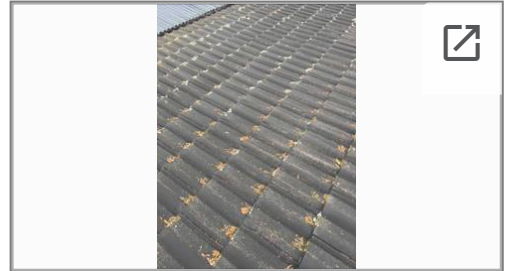
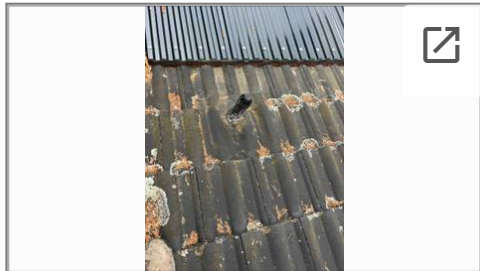
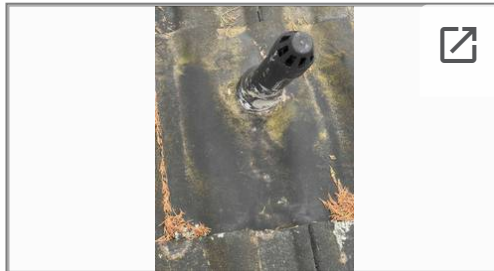
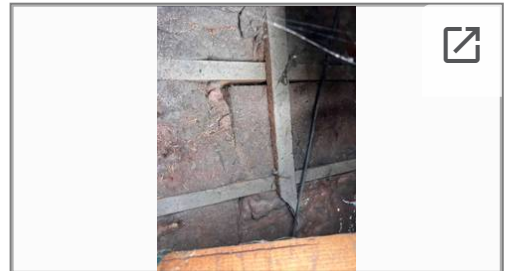
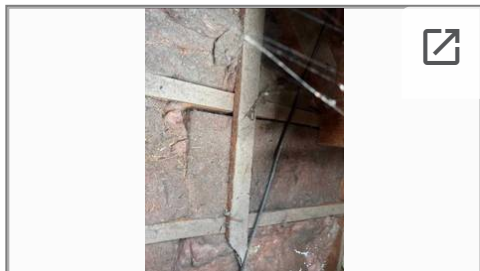
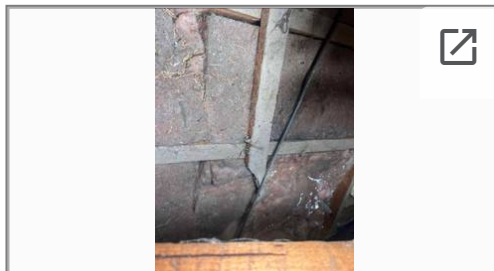
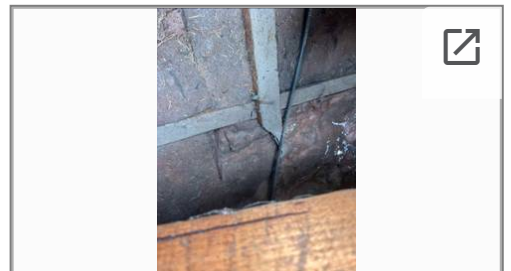
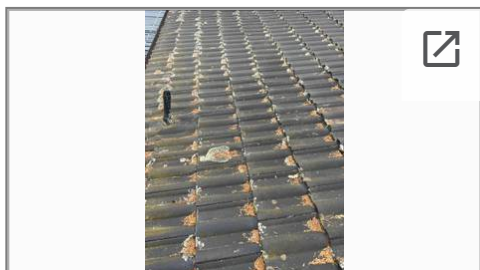
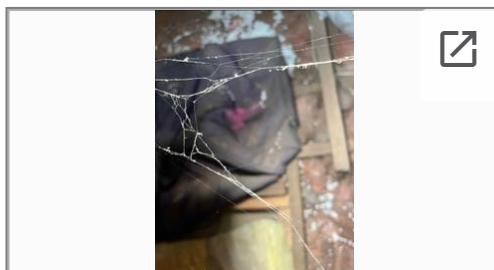
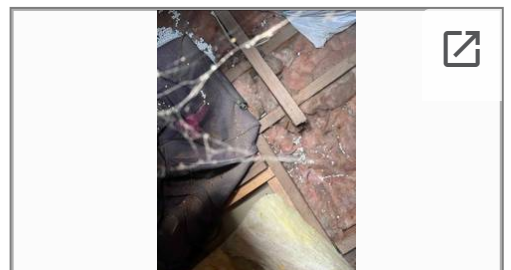
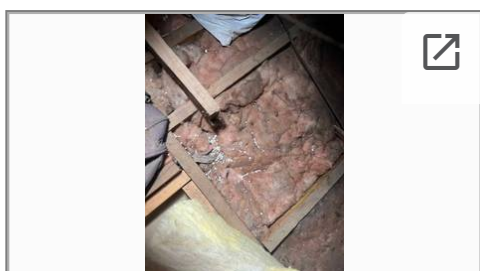
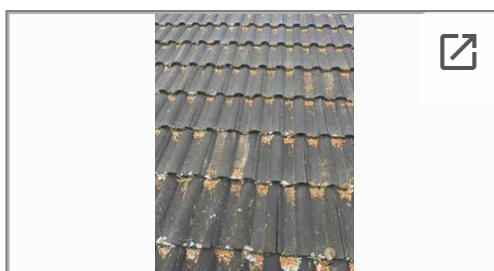
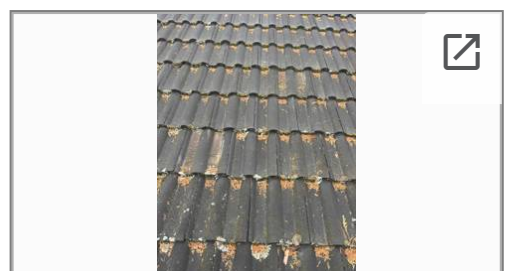
After careful inspection and investigation I do not believe water ingress is occurring via the roof. Currently the roof looks to be in good condition.

- Ridge caps are in good condition
- Mortar and pointing are in good condition
- Solar panel penetrations are in good condition
- Penetration flashings are in good condition

Only issue is the eaves gutter are full of debris and missing overflow provisions.

I do not believe the causation of water ingress into the bathroom is a result of a roof leak.
