Engineers Initial Visual Report

Address: 16 Aaran Close, Endeavour Hills, VIC 3802
Client: ENData PTY Reference number: 6210261821
Clear Engineering Services Reference number: 12222007

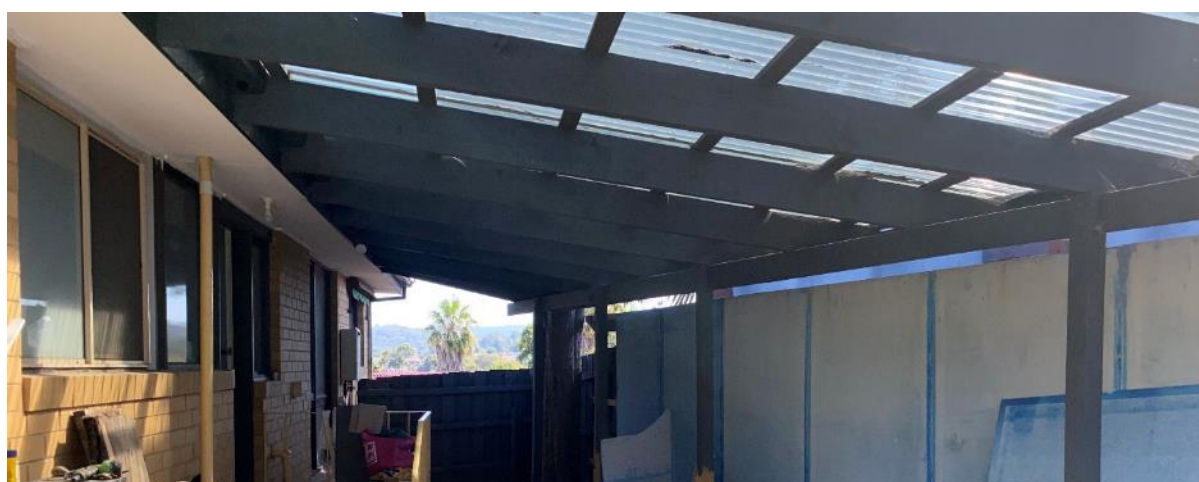
- The Insured claims that the sheet roof cladding of the eastern pergola leaks during regular rainfall.
- Roof battens are 25 mm thick, whereas the minimum in AS1684: *Residential Timber Framed Buildings* is 35 mm.

Photo 16 shows a typical view of the underside of the timber pergola structure.

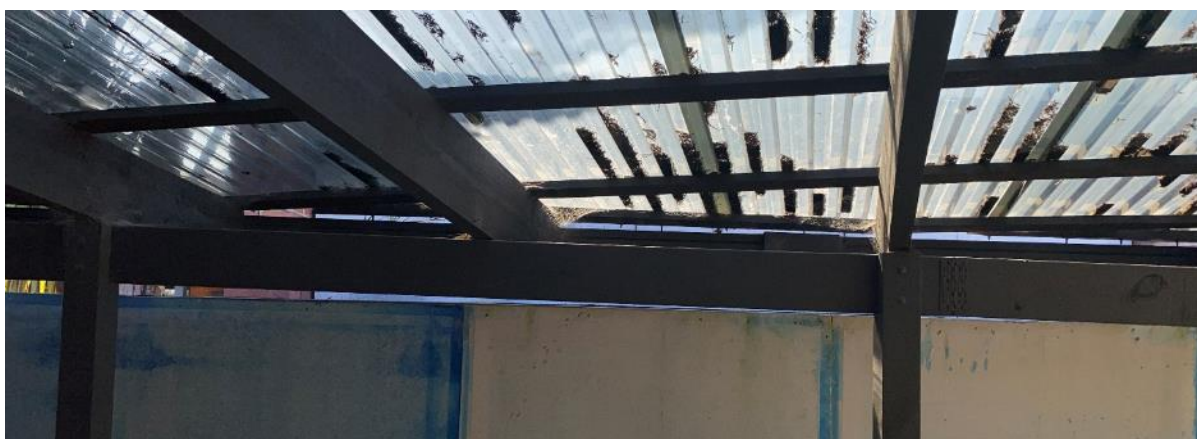
Photo 17 shows the underside of the timber pergola structure.

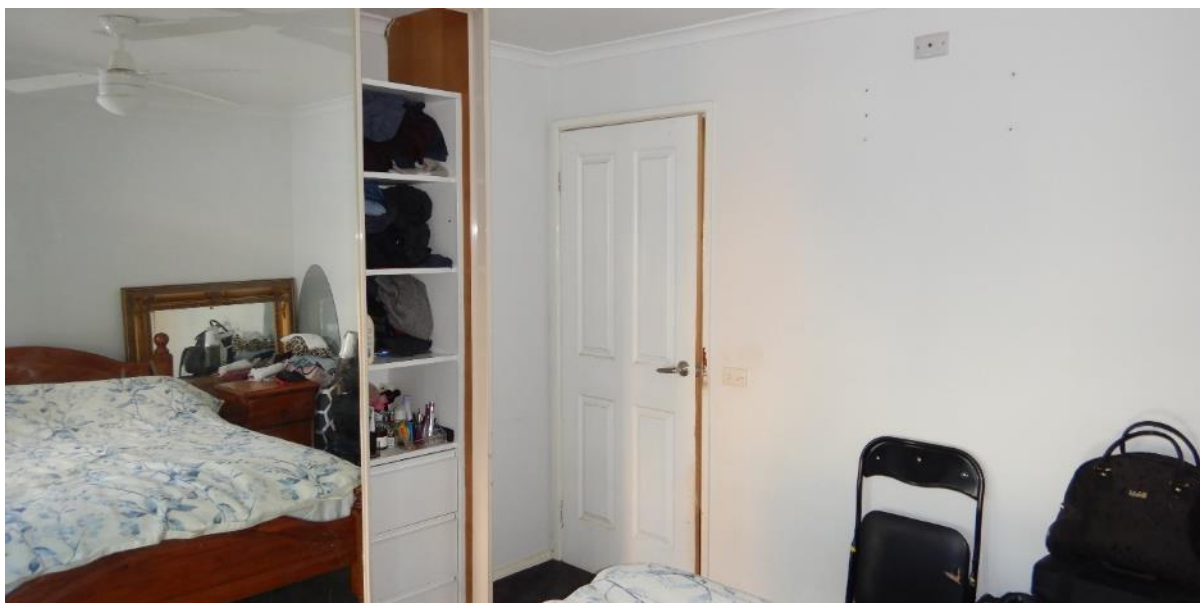
- Hairline to 20 mm gap between the plasterboard wall lining and the wardrobe
- Patching was noted along the junction of the wardrobe and wall lining.

Photo 19 shows a typical view of bedroom 1.

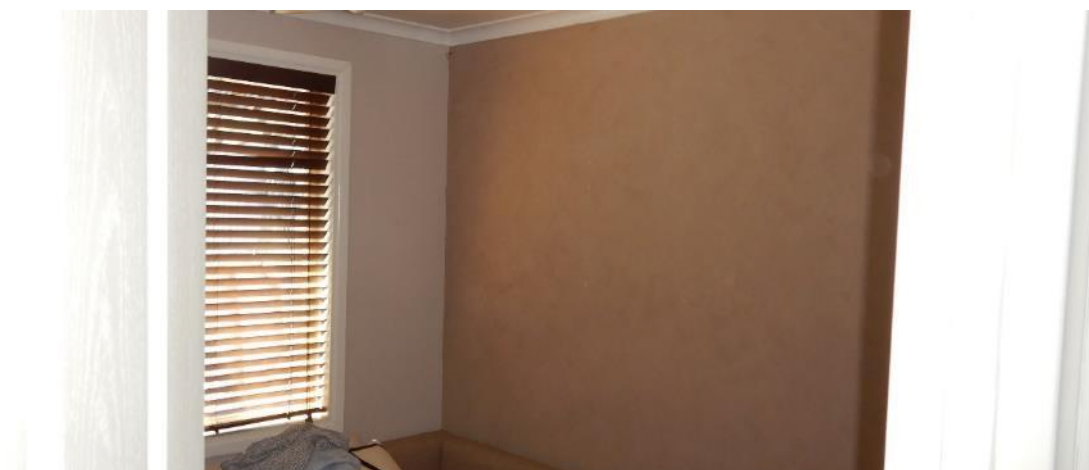
- A 1.0 mm vertical crack in the plasterboard wall lining extends across the height of the wall.
- Hairline vertical crack in the plasterboard wall lining extends from the door architrave.
- Dislodgement of the door casing at the entrance door
- Flaking paint/moisture damage to the plasterboard ceiling linings

Photo 22 shows a typical view of bedroom 3.

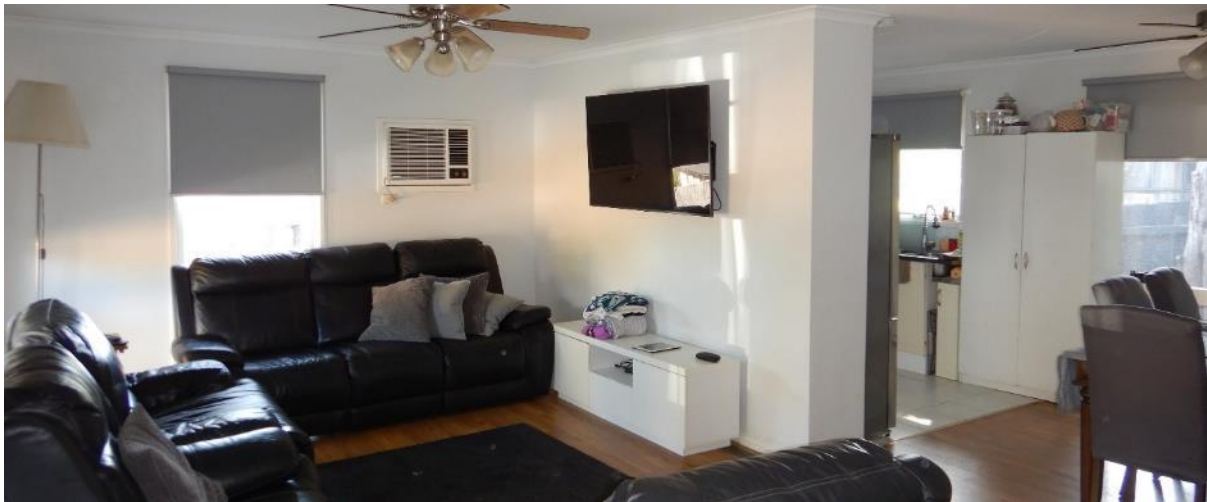
- Hairline vertical cracks in the surface of the wall lining that extend the height of the wall
- Hairline crack above the door architrave extending to the cornice
- The paint along sections of the cornice and ceiling has bubbled.
- Minor cupping at the junctions of the length and heads of several timber floor coverings in the north-western corner.
- ~3.0 mm gap between the window casing and plasterboard wall lining and along the skirting board
- The sliding door that connects the lounge to the hallway scrapes along the roller brackets and has resulted in a scrape mark forming along the lower section of the door.

Photo 31 shows a typical view of the lounge room.

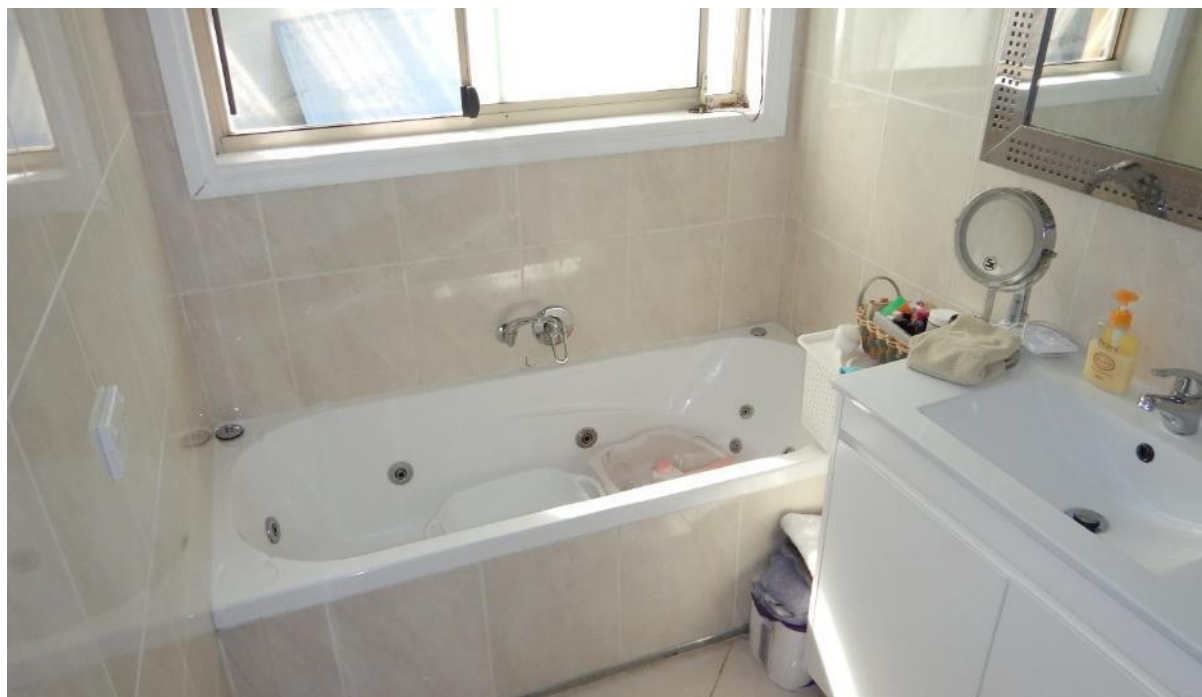
- Hairline to 1.0 mm crack in the tile mortar at the wall-wall junction and wall-floor junction
- Hairline crack along the mitre joint of the architrave

Photo 39 shows a typical view of the bathroom.

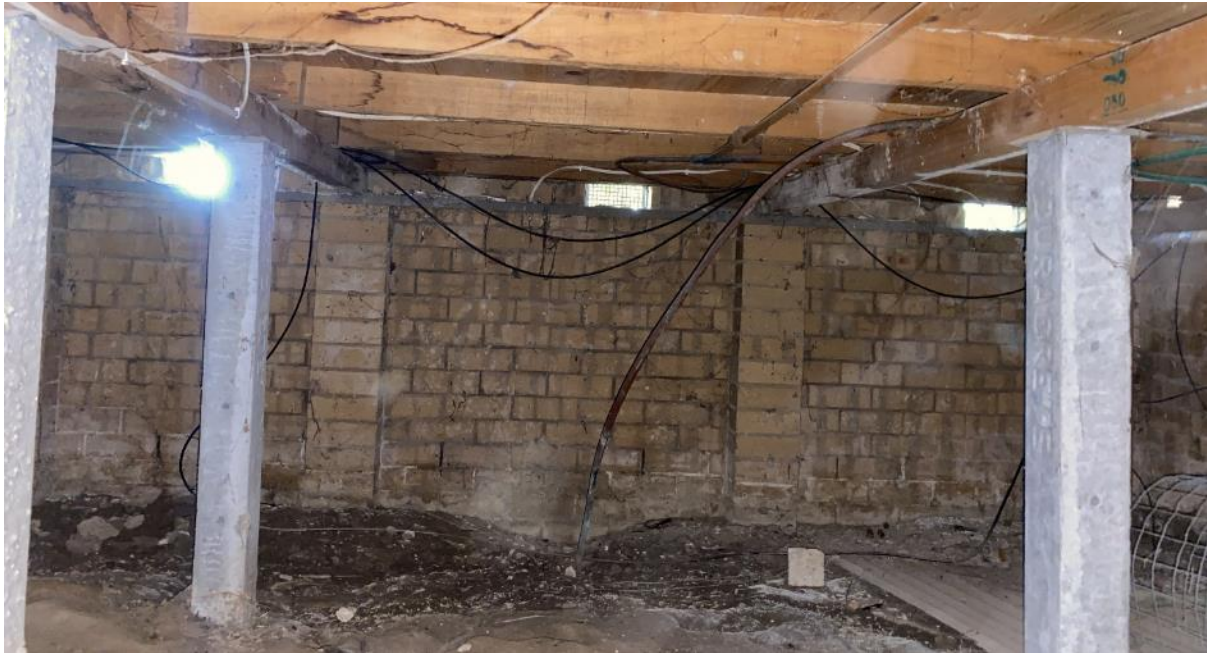
- 4.5.1. An inspection of the subfloor was conducted which was accessed through an external hatch on the east side of the building.
- 4.5.2. The subfloor is constructed of concrete stumps, timber bearers, and timber joists.
- 4.5.3. The perimeter is constructed of an engaged brick pier sub wall.
- 4.5.4. There is evidence of prolonged dampness along the surface of the ground in the north-western corner and efflorescence.

Photo 43 shows a typical view of the western sub wall.

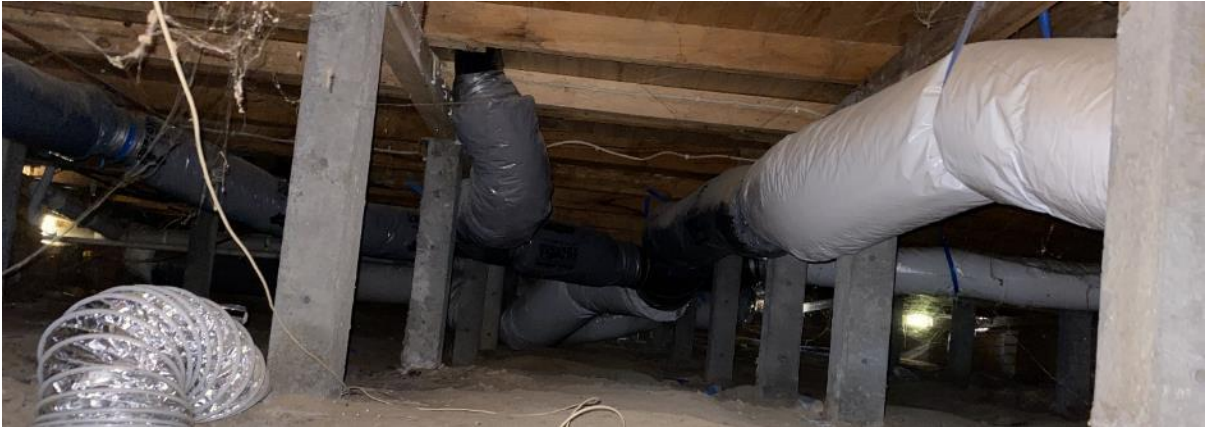
Photo 45 shows the centre of the subfloor cavity looking south.

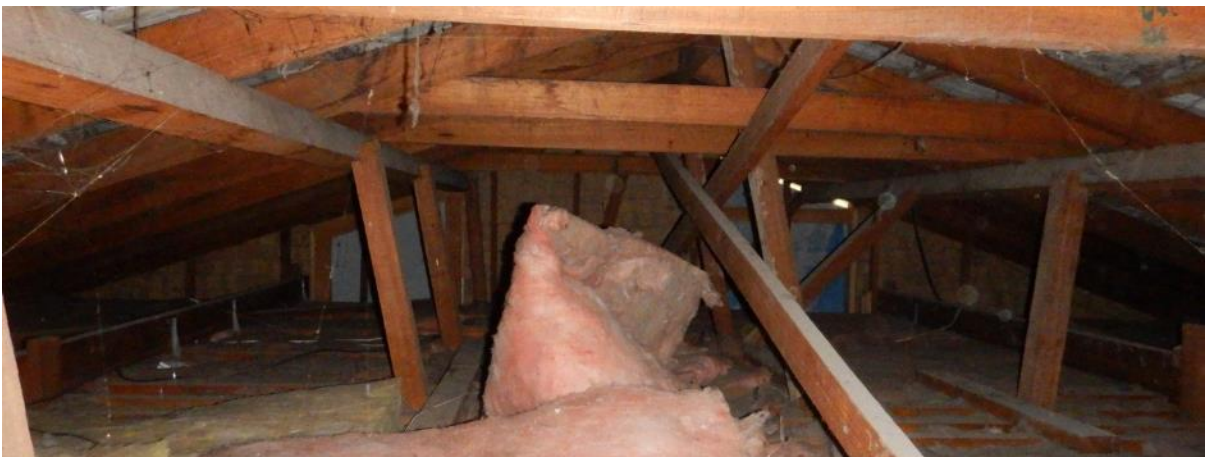
- 4.6.1. The roof is constructed of pitched hardwood roof framing.
- 4.6.2. The pitch of the roof is 18 degrees.
- 4.6.3. No sarking has been installed between the underside of the tiled roof cladding and the timber roof battens.
- 4.6.4. Efflorescence deposits were noted along the underside of the roof tiles.
- 4.6.5. Watermarks were noted on the internal side of the plasterboard ceiling linings directly above the bathroom.
- 4.6.6. Newly installed plasterboard sheeting was noted directly above the area of water ingress.
- 4.6.7. Adhesive daub connections between the plasterboard sheeting and the ceiling joists are situated at 175 mm – 200 mm centres.

Photo 46 shows a typical view of the roof cavity.

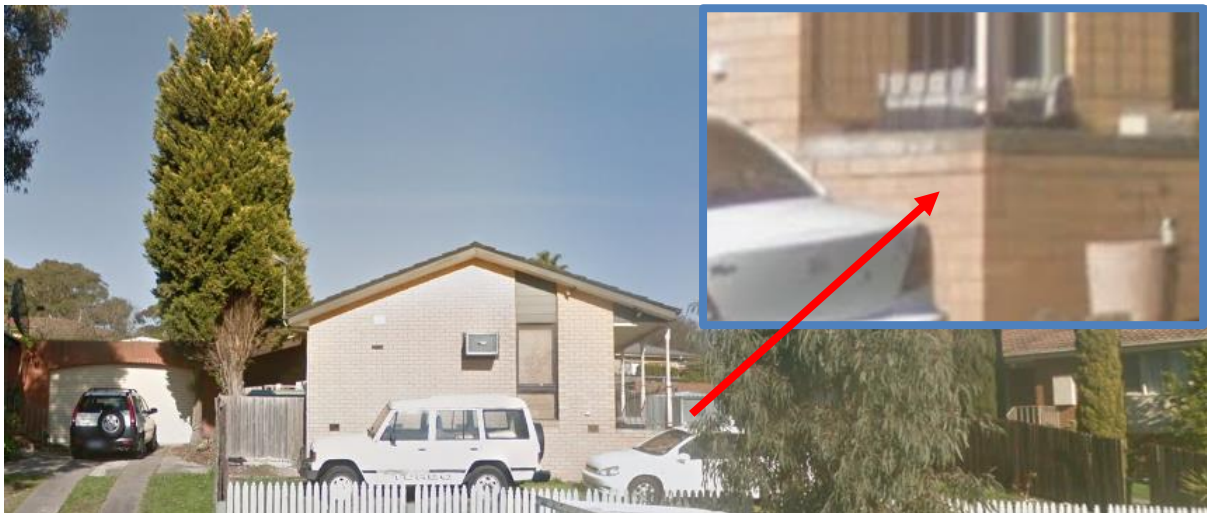
Picture 6: Google Street View dated July 2014

- 5.3.1. We have reviewed the images available on Google Street View to determine the timeline of the damage.
- 5.3.2. We note in January 2008 a group of mature trees/shrubs are situated adjacent to the footings along the northern elevation.
- 5.3.3. The group of mature shrubs along the northern elevation were removed between January 2008 and July 2014.
- 5.3.4. Cracks to the brick cladding around the porch (before the wall cladding was rendered) can be seen in July 2014.
